REPORT OF INVESTIGATION

Fatal Powered Haulage Accident
January 27, 2011

Baylor Mining, Inc.
Jims Branch No. 3B Mine
New Richmond, Wyoming County, WV
I.D. No. 46-09243

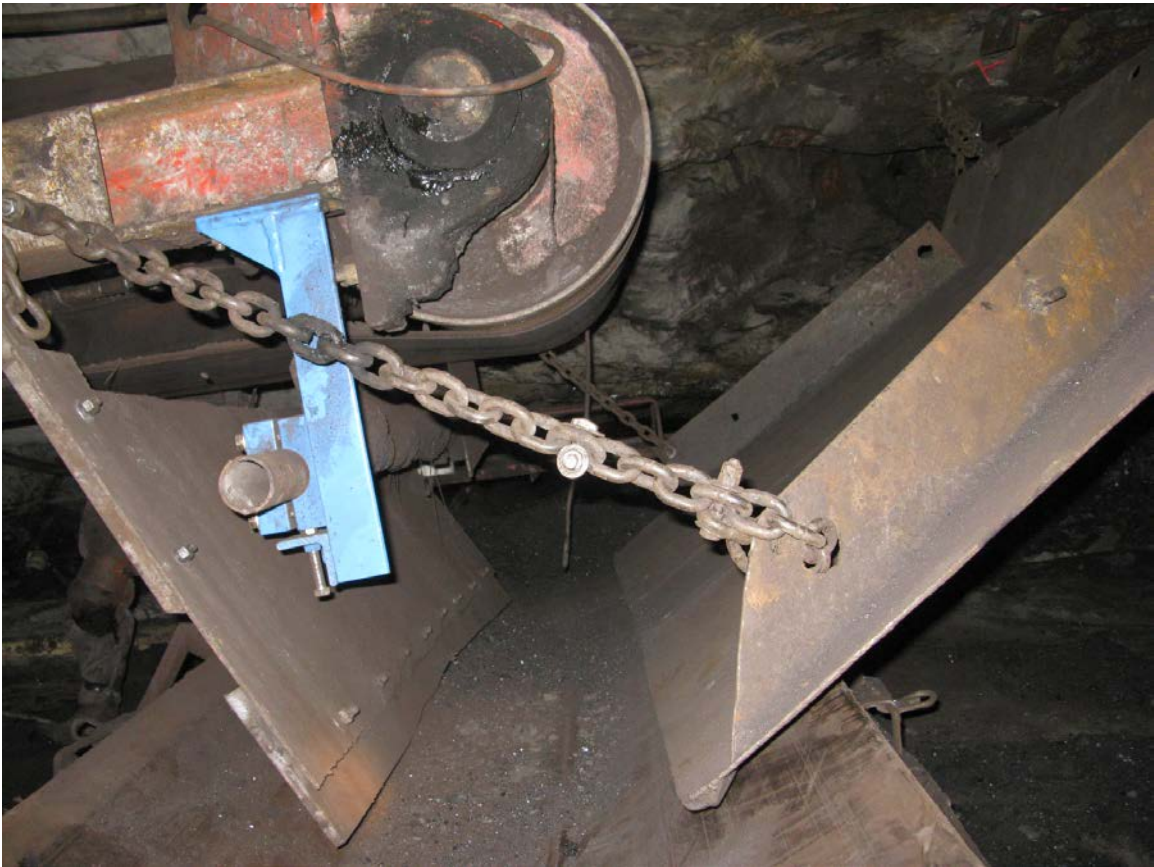
Photo of Reconstructed Accident Scene – Minus Discharge Roller Guarding

It is likely this accident occurred when the victim, who had little mining experience, attempted to cross the moving No. 3 conveyor belt just inby the No. 4 conveyor belt head and fell on top of the No. 3 conveyor belt. The No. 3 conveyor belt immediately carried him into the discharge coal guide boards, causing him to become caught in the structure.

Based on the evidence at the accident scene, along with the victim's location and position, when located, the most likely cause of the accident was that Lester fell onto the No. 3 conveyor belt, while attempting to cross the moving belt, just inby the No. 4 conveyor belt head. This caused the victim to be pulled under the expanded metal guarding and become lodged on the inby edge of the drip board chute attached to the No. 4 conveyor belt head.

Corrective Action: A Safeguard Notice was issued requiring that persons shall not cross moving conveyor belts, except where suitable crossing facilities have been provided.

Corrective Action: The operator has included a requirement in the company's safety plan that when conveyor belts are installed that are not in line of the receiving belt or if cross belts are not dumping directly over the receiving belt tailpiece, and height allows, a belt crossover will be installed on the receiving belt inby and outby the belt head dumping point. An additional crossover was installed inby the number 4 belt conveyor discharge roller and inby the number 2 belt conveyor discharge roller.

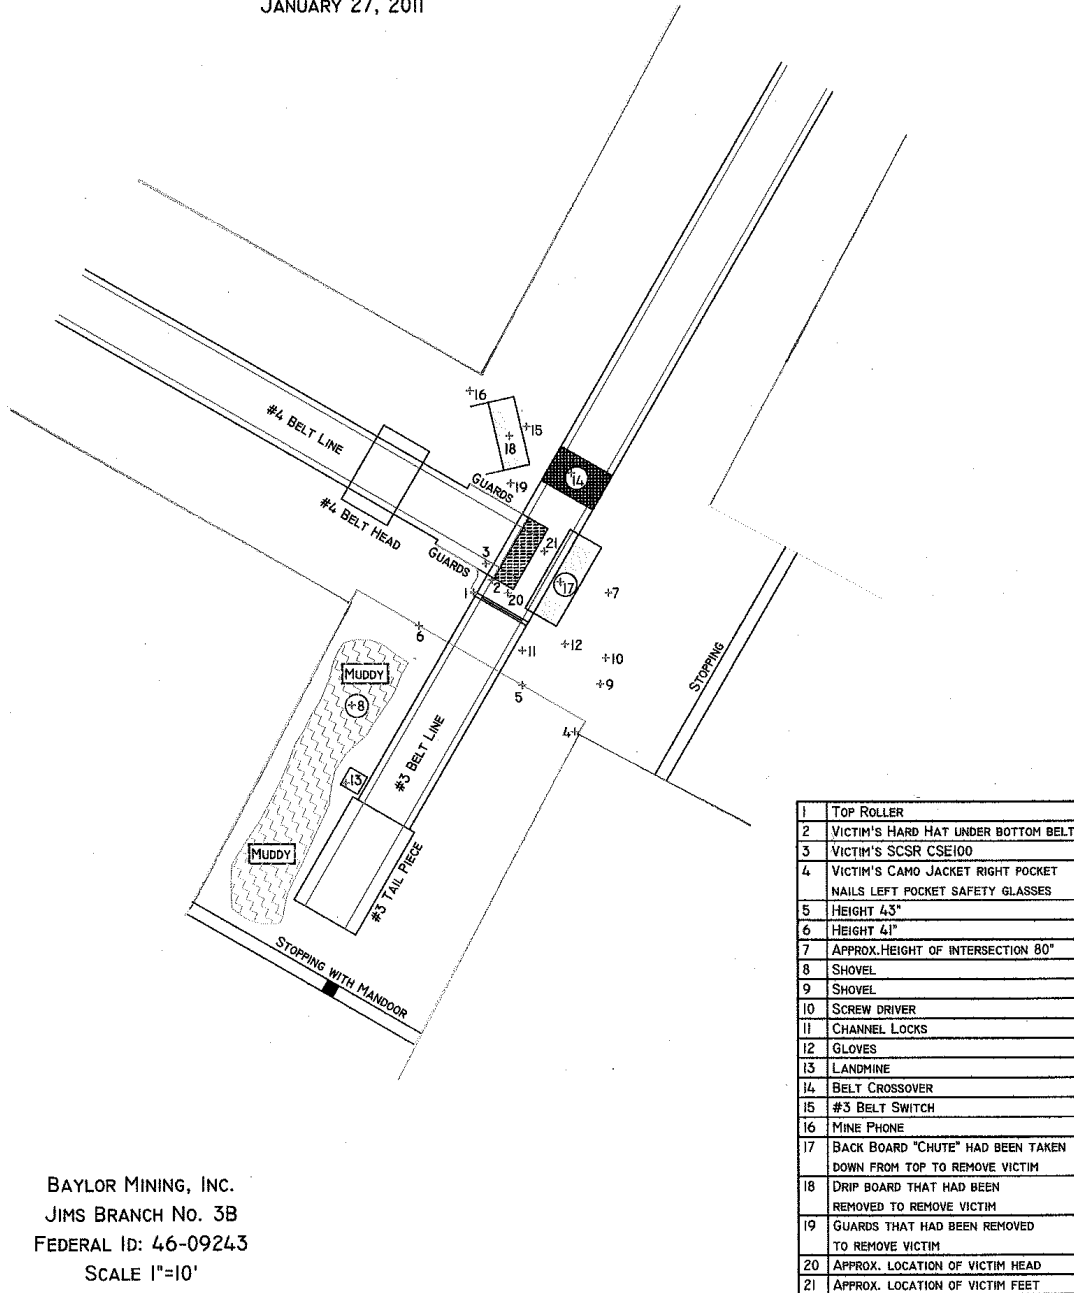
APPENDIX C Sketch of the Accident

The mining height around the No. 4 Conveyor Belt Head was approximately 6 feet 8 inches high, while the mining height adjacent to the Conveyor Belt Head averaged just 42 inches. See Drawing of the Accident scene in Appendix C.

The following is a list of the physical evidence at the scene of the accident: Lester's jacket was found placed on the offside rib, evidence of belt cleaning, fresh grease on a grease fitting at the offside of the No. 4 Conveyor Belt Head, a wrapper from a package of crackers, and the presence of two coal shovels; one on each side of the tail piece for the No. 3 Conveyor Belt.

In addition, there were signs of recent work at the scene of the accident, which included fresh grease on the grease fitting, located on the off side of the No. 4 Conveyor Belt Head. This was evidenced by very little dust accumulations on the application of fresh grease. However, a grease gun was not found at the accident scene. There was also evidence that the No. 3 Conveyor Belt, between the tail piece and the No. 4 Conveyor Belt Head, had been cleaned recently (shoveled).
