REPORT OF INVESTIGATION

Fatal Powered Haulage Accident
February 11, 2011

West States Skanska, Inc. (VH8)
Cortez, CO

Kayenta Mine
Peabody Western Coal Company
Black Mesa, Navajo County, Arizona
MSHA I.D. No. 02-01195

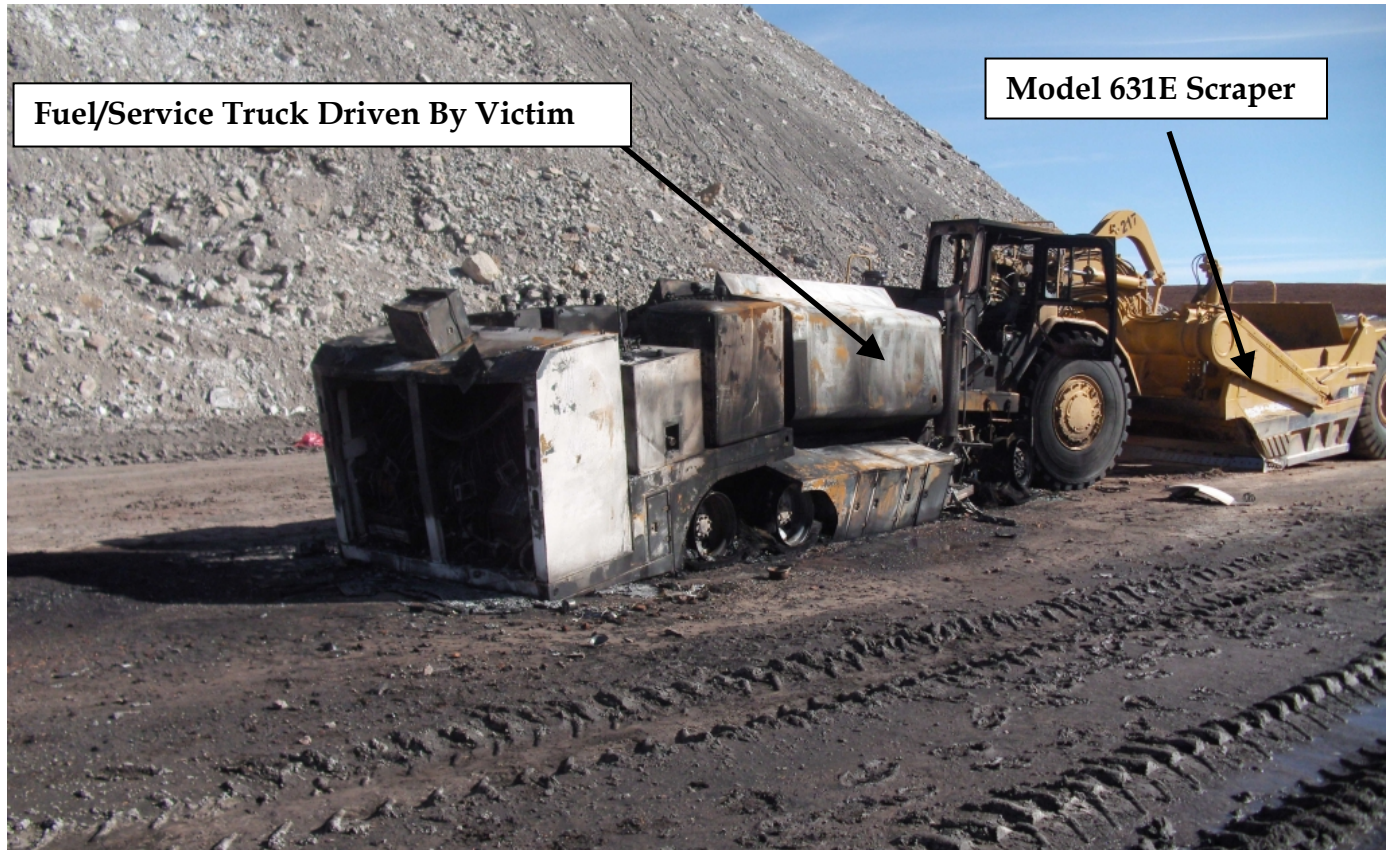
VEHICLE COLLISION SITE

On Friday, February 11, 2011, at approximately 2:00 p.m., Roy Lee Black (victim), a 55-year-old serviceman with 30 years mining experience, was killed in a powered haulage accident at the J21 Pit, Ramp 38 area of the Kayenta Mine. The accident occurred as Black was driving a combination fuel/service truck on a two-way haul road between ramps 40 and 38 after servicing equipment around the mine site. Several scrapers were operating on the same haul road as part of a topsoil removal operation. The traffic pattern was two-way, right-hand traffic. A scraper was being driven, traveling in the opposite direction on the haul road and on the wrong side for the right-hand traffic pattern. The scraper and the fuel/service truck collided.

Because of a blind intersection, scraper operators drove on the left side (left-hand traffic pattern) of the haul road when entering the haul road. Traffic approaching on the same side of the haul road (right-hand traffic pattern) could not be seen because of a high berm. The road was not marked adequately with signage to ensure that the equipment operators knew which vehicle had the right of way.

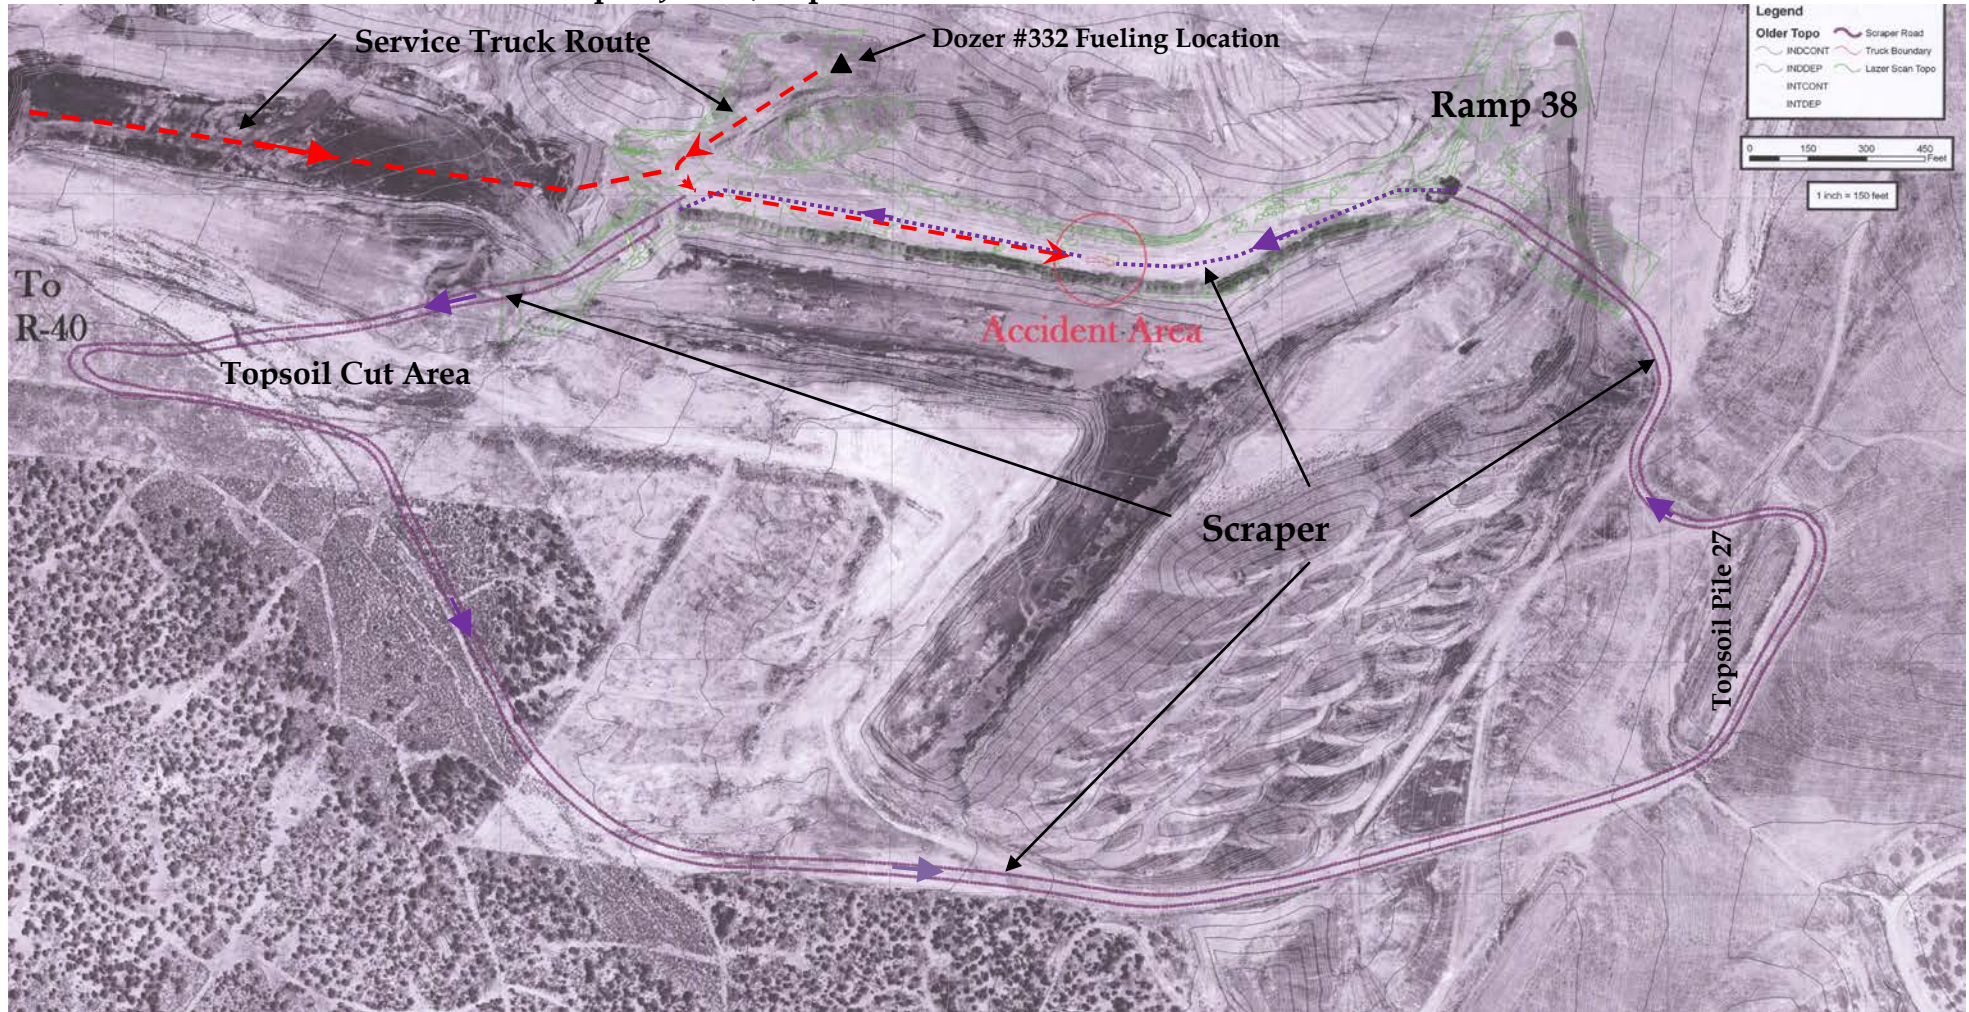
Map of J21 Pit, Topsoil Removal Area and Accident Scene

The location of bulldozer #332 and the route that Black's service truck traveled is depicted on Appendix D. The service truck traveled approximately 900 feet westerly and the scraper traveled easterly about 650 feet on the haul road before the collision.

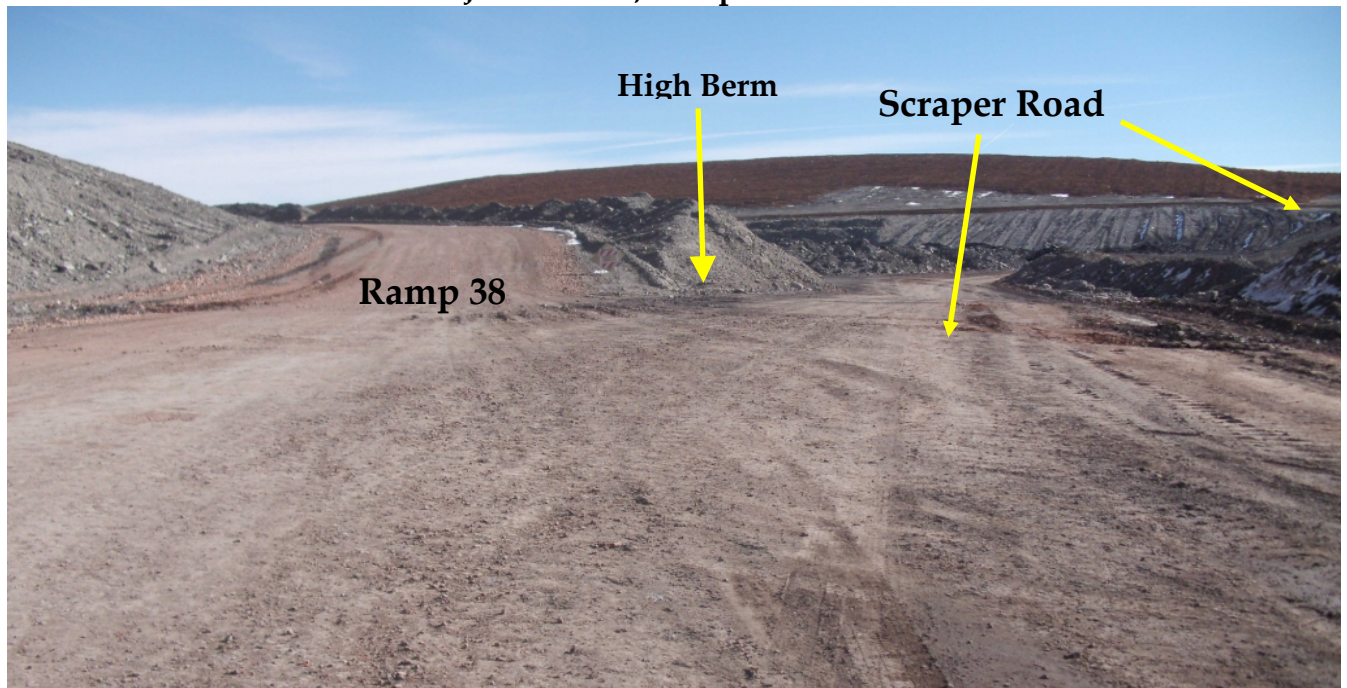
Root Cause: The traffic pattern of the topsoil removal operations caused the scrapers to stay to the left side when entering the east side of the haul road because of the high berm and possible traffic approaching from the right side. The road was not marked clearly with signage to ensure that equipment operators clearly knew which vehicle had the right of way.

3. A 104(d)(1) Citation , Number 6688935, was issued to Peabody Western Coal Company for a violation of 30 CFR § 77.1600(b). Signage was absent to clearly indentify which vehicle had the right of way at the intersection of ramp 38 haul road and the scraper road and also at the west end intersection of this scraper road and the haul road near ramp 40. The traffic pattern of the topsoil removal operations caused the scrapers to stay to the left side when entering the intersection at ramp 38. The scrapers traveled on the left side because of a high berm separating the roadways and possible traffic approaching from the right side. The scrapers had been using this traffic pattern for approximately two weeks. On February 11, 2011, a fatal accident occurred when a Caterpillar 631E Scraper #217 (Serial No. 1AB01738) collided with a Model 348 Fuel/Lube Service Truck (VIN 797542) on the haul road at the J21 Pit Area, ramp 38. This violation is an unwarrantable failure to comply with a mandatory standard.

Intersection of Scraper Road and Ramp 38, looking easterly

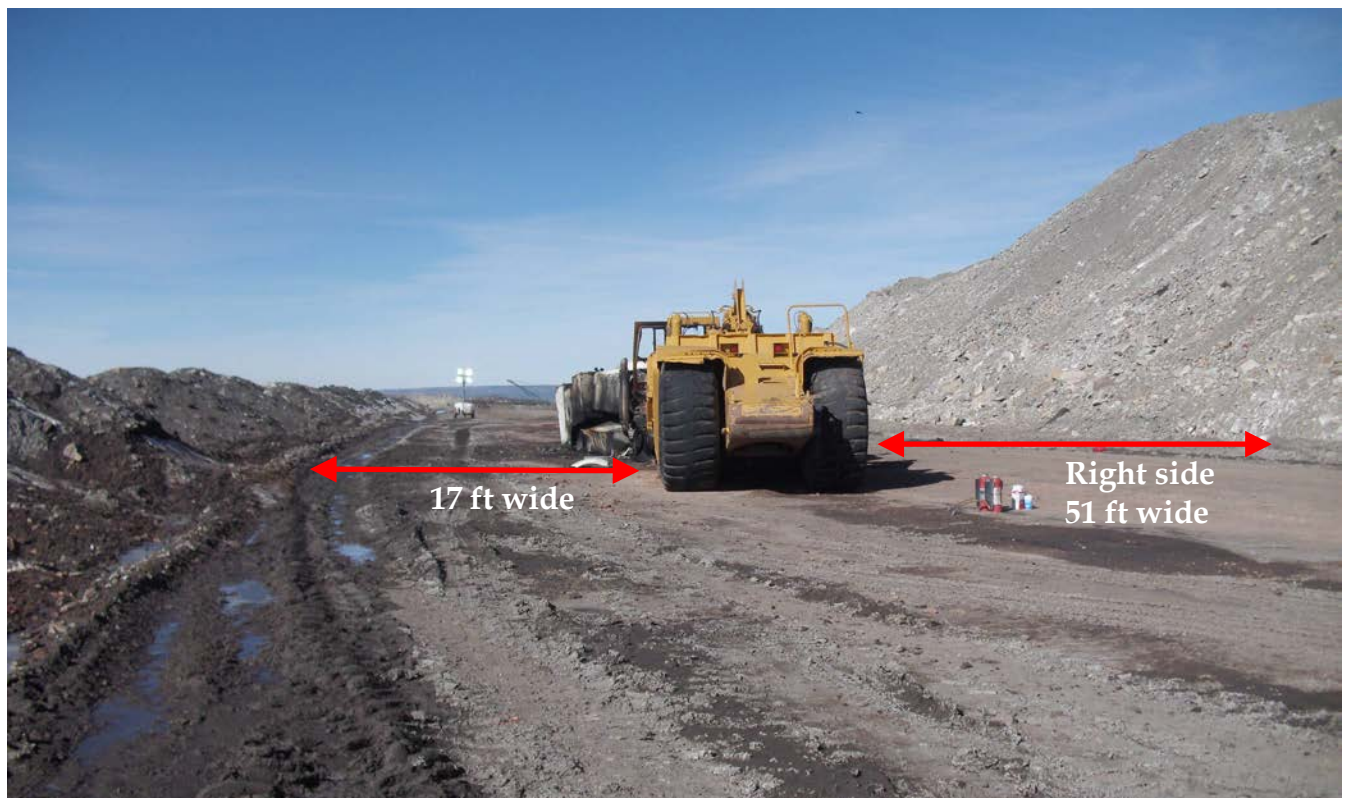
Appendix E shows the position of Scraper #217 on the left side of the haul road at the collision site. The haul road was approximately 80 feet wide at that point. The haul road varied in width from 100 feet at ramp 38 to 150 feet at the west end. At ramp 40, it was relatively flat in slope.

Scraper on Left side of Haul road at collision site, looking westerly
