REPORT OF INVESTIGATION

Fatal Machinery Accident  
March 25, 2011

Mine No.1  
Matrix Energy LLC  
Lovely, Martin County, Kentucky  
ID No. 15-18575

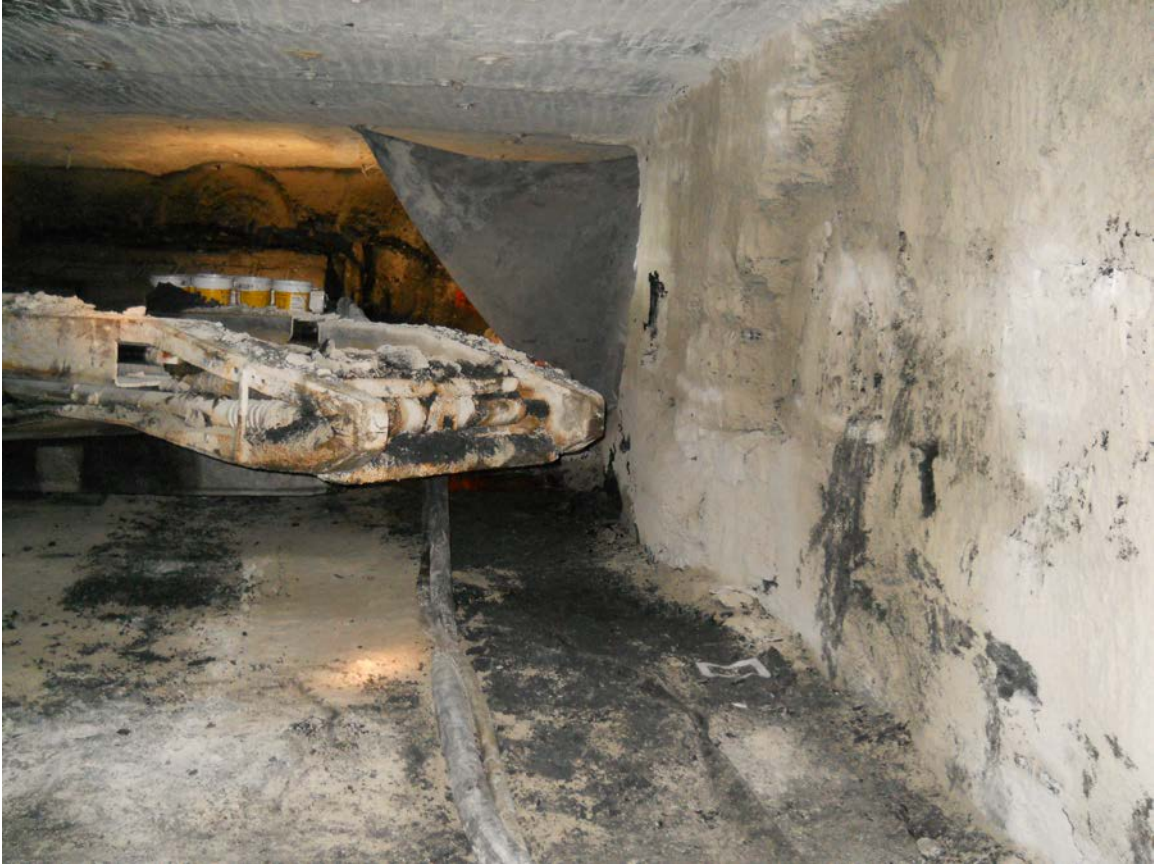
**Photograph of Accident Scene**

When investigators first arrived at the accident scene, the continuous mining machine was positioned nearly parallel with the inby coal rib in the crosscut and the boom was fully extended to the right, as viewed from the rear of the machine as shown in Appendix C. The cutting head of the machine was located approximately 40 inches from the solid left rib of the No. 2 entry. The tip of the machine conveyor boom was 18 inches from the inby coal rib. Based on evidence and measurements taken at the scene, it was evident that the boom had been moved approximately 13 inches away from the inby coal rib to free the victim at the time of the accident.

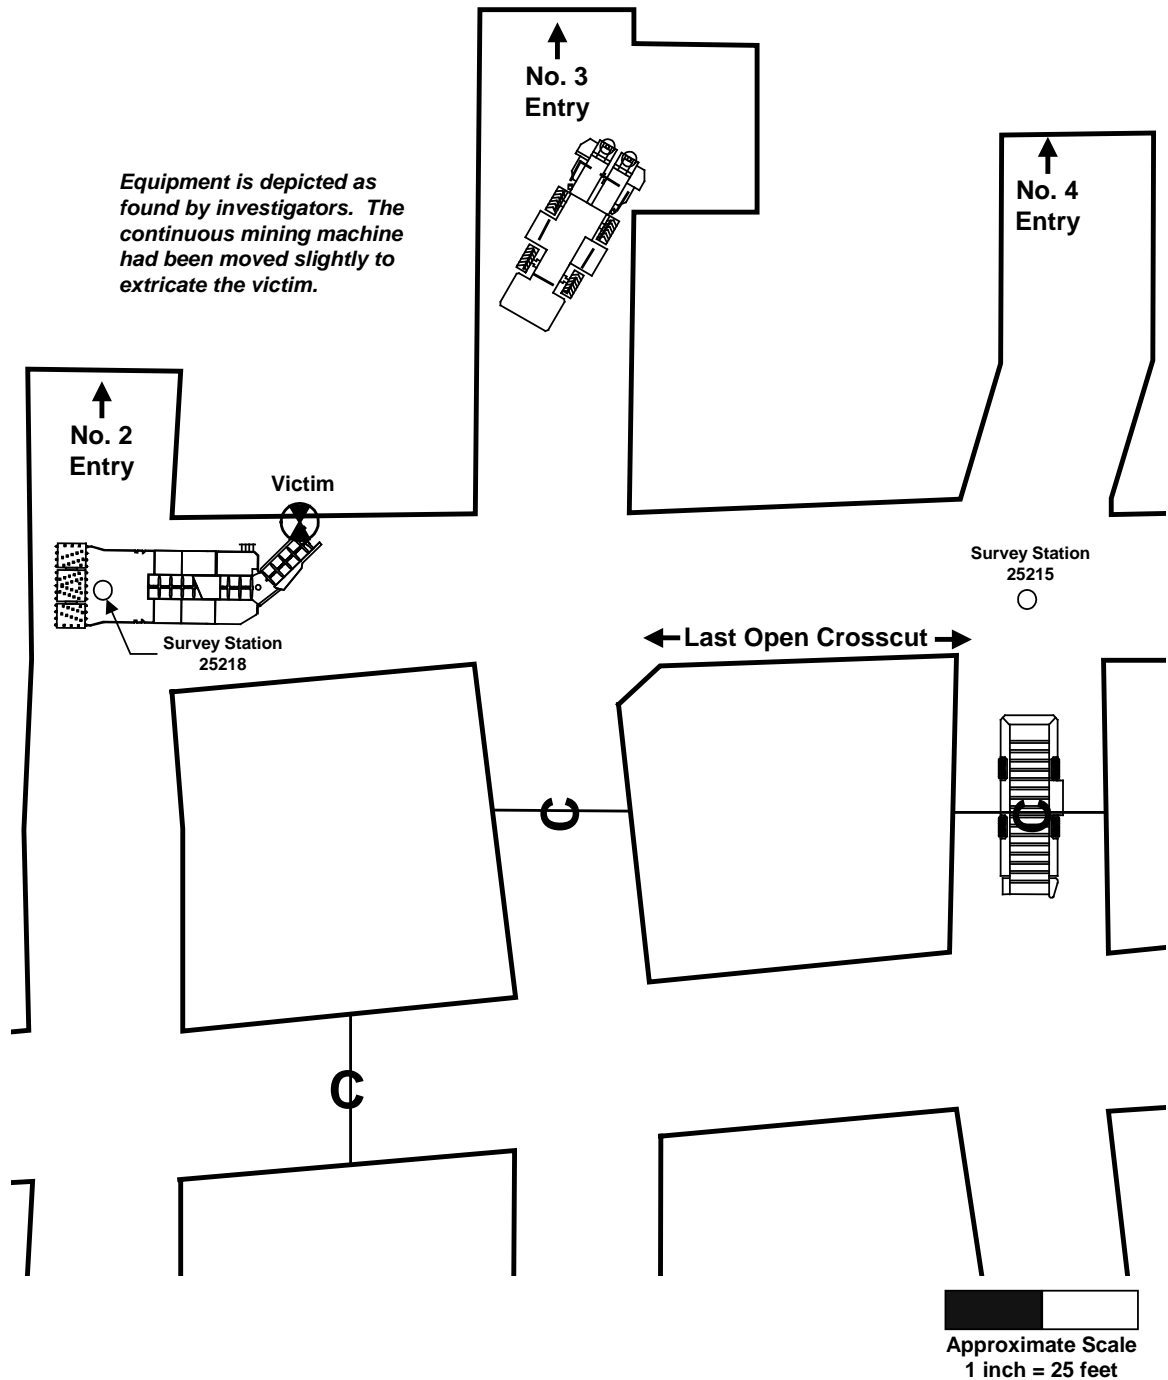
Fatal Accident Sketch  
Matrix Energy LLC  
Mine No.1 (I.D. 15-18575)  
March 25, 2011

The accident occurred in the crosscut between the No. 2 and No. 3 entries on the #2 Section; approximately 25 feet from Survey Station No. 25218 (see Appendix C). The mining height in the immediate area was seven feet and the width of the crosscut was approximately 20 feet. The working section consisted of seven entries, mined on 60-foot centers.
