REPORT OF INVESTIGATION

Fatal Slip/Fall of Person Accident
June 9, 2011

Rocky Mountain Steel, Inc (7WU)
Montrose, CO

West Elk Mine
Mountain Coal Company, LLC
Somerset, Gunnison County, Colorado
MSHA I.D. No. 05-03672

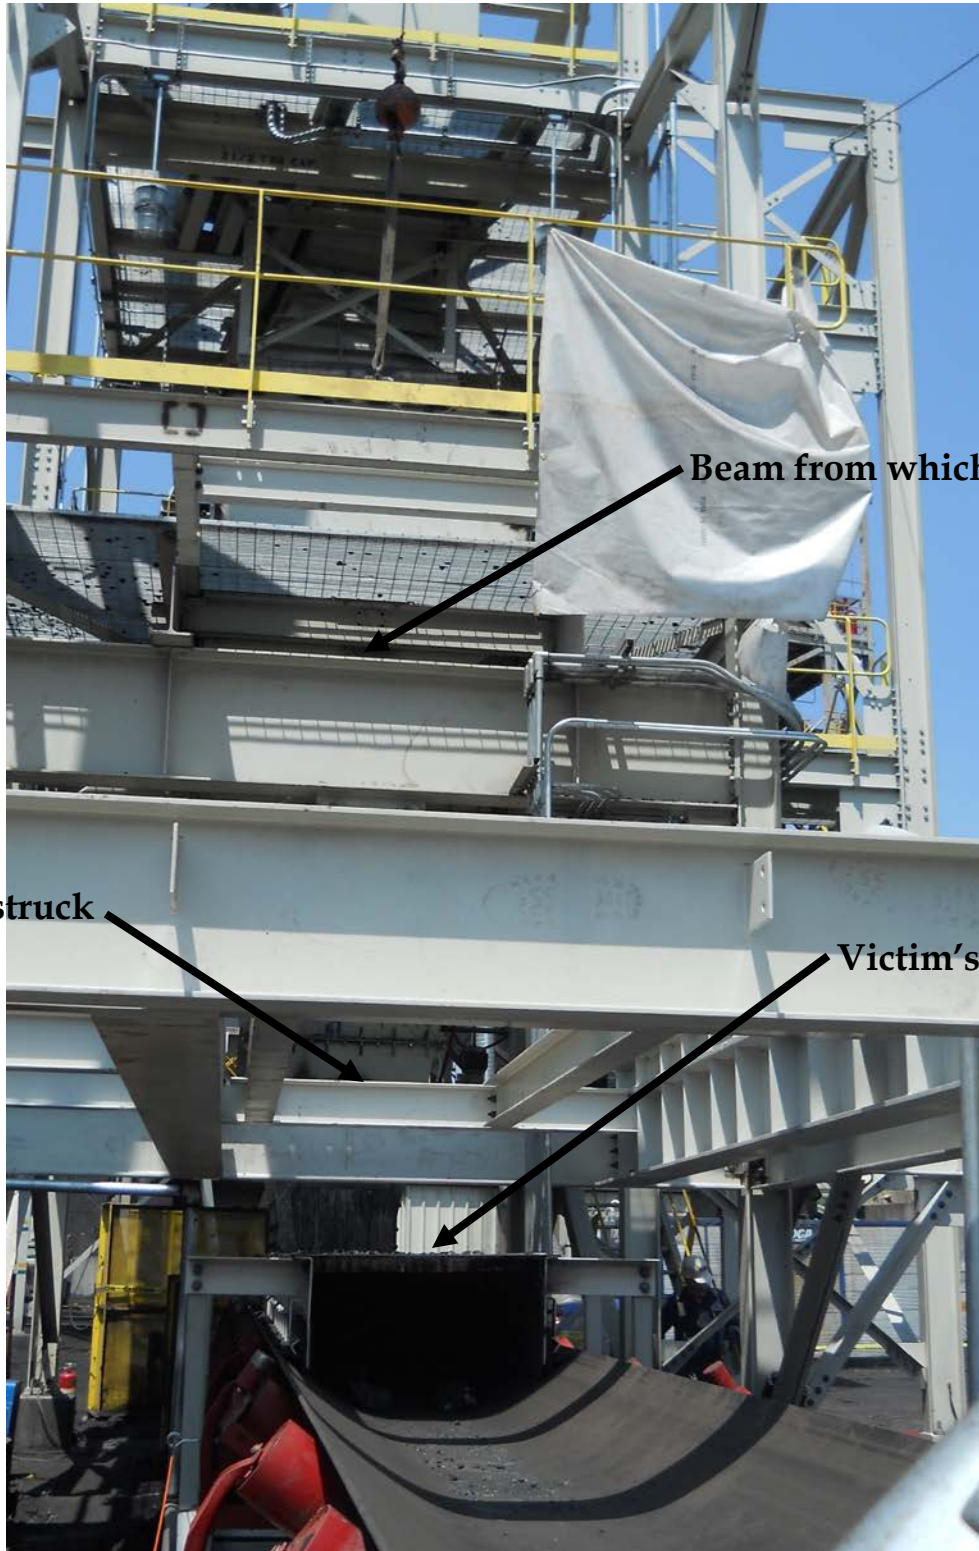
VIEW OF SCALPING TOWER ACCIDENT SITE

Beam from which victim fell

Cross Beam struck

Victim's final position

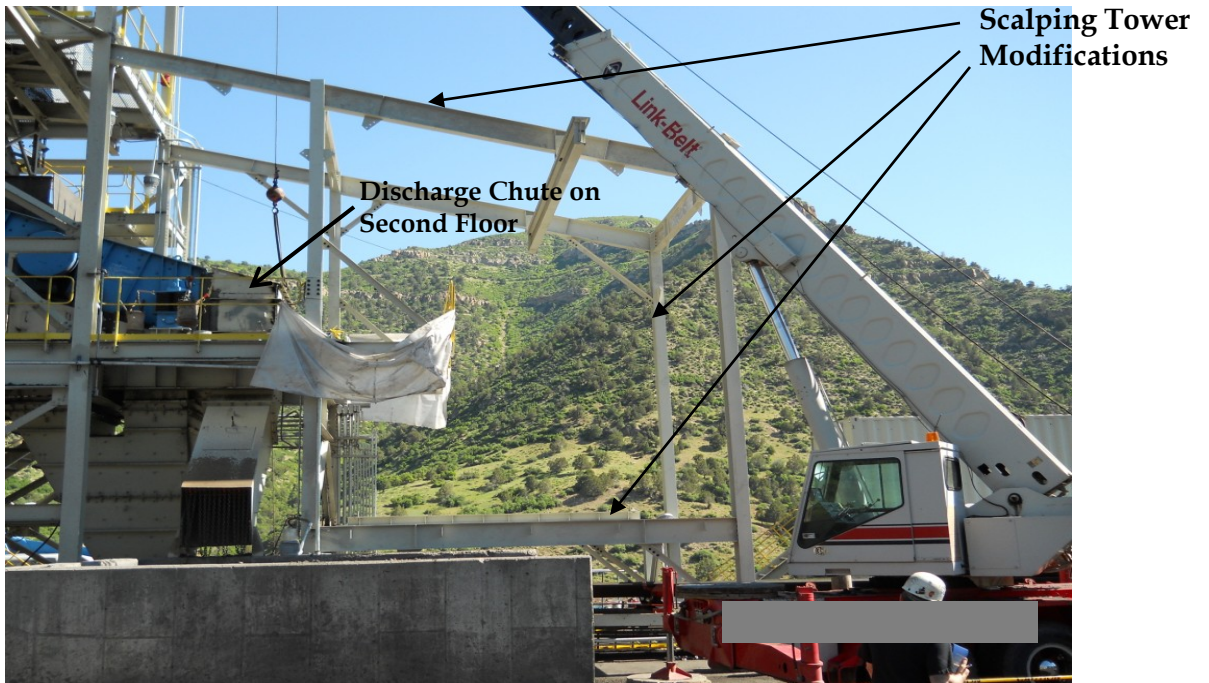
Appendix C:
General Accident Site

The accident occurred at the Unit 2020 Scalping Station tower construction site, located at the surface facilities of the West Elk Mine (see Appendix C). Rocky Mountain Steel is a contract iron works company in Grand Junction, Colorado, but has contracts throughout the western United States. Rocky Mountain Steel relies on Underground Staffing Connections, Contractor ID No. 9HI, an independent manpower company from Delta, Colorado, to fill laborer requests. On this project, Underground Staffing, Inc. provided four ironworkers and Rocky Mountain Steel had one supervisor on location to direct the workforce. These five individuals had worked together several times in the past on other iron work projects.

The beam where the victim was standing was located about 25 inches below the floor level grating and was 11-inches in width. (see Appendix C). The 5¼-inch wide cross beam struck by the victim was located 96 inches below and 38 inches to the east of the 11-inch wide beam. The distance from this cross beam to the conveyor dust cover was 31½ inches. The conveyor cover was 36¾ inches wide and approximately 67 inches off the ground level. A diagram showing these beams is located in Appendix D.

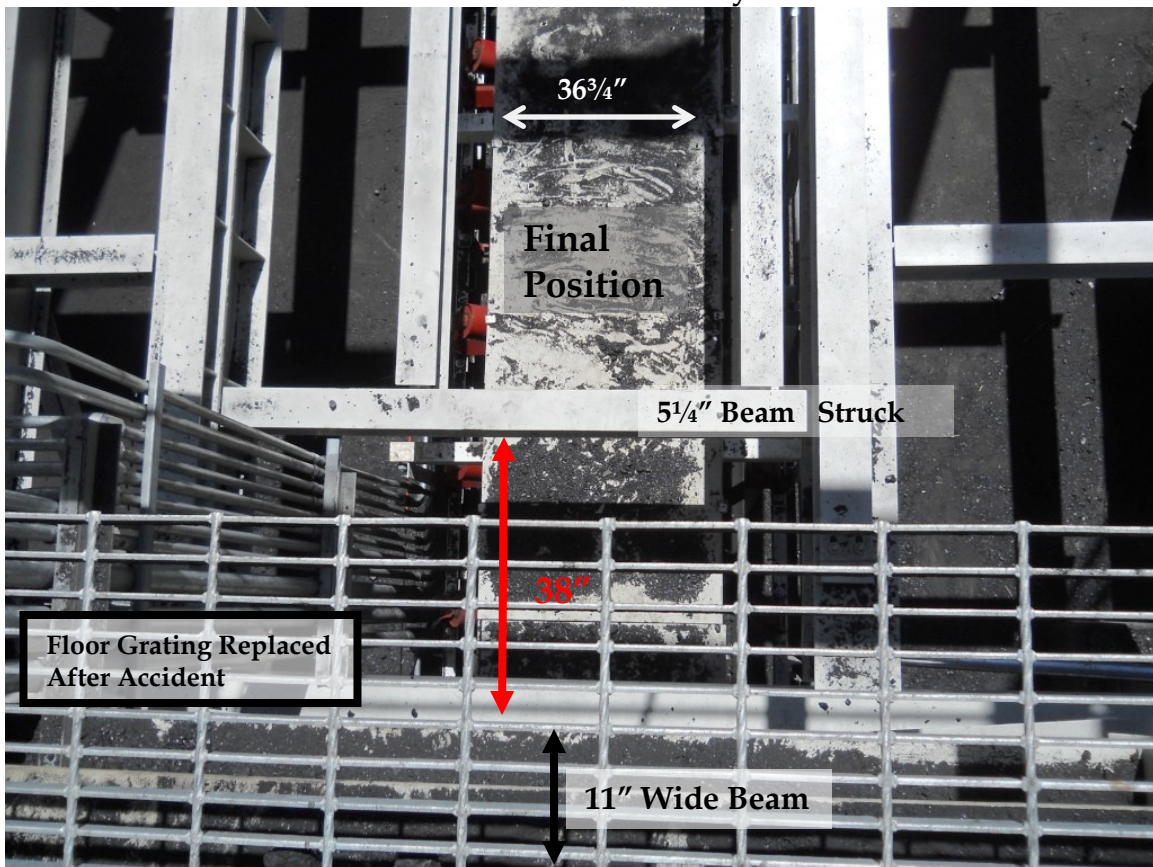
Photo of Cross Beam Struck by Victim:

Benally's right foot slip and Benally fall from the beam. Rule stated, at that time, he saw Benally with the lanyard in his hand. Rule assumed Benally was climbing up when he unhooked. Benally fell approximately 8 feet and struck a 5-inch wide cross beam with his chest. Benally flipped over this cross beam and landed on the conveyor dust cover, 32-inches below the top of beam.

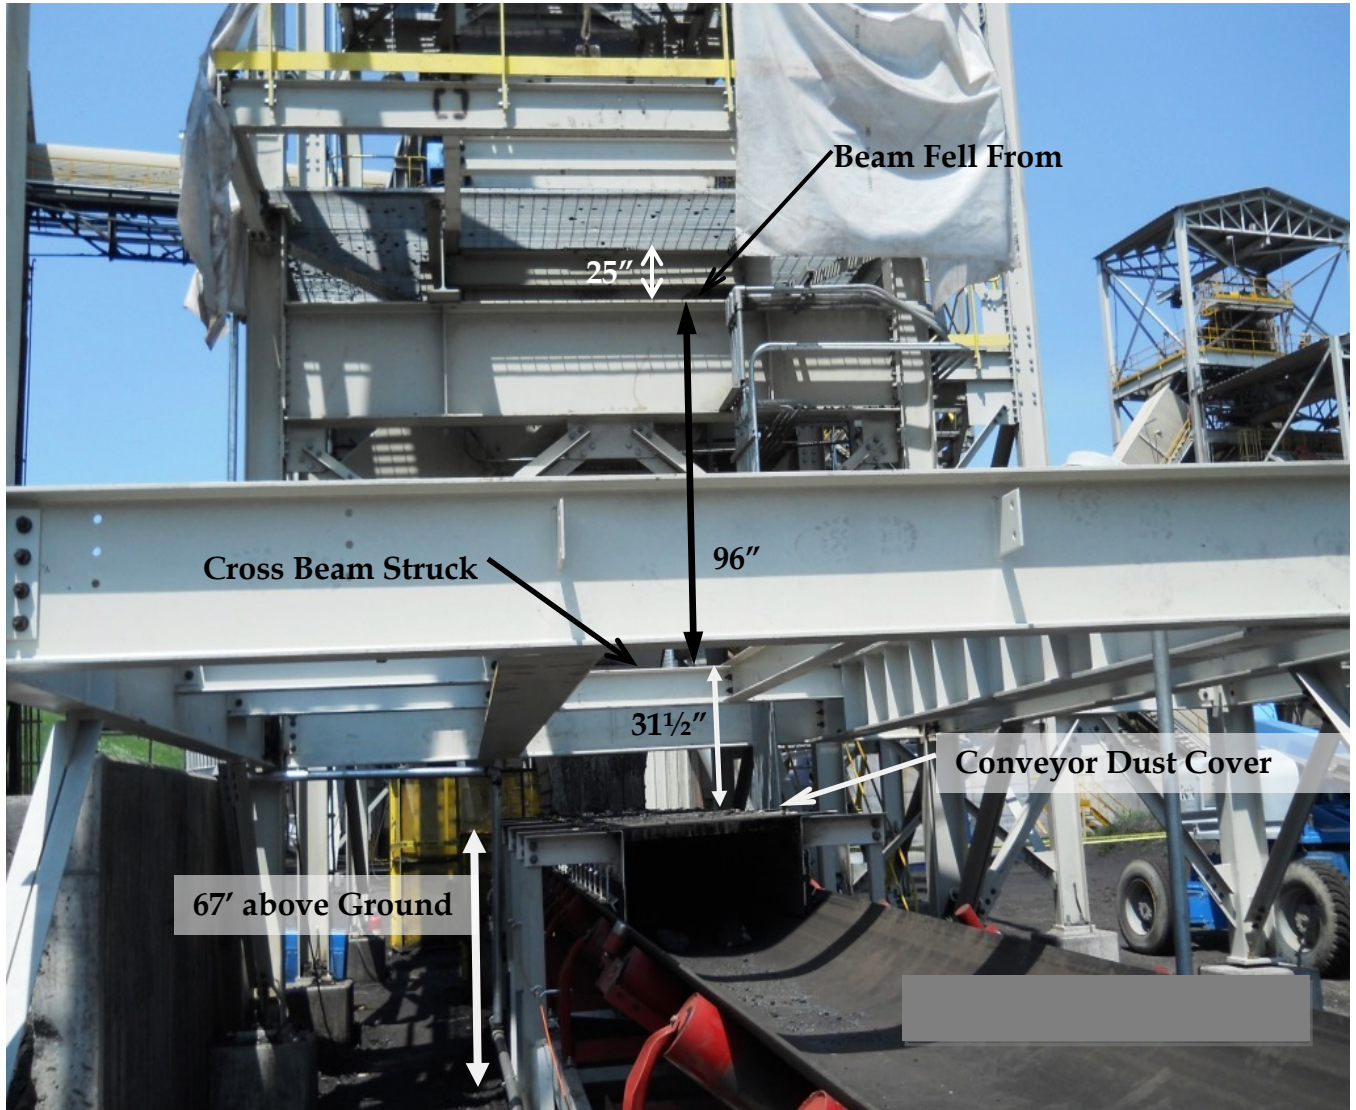
Photo of Scalping Tower Accident Site

Extraneous material consisting of coal, coal dust, and chunks of coal were covering the steel I-beam where the victim was standing and working. The coal was dry and ranged from very fine particles, to about ½ inch in diameter. A section of grating had covered the I-beam when the crew first entered the work area that morning. In the process of modifying the chute, the grating had been moved away from the area, exposing the “I” beam.

Corrective Action: Management conducted and documented a safety meeting with the Rocky Mountain Steel employees and reiterated the need to ensure the work areas and travelways are free from extraneous materials and coal. Rocky Mountain Steel management has instituted a written policy, which states that all personnel will be trained prior to beginning work on any projects. The training will teach employees how to recognize and report all slip, trip, and fall hazards for corrective measures before commencing work in the areas identified with hazards.

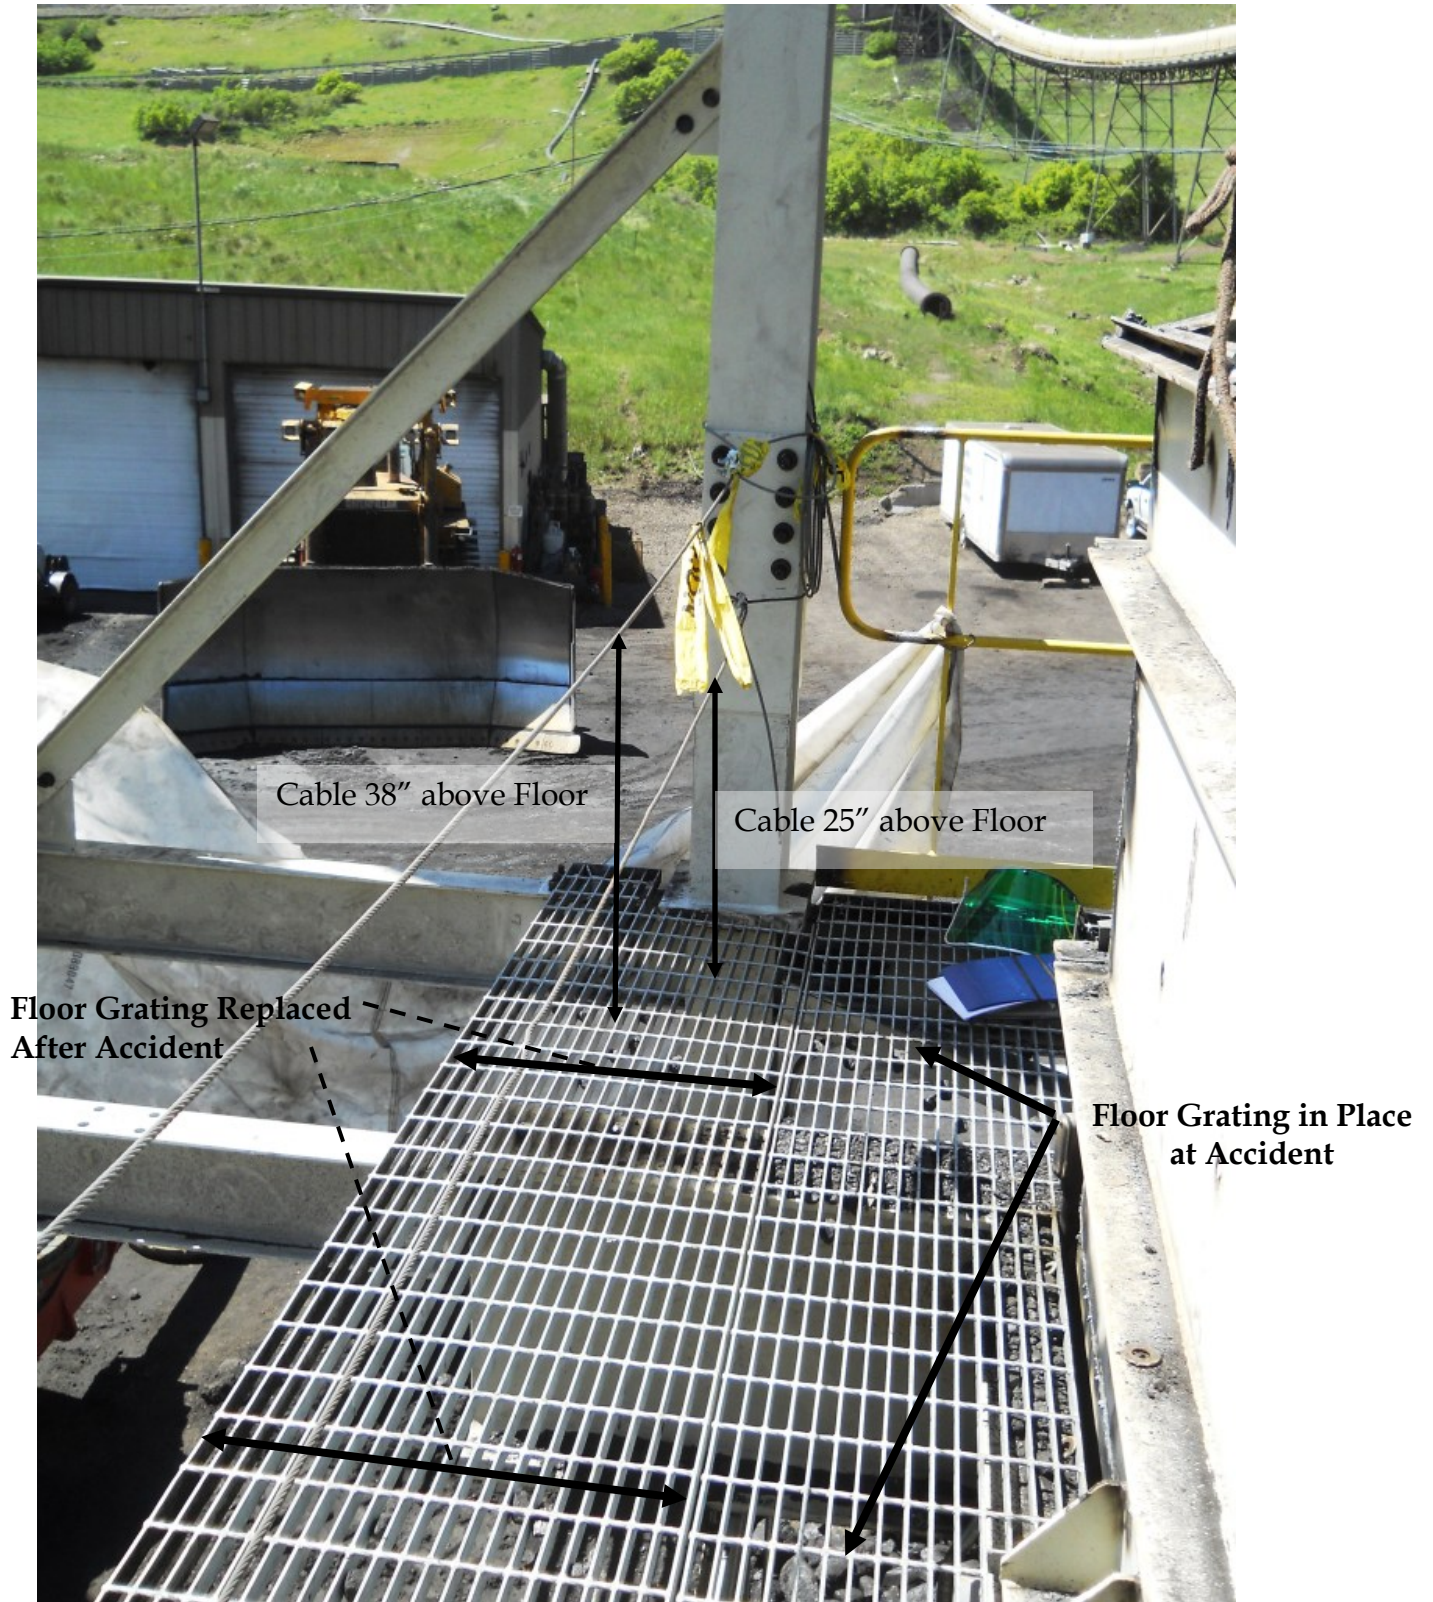
**Appendix E:
Photo of Steel Cable Tie Offs**

Two ¾-inch steel cables were hung across the two columns on the second floor for use as tie off points for lanyards when working on the second floor of the scalping tower. The cables were positioned about 25 inches and 38 inches above the floor level and were secured to the columns with two cable clamps at each end (see Appendix E).

Corrective Action: Management for Rocky Mountain Steel conducted and documented a safety meeting to reinforce the regulations and company policy concerning fall protection measures. The requirement to have a lanyard always connected (tied-off) to a suitable anchor, and when possible, tying off above waist level were stressed. The requirement to inspect and check the fall protection equipment (harness, lanyards, d-ring connectors, snap connectors, tie cables, beamers, and anchor points) prior to use was also discussed.

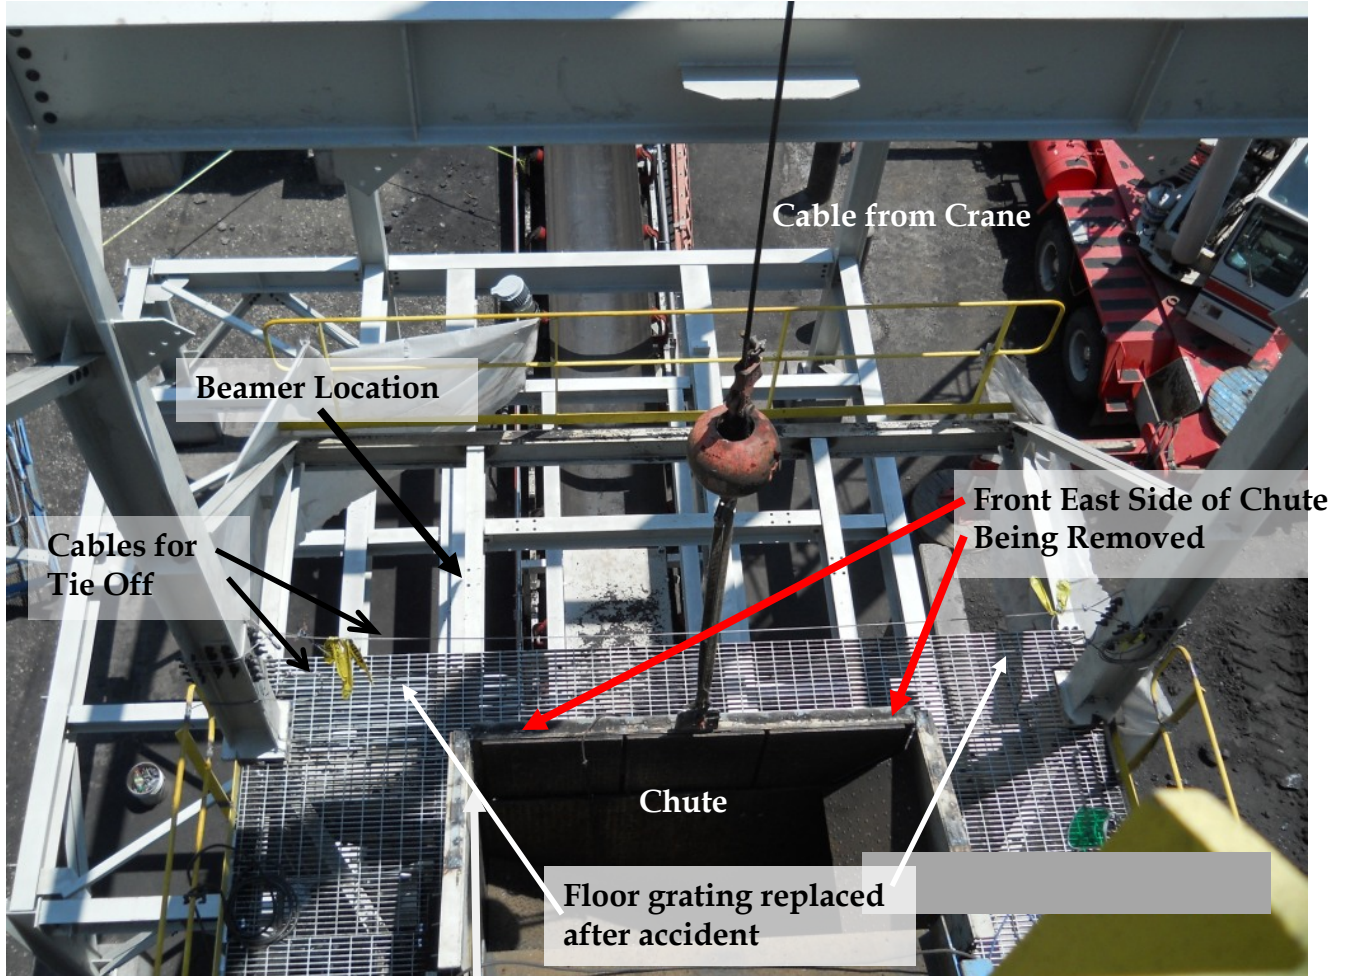
Photo of Chute on Second Floor

A metal clamping device with flanges (called a beamer), which easily attached to the web and flanges of steel I-beams, was used as an anchor point for securing lanyards. A beamer can be moved freely along the length of a beam or column and still provide anchorage for a lanyard. This beamer and its operation was inspected and appeared to be functional (see Appendix F).
