UNITED STATES
DEPARTMENT OF LABOR
MINE SAFETY AND HEALTH ADMINISTRATION
COAL MINE SAFETY AND HEALTH

REPORT OF INVESTIGATION

Rib Roll Accident
June 27, 2011

Eagle #1 Mine
Rhino Eastern, LLC
Bolt, Raleigh County, West Virginia
I.D. No. 46-08758

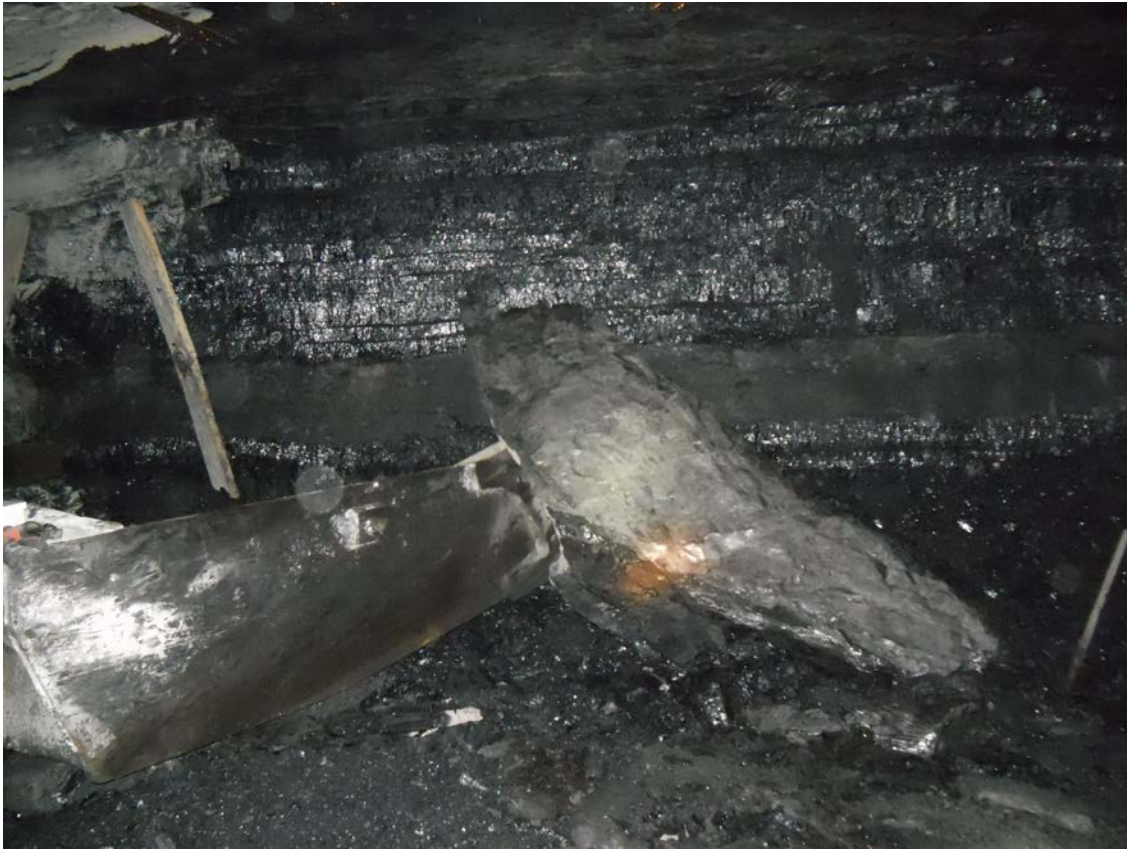
On June 27, 2011, at approximately 1:10 a.m., Joseph Cassell, Crew Leader (Victim), was killed, after receiving crushing injuries, when a portion of the rib comprised of coal and rock, fell and struck him. The victim was in the process of cleaning the mine floor to install a wooden support timber, because of a deteriorated rib, when the accident occurred. The piece of material that fell was approximately 100 inches long, 32 inches thick, and 37 inches in height. The accident occurred one crosscut outby the loading point of the mechanized mining unit 004 (MMU-004) mining section.

The accident occurred because the rib bolts installed previously in the top portion of the rib were insufficient to stabilize the rib of the entry and prevent material from falling when the mine floor was being cleaned.

The top portion of the rib that struck the victim had three rib bolts installed near the bottom of the top split of coal. The location of the rib bolts was inadequate to support the weight of the broken rib material properly. As the material fell, two of the three bolts pulled out of their expansion shells. The remaining bolt was bent at a downward angle, and the rib material broke around the rib support.

The rib material broke when it separated from the coal pillar. The largest intact portion had dimensions of 100 inches long, 32 inches thick, and 37 inches in height. The fallen material was composed of coal with several thin shale streaks and weighed approximately 90 pounds per cubic foot. A calculation of the total weight of the intact piece of material was approximately 6,000 pounds.

Corrective Action: The mine operator revised the roof control plan and obtained walkthrough roof bolting machines to install rib bolts from a safe location. The revised plan now specifies five-foot long fully grouted rib bolts, and multiple rib bolts when the mining height exceeds seven feet.

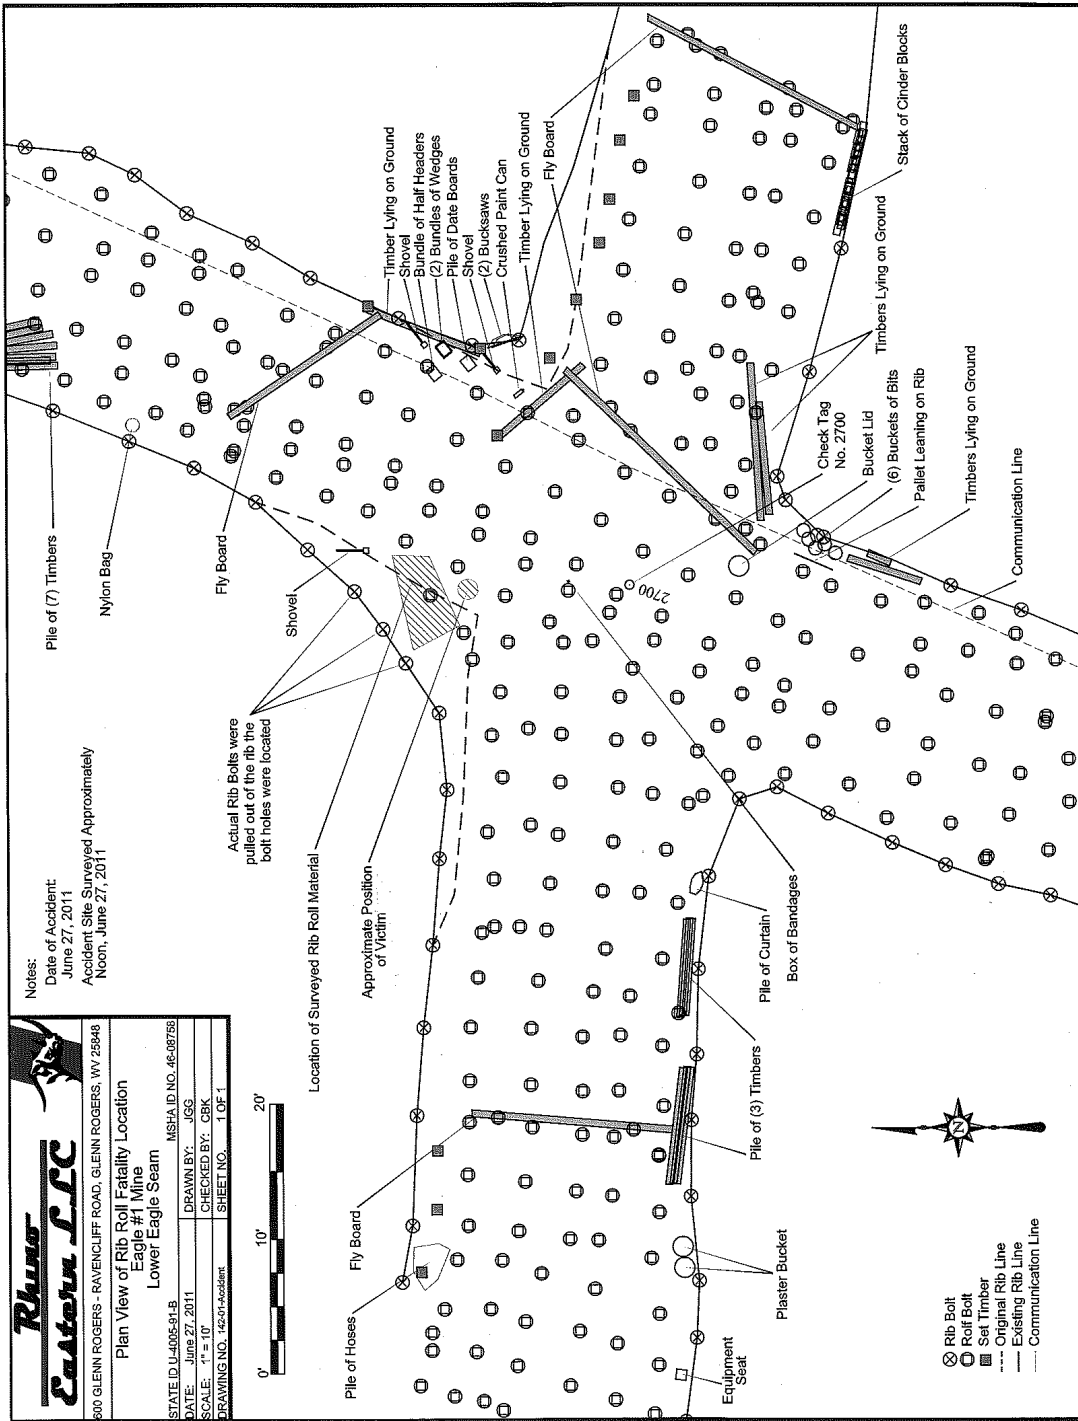
Plan View of Rib Roll Fatality Location
 Eagle #1 Mine
 Lower Eagle Seam

The 1C Belt Panel was driven in a south-southwest direction, with an approximate azimuth (the angle measured from north, eastward along the horizon) of 198 degrees, on 70 foot, by 70 foot centers, and was stopped four cross cuts in by the accident location. The accident occurred in the No. 3 Entry of the 1C Belt Panel.

The mining height at the accident scene exceeded 7 feet. The strata measurements at the scene of the accident from the bottom of the coal seam extending upwards were: bottom rock - 15 inches; bottom split of coal - 36 inches; gray shale rock - 12 inches; upper split of coal - 36 inches; and gray shale top rock - 6 inches. The total seam height was 105 inches, or 8 feet, 9 inches.
