UNITED STATES  
DEPARTMENT OF LABOR  
MINE SAFETY AND HEALTH ADMINISTRATION

REPORT OF INVESTIGATION

Fatal Fall of Face, Rib, or Pillar Accident  
June 29, 2011

Manalapan Mining Co., Inc.  
P-1 Mine  
Smith, Harlan County, Kentucky  
ID No. 15-19102

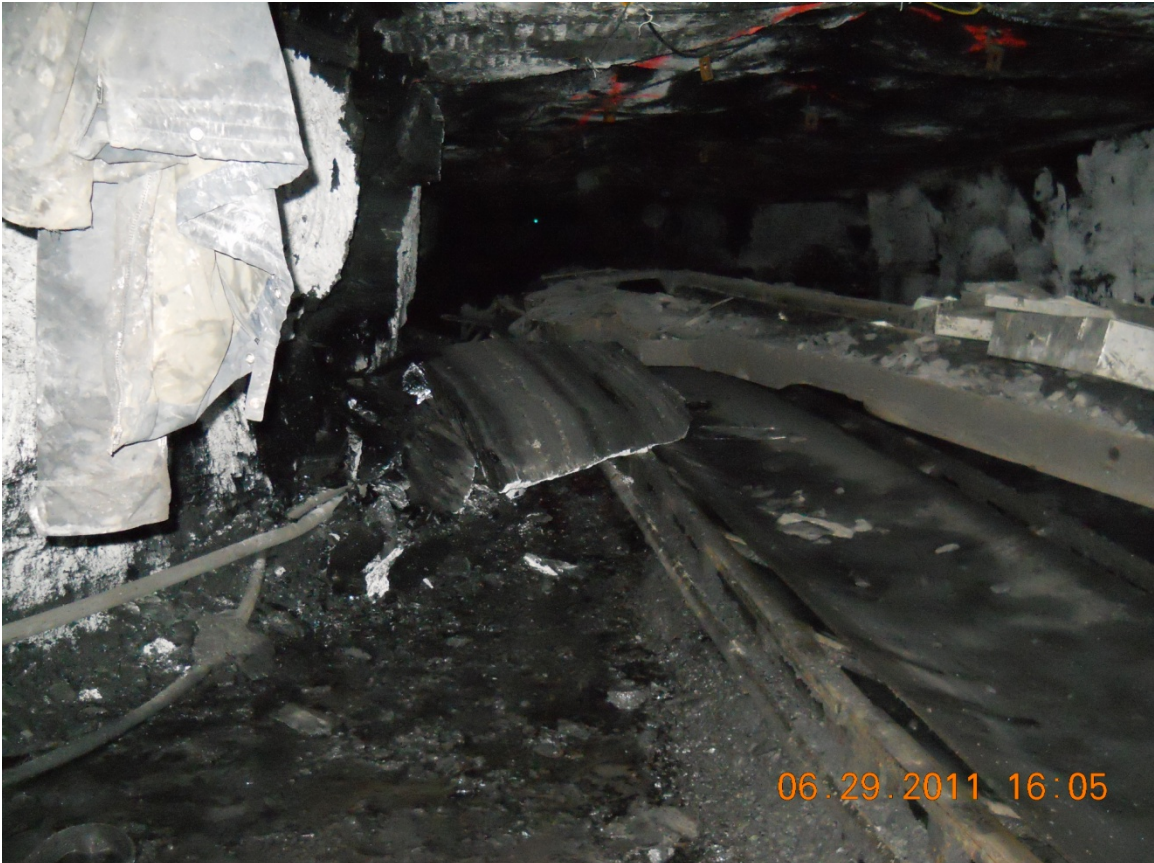
The mining height in the #3 Entry is approximately 83 inches and crosscuts average 20 feet wide at the accident site. The portion of rib that struck the victim measured approximately 82 inches long, by 36 inches wide, by 11 inches thick (See Photograph #1 of Appendix C). The average mining height is normally 42 to 44 inches. However, in this particular area, a coal rider seam is within the immediate roof strata. The operator increased the mining height so that permanent support could be anchored in solid roof strata above the coal rider seam. The increased mining height contributed to the loose rib conditions on the 002 MMU.
