REPORT OF INVESTIGATION

Preparation Plant

Fatal Electrical Accident  
July 27, 2011

Superior Processing, Inc.  
Superior Cleaning Plant  
I.D No. 46-03303

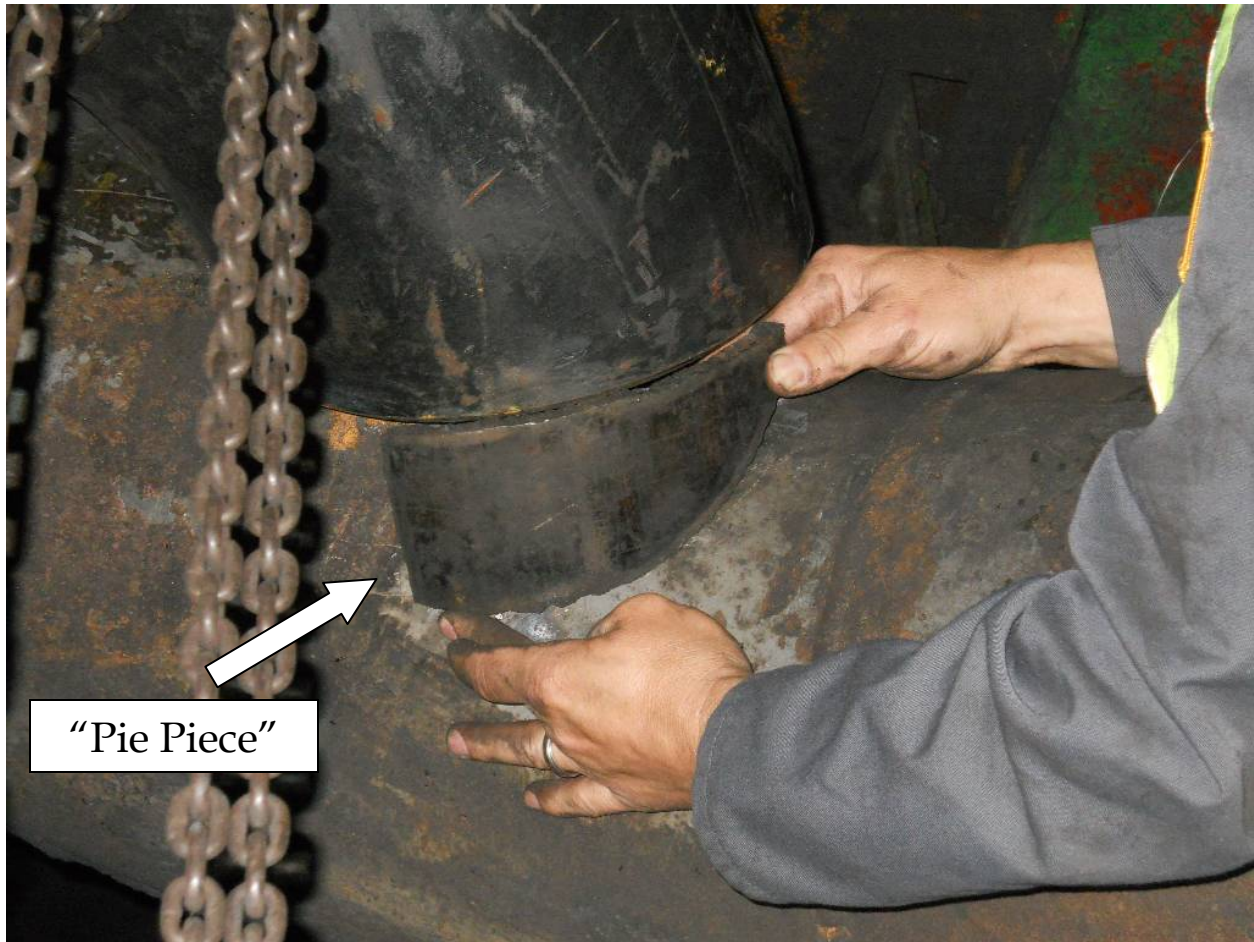
Marcus Green, Crane Operator/Welder, and Kevin Riley, Laborer/Welder, were assisting Stacey with tying in pipe, by welding, from the sump in the floor of the plant, up to the thickener tank. Stacey made actual connections of the two pipes, as all agreed he was the better welder. Green and Riley assisted Stacey by fabricating small sections of metal pipe, referred to as "pie pieces," using a cutting torch and grinder. These fabricated pipe sections were used by Stacey to fill gaps between the two pipes (See Photo 1 in Appendix B).

The accident occurred in the filter room section of the old cleaning plant that was being modified by the contractor. This floor was located several levels above the ground floor. The victim was working in an area 42 inches high, by 48 inches wide, and 85 inches above the filter room floor. Various pipes and apparatus were within this work area. To work in this area, the victim had to rest his left foot on a circular gate valve (see Overview Photo on Page 3) with his body situated in a squatting position on his right leg leaning against the large pipe, while resting his back against the plant structure.

Location of the accident and environmental factors caused the victim to be in a dangerous situation in order to weld these two pipes together. The confined work area and the temperature and humidity lowered the victim's body resistance to the effects of electric shock.

Photo 1 - Location where welding was being conducted

The plant operator and contractor developed and implemented procedures for persons who weld to use an insulating safety mat/blanket when welding in confined areas and or wet spaces. In addition, weekly safety meetings will include topics such as:

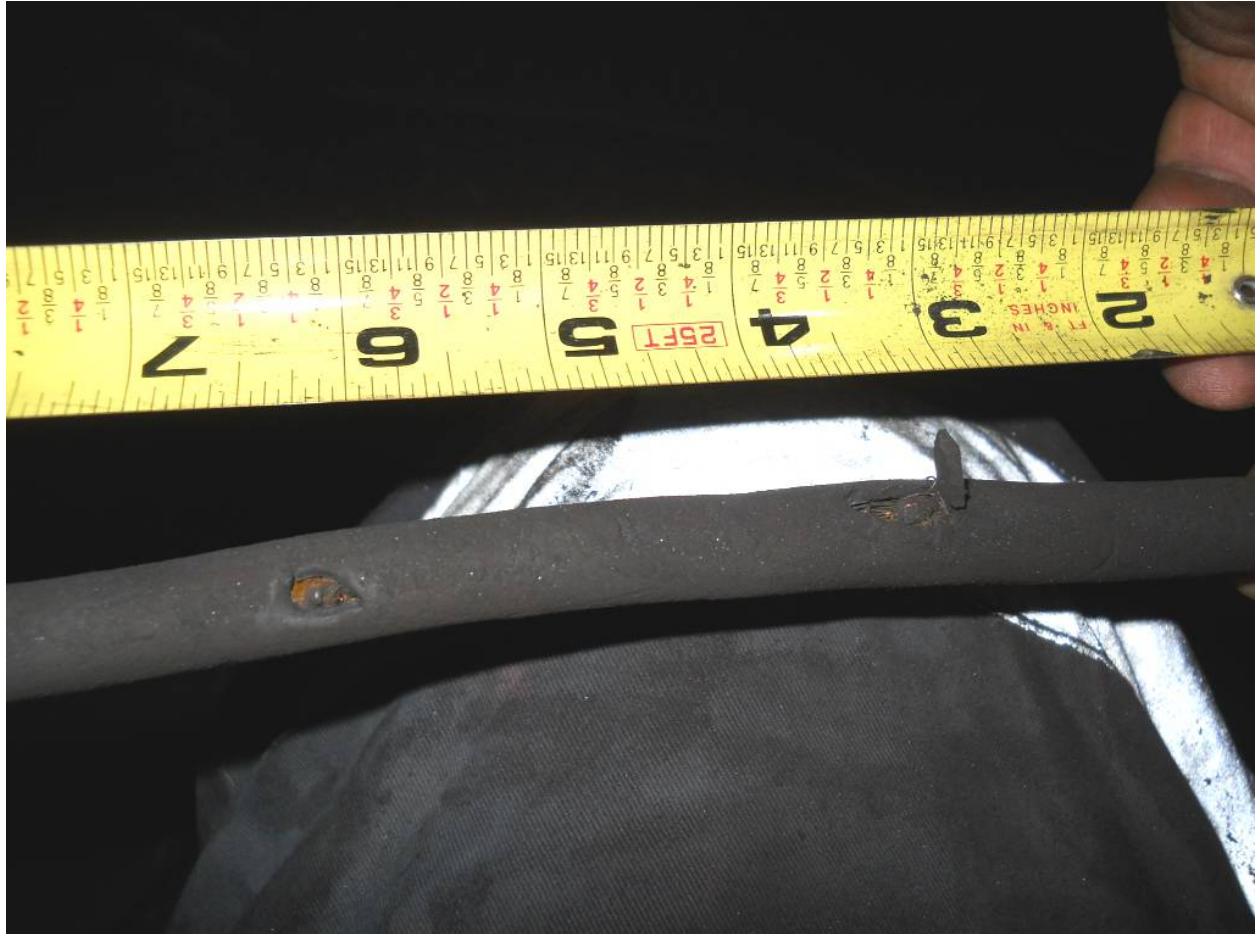
The electrode cable or “hot” lead measured approximately 198 feet in length and was a No.1 size American wire gauge (AWG) welding wire. Examination of this welding electrode (hot) lead began by measuring the total resistance from the electrode cable where it attached to the welder back through the plant structure to the “work” or ground lead where it attached to the welder. The electrode lead was attached to the pipe that was being welded by the electrode holder at the area where the victim was working. This measurement indicated 18 to 20 ohms of resistance. It was indicated upon inspection of the electrode (hot) and work (ground) leads that the high resistance in this circuit was the result of two different circumstances. First, the work (ground) lead was only 4-feet in length and was attached to a plant I-beam structure near the welder. A lug was not used for this attachment and the work lead was attached to the plant by twisted copper wires beneath a washer and bolt on the I-beam. The area was rusty and the copper wire was frayed and appeared deteriorated. This connection measured 3 ohms resistance. Resistance in the 198-foot long, No.1 AWG electrode (hot) lead measured 3 ohms. This is an unusually high resistance for a copper conductor of this size and length. Upon investigation, it was determined that this electrode lead was actually 2 electrode cables combined by clamping an electrode holder of the first lead to the lug of the second lead and taping up the connection for insulation protection. When this connection was taken apart and examined, the 3 ohm resistance was reduced to 0.1 ohms when the two leads were reconnected. This indicated that the initial 3 ohms resistance in the electrode (hot) lead was caused by this poor connection between the two cables. In addition, this electrode (hot) lead had 32 places that had been repaired by using electrical tape and there were 18 damaged places, where the copper conductors were exposed. Two of these damaged places were 68 and 72 inches from the victim and measured  $\frac{1}{4}$  inch, by  $\frac{3}{4}$  inch (See Photo 2 in Appendix B). Witnesses interviewed stated that the victim had excess electrode welding lead pulled up close to him while he was welding in this area of the filter room.

The damaged and deteriorated condition of the welding electrode lead along its entire length, especially within 72 inches of the victim, was a factor that contributed in this accident. Witnesses interviewed stated that the victim had excess electrode welding lead pulled up close to him while he was welding in this area of the filter room.

Condition or Practice: The Miller Model 250 welder, serial number 70-543883, located on the ground floor of the Superior Processing plant and which is available for use, is not being maintained to assure a safe operating condition. The No.1 AWG electrode or "hot" lead has 18 damaged areas in its 198 foot length, in which the energized copper conductor is exposed while the welder is energized. Two (2) of these damaged bare areas measure 1/4 inch, by 3/4 inch and are located at 68 and 72 inches from the electrode holder that was involved in a fatal electrical accident on 07/27/2011. These two damaged areas have experienced arc damage from contacting the work or plant structure. This damage is obvious and extensive. These damaged areas in this energized electrode lead exposes plant personnel and contract workers to an electrocution

hazard while the welder is energized. 32 additional repaired areas had been taped from previous damage or contact with the plant structure while energized. This indicated that damage to this electrical lead is a common occurrence. Agents of the operator are frequently in this area where the plant modifications are being made, to conduct daily examinations of working places for hazardous conditions. The operator has engaged in aggravated conduct constituting more than ordinary negligence by allowing this welder electrode lead to be allowed to exist in this dangerous condition. This is an unwarrantable failure to comply with a mandatory standard.

Photo 2 - Damaged Welding Lead

The plant operator and contractor developed and implemented procedures indicating that during any shift in which welding is being performed, the welding electrode lead will be examined for defects and any defects found will be repaired prior to use.
