**UNITED STATES
DEPARTMENT OF LABOR
MINE SAFETY AND HEALTH ADMINISTRATION**

REPORT OF INVESTIGATION

**Fatal Machinery Accident
August 8, 2011**

**Century Mine
American Energy Corporation
Beallsville, Belmont County, Ohio
I.D. No. 33-01070**

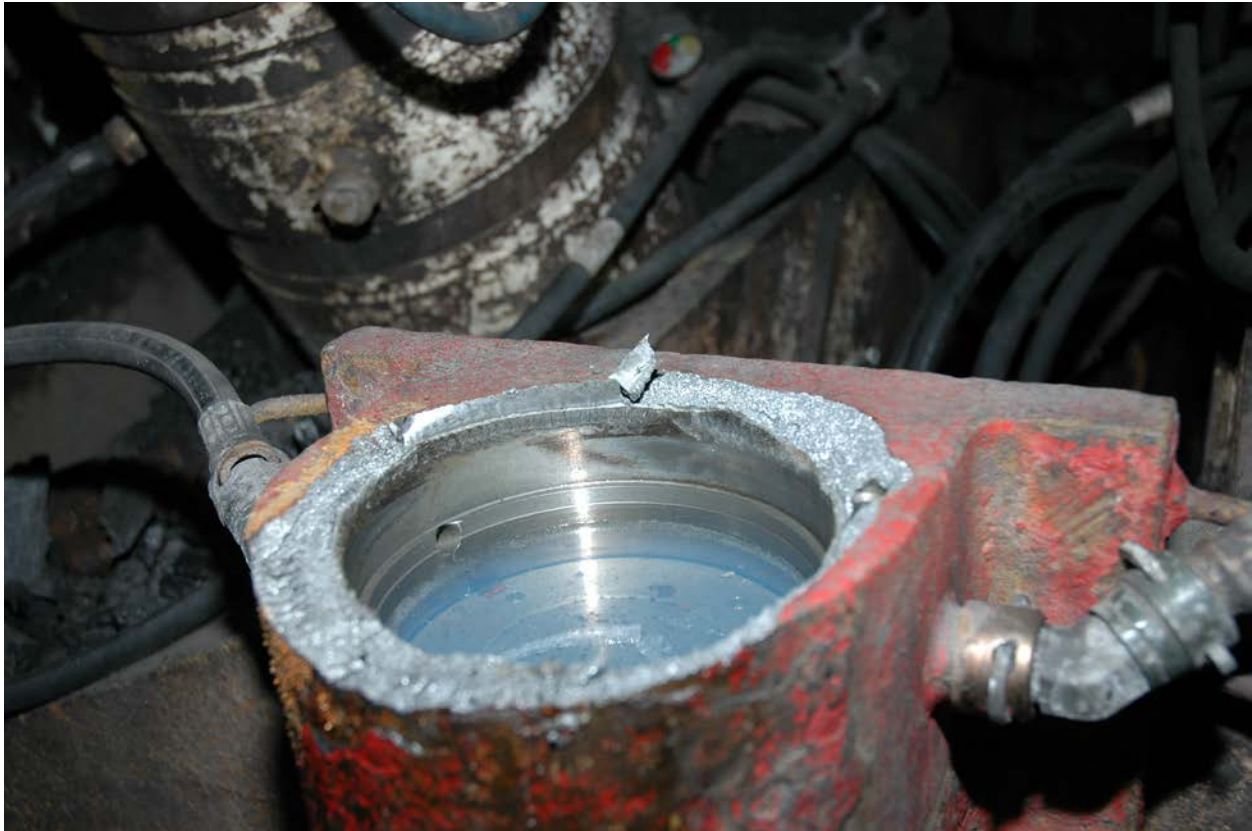
PHOTO of BASE LIFT JACK

During the accident investigation, the incoming hydraulic pressure was confirmed as being turned off in No. 22 shield and base lift cylinder. The failed base lift cylinder was painted red in color and had a predominant marking of "DHI," on the separated top of the cylinder, indicating Dover Hydraulics Inc., which was the last vendor to rebuild the base lift jack. Visually, it was determined that that rod of this hydraulic cylinder could not retract fully into the cylinder. The drawing provided of the base lift cylinder illustrated the base lift cylinder as being retracted fully. Physically, the piston of the failed hydraulic base life cylinder would contact the bottom of the cylinder internally and not retract fully. Oxidization was observed on the exposed surface on the top of the hydraulic cylinder and the outer edge of the cap portion that separated from the cylinder. No hydraulic pressure relief is provided in the base lift hydraulic circuit.

It was also found that at an undetermined time prior to the accident, an improper weld repair was made to the cylinder by the mine operator. This repair reduced the strength of the end cap. The cylinder defect would likely have been prevented or identified by adhering to industry standards in design, proper welding, nondestructive examination, and proof testing of the cylinder in accordance with industry standards after manufacture, the weld repair, and rebuild.

- The failure initiation site occurred at an improper repair weld.
- No fatigue or impact damage to the cylinder was noted. However the improper weld repair at the failure initiation site caused hydrogen embrittlement of the original weld.

- The closing of a valve that trapped hydraulic fluid in the cylinder resulted in an over pressurization of the cylinder when the piston was subjected to external mechanical forces.

All base lift cylinders suspected of over-pressurization were identified and removed from the face for evaluation. The mine operator has designed and installed hydraulic protection to limit the pressure in the base lift cylinder hydraulic circuit. The design and modifications were reviewed by a professional engineer.
