REPORT OF INVESTIGATION

Fatal Roof Fall  
August 15, 2011

Mingo Logan Coal Company  
Mountaineer II Mine  
I.D. No. 46-09029

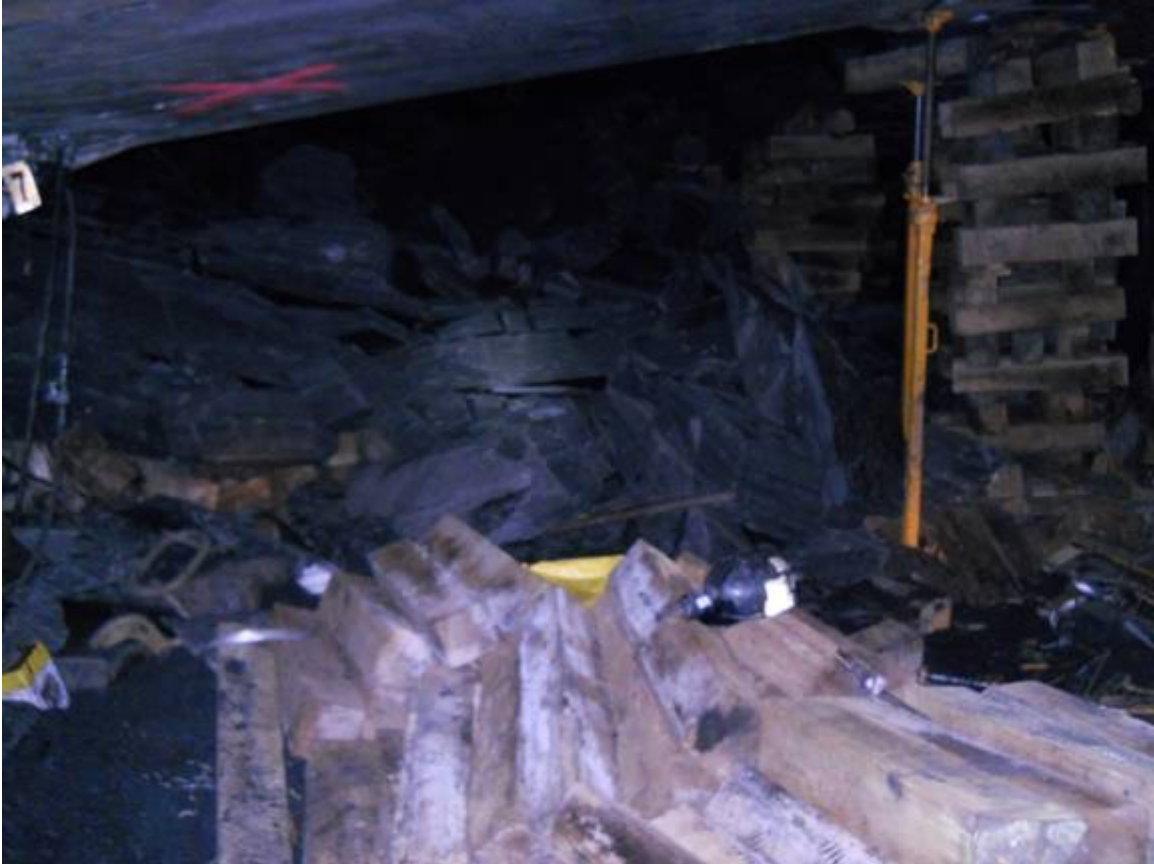
On August 15, 2011, at approximately 5:50 a.m., Charles M. Hall (Victim), a 46-year old general laborer on the Move Crew, was killed during installation of cribs in the face area on the 1 Right Headgate. Hall was struck by falling rock from the mine roof while building a wooden crib where the No. 8 longwall shield had been removed.

The accident was caused by failure to follow the approved roof control plan for the recovery of the longwall shields. The roof control plan required that a crib, constructed of wooden blocks, be installed near the longwall face (within 5 feet of installed roof bolts) prior to the installation of the inby (gob) crib. Instead of following this procedure, after the recovery of the No. 8 shield, a wooden crib was first installed near the gob (fallen roof material), in excess of 10 feet from roof bolts. Failure to follow the approved roof control plan exposed the victim to hazards of unsupported mine roof. Additionally, several cribs had not been installed in the prescribed locations between the No. 8 and 11 shields.

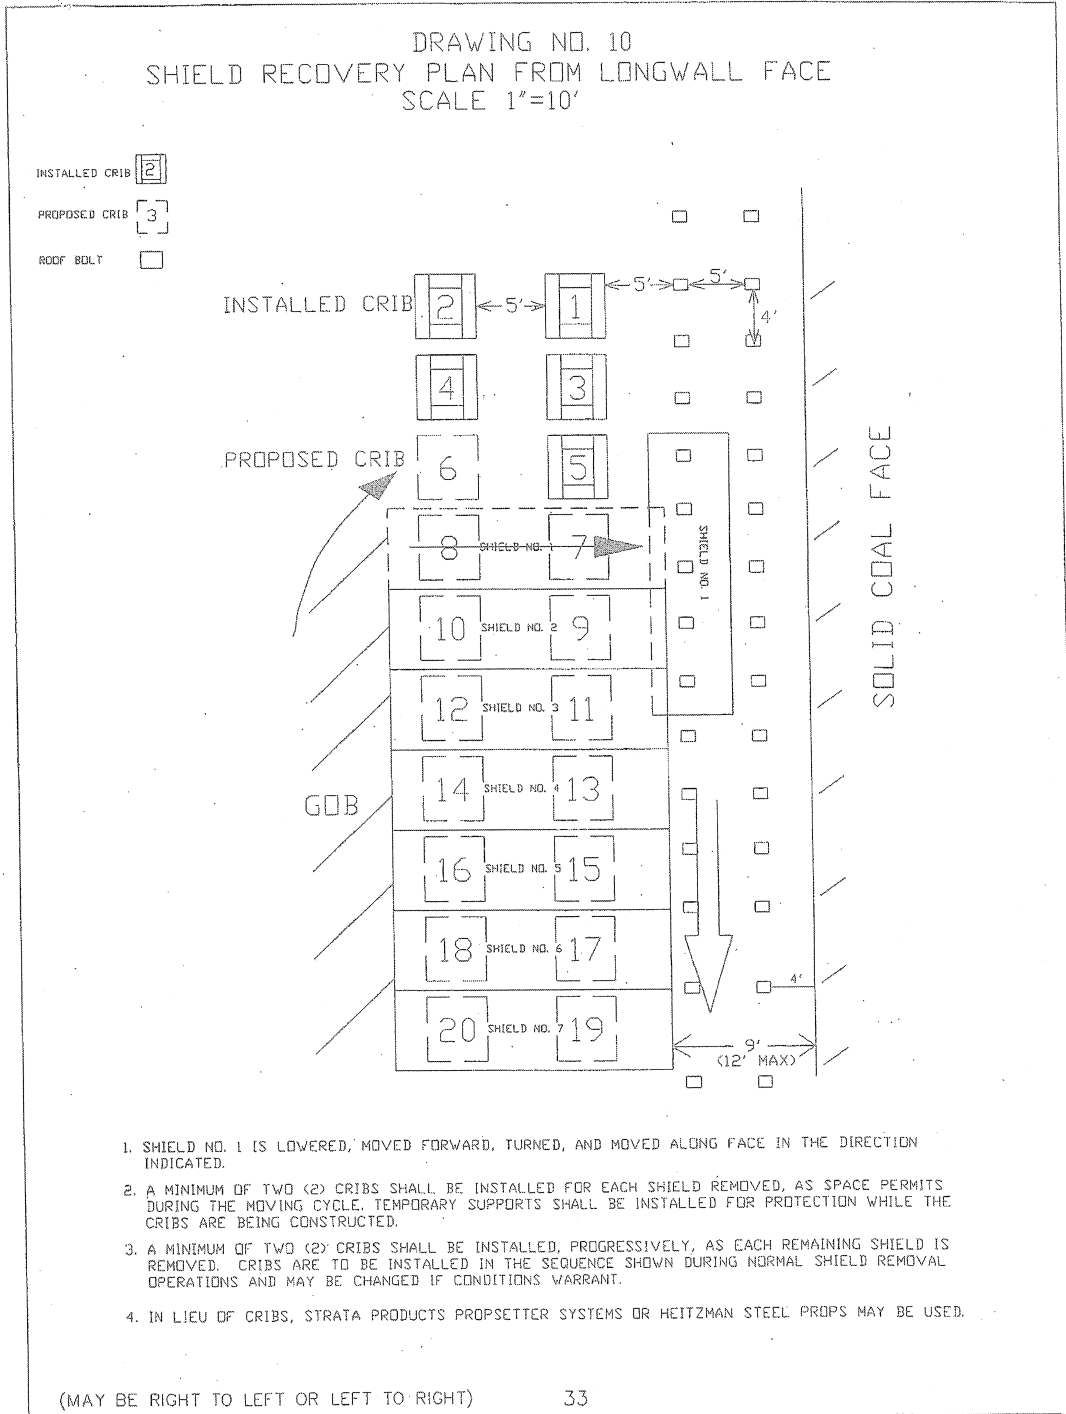
### Roof Control Plan Excerpt

Drawing No. 10, Page 33, of the approved roof control plan states: "1) Shield will be lowered, (the shield that is currently being removed), moved forward, turned, and moved along face in the direction indicated. 2) A minimum of two (2) cribs shall be installed for each shield removed, as space permits during the moving cycle. Temporary supports shall be installed for protection while the cribs are being constructed. 3) A minimum of two (2) cribs shall be installed, progressively as each remaining shield is removed. Cribs are to be installed in the sequence shown during normal shield removal operations and may be changed if conditions warrant. 4) In lieu of cribs, Strata Products Propsetter Systems or Heitzmann Steel Props may be used." A Copy of this portion of the mine's roof control plan is located in Appendix C.

The Approved Roof Control Plan was not being complied with on the 009-0 MMU, 1<sup>st</sup> Right Longwall Section, which has resulted in a fatality. Evidence collected during the investigation of the accident revealed that visible cribs, constructed during the removal of the previous four longwall shields, (Shields 9-12) had been constructed primarily in the bolted walkway, instead of in the designated area adjacent to the shields being removed. Additionally, the crib installation after the removal of longwall Shield No. 8 did not adhere to the approved plan, in that the crib nearest to the gob (caved area) was being built first and preparations were being made to build a second crib between the gob line crib and the immediate longwall face. As shown in the approved roof control plan, Drawing No. 10, page 33, Item 3, referring to the sequence in which the cribs are

to be installed; the first crib is to be built within a 5-foot spacing from the face area roof bolts prior to construction of the crib closer to the gob line. Mine management engaged in aggravated conduct, constituting more than ordinary negligence, by allowing the cribs to be built in violation of the approved roof control plan, which exposed workers to unsupported roof. This violation is an unwarrantable failure to comply with a mandatory standard.

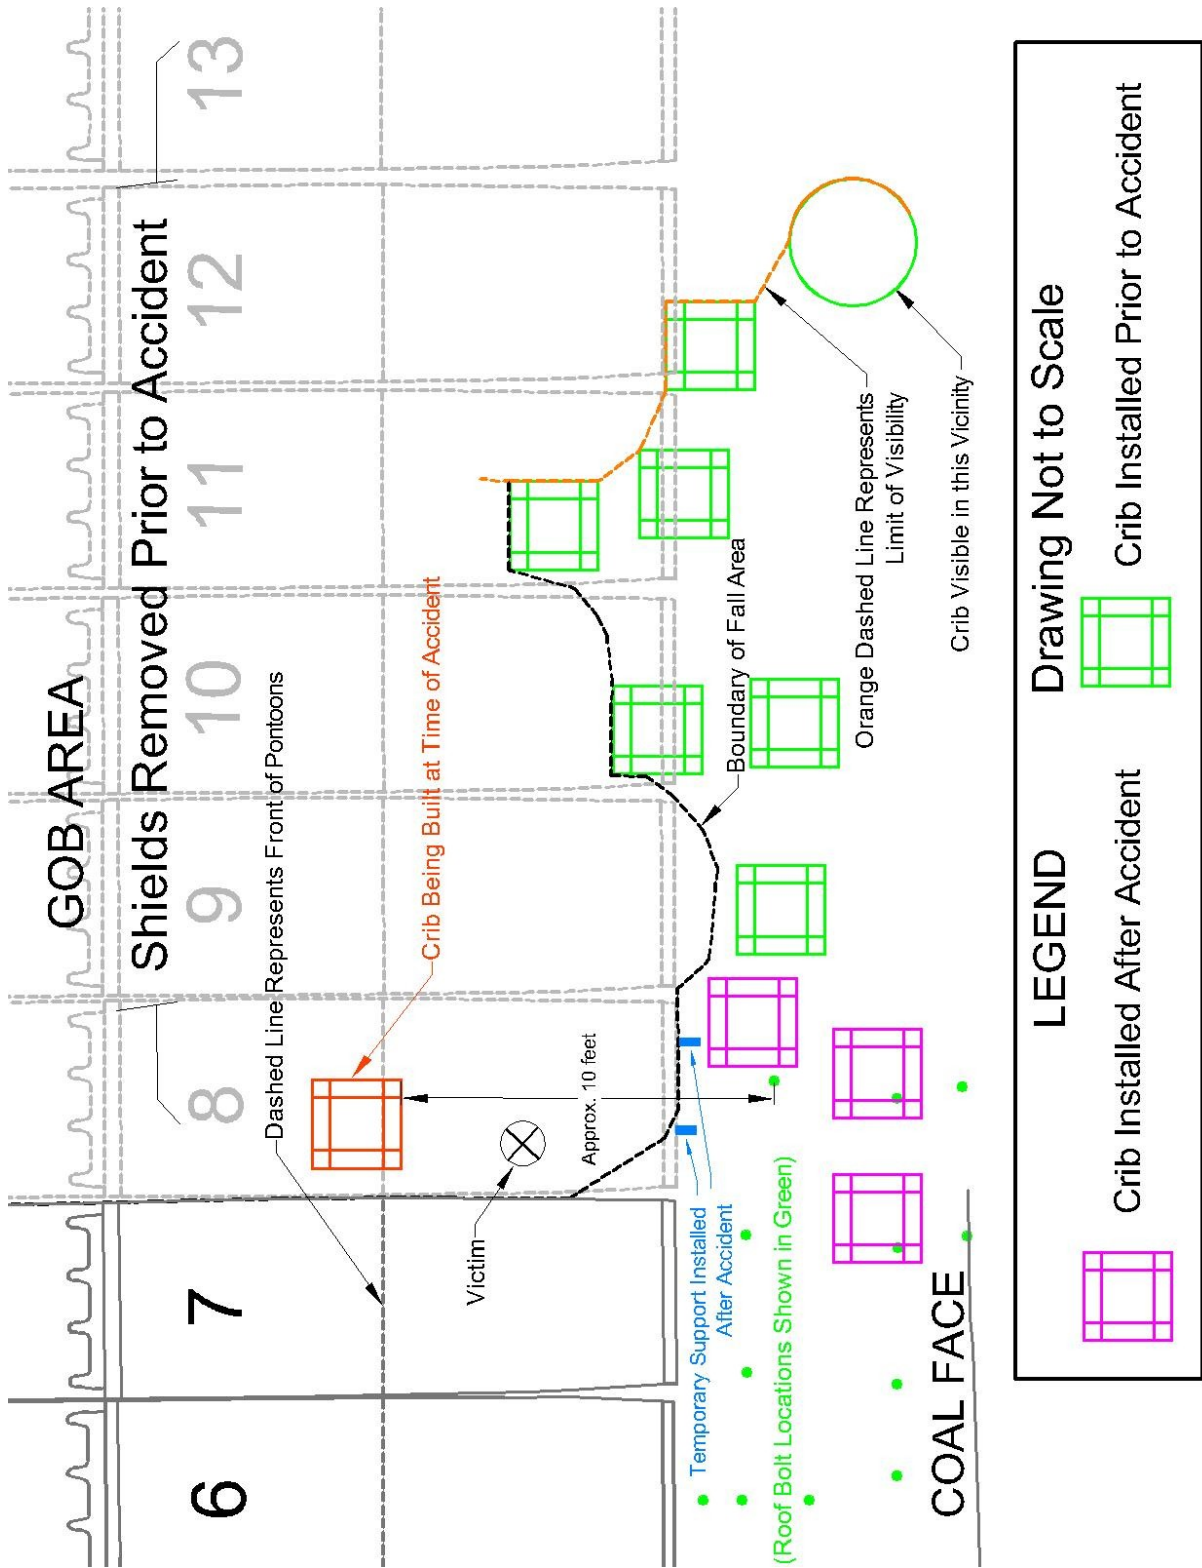
**APPENDIX D**  
Schematic of Accident Scene

The longwall face was approximately 1,000 feet wide and utilized 176 shields. Removed shields were being transported from both the headgate and tailgate panels. The plan for removal of these shields required that removal start at the middle shield, and the removal progressed outward, toward both the headgate and tailgate sides. At the beginning of the shift in which the accident occurred, the headgate side of the longwall had 18 shields remaining. Two cribs were required to be set after each shield removal, and two temporary supports were to be set prior to the construction of each crib. Evidence indicates that only one crib had been set in the prescribed location after the removal of the Nos. 11, 10, and 9 shields. Upon removal of the No. 8 shield, Hall started to build a crib in the previous location of the No. 8 shield, when the accident occurred. This was the first attempt during this shift to construct a crib in the inby (gob) location. The other cribs constructed previously during the shift for shield removal were located further outby the gob, or within the area that had been roof bolted (See Appendix D).

*Root Cause:* The mine operator failed to follow the approved roof control plan. At the time of the accident, the victim was constructing an inby (gob) crib at a distance of approximately 10 feet from permanent roof support bolts (where the No. 8 shield had been removed) and within approximately 5 feet of the No. 7 shield. Temporary supports (screw jacks) were being used to support the roof where the crib was being constructed. The attached sketch (Appendix D) shows the location of the victim, the crib being constructed, and the approximate 10-foot distance from the primary roof support bolts to the location of the crib. The mine operator did not utilize the proper sequence of installation for cribs being constructed adjacent to the next shield to be removed. The approved roof control plan required that the sequence of installation of cribs progress from the permanently supported area toward the gob. Instead, it was found upon investigation of the accident, that the inby (gob) crib was being installed prior to the installation of a crib within 5 feet of permanent roof support bolts.

*Root Cause:* The mine operator failed to follow the approved roof control plan. The majority of cribs, which were installed during the removal of Shields No. 11 through No. 8, were installed under permanently supported (roof bolted) area near the face. Because the cribs were installed at this location, the cribs did not serve their intended purpose of supporting the roof, located adjacent to the next shield to be removed. The attached sketch (Appendix D) shows the approximate location of each crib, as observed during the investigation of the accident. No crib blocks were visible within the fall area.

*Corrective Action (Addresses the Previous Two Root Causes):* The operator submitted a revised longwall shield recovery plan. The revised plan was approved by MSHA. The revised plan requires the utilization of geo-synthetic mesh roof support during the removal of all longwall shields. The revised plan also provides for the use of walking shields or mobile roof supports as the primary method of shield removal. This method provides additional protection for miners constructing cribs adjacent to the next shield to be removed and under areas of roof that have not been permanently supported. The Move Crew employees were trained in the revised shield recovery plan requirements, including the support installation sequence prior to the subsequent longwall
