**REPORT OF INVESTIGATION**

**Fatal Machinery Accident**

**October 17, 2011**

**Shoemaker Mine  
Consolidation Coal Company  
Dallas, Marshall County, West Virginia  
MSHA ID No. 46-01436**

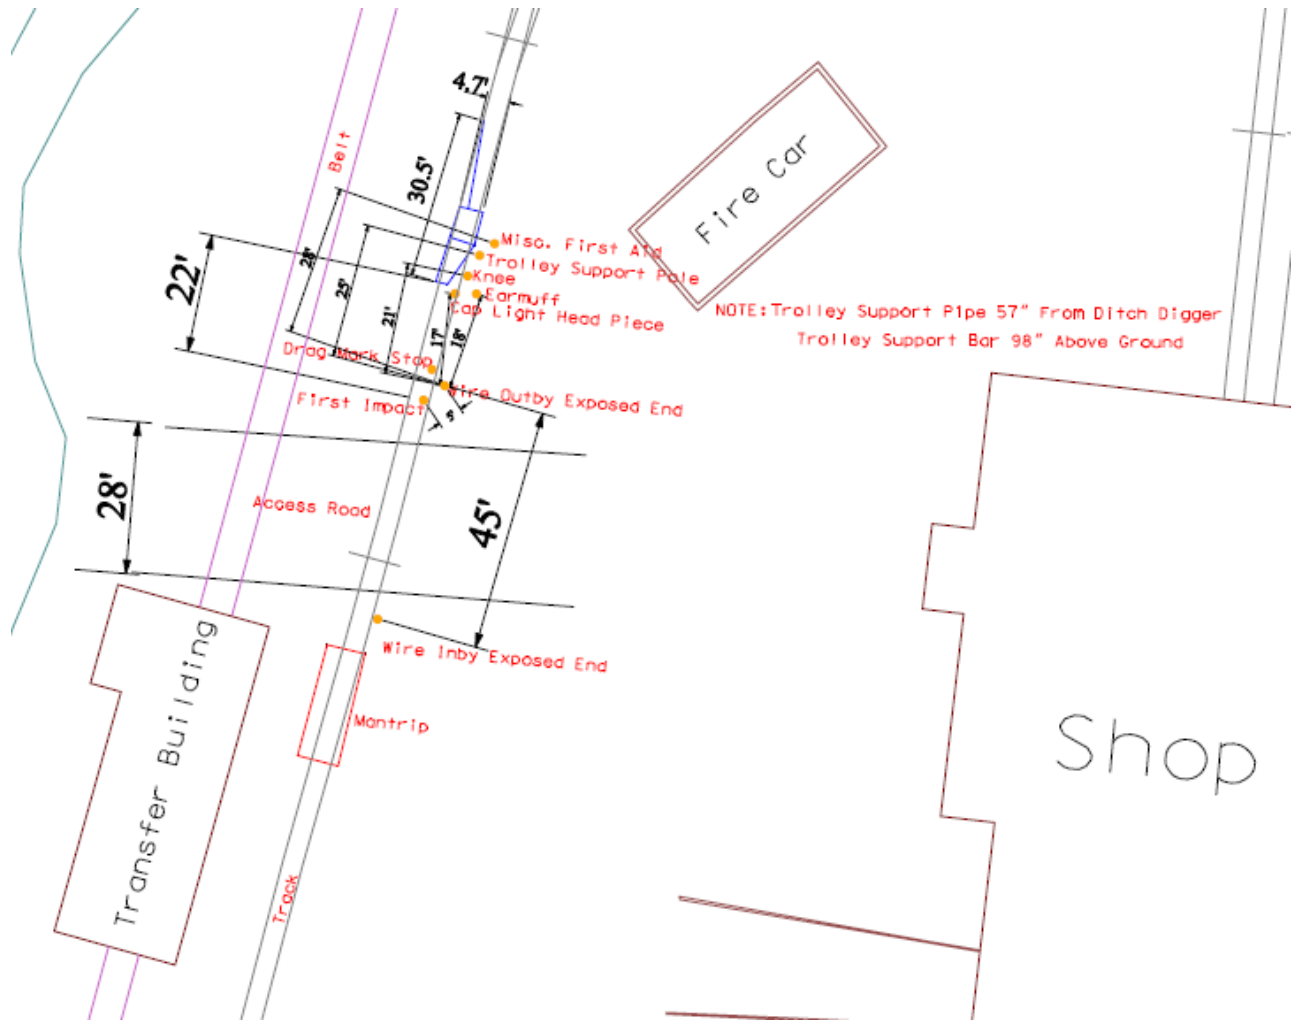
## Drawing of Accident Scene

McIntire approached the Jump Area with the ditch digging machine and attempted to coast through the Jump Area, stopping just short of the outby end of the energized trolley wire. Ontko, following on the mantrip, stopped on the inby side (nearest the mine portal) of the jump area. McIntire exited the operator's compartment of the machine, walked around to the opposite side, and swung the trolley pole to the forward (outby) direction, attempting to reach the outby trolley wire. The trolley pole failed to reach the trolley wire by two to three feet. McIntire obtained a jumper wire lying close by and connected one nip to the energized trolley wire, while standing alongside the right front of the machine. He placed the other nip onto the machine trolley pole shunt wire. When the nip contacted the trolley pole shunt wire, Ontko observed an arc flash, then saw the machine surge forward, striking and dragging McIntire. Ontko exited the mantrip immediately, and ran to the trolley wire, removing the nip, thereby de-energizing the machine.

The Jump Area had been in existence at the yard area of River Portal surface area since the circa 1950's. This is a section of track, with a gap in the trolley wire, which measures forty-five feet in width. The portion of the Jump Area where the accident occurred is on relatively flat ground. An access road crossed the track in the area of the trolley wire gap. General practice when crossing the Jump Area was to pick up speed, grab the trolley pole before it came off the wire, continue coasting through the gap in the trolley wire, and then replace the trolley pole onto the trolley wire. Most track-mounted vehicles were able to cross the Jump Area with relative ease, due to their speed and momentum. Depending on speed and track conditions, the ditch digging machine would not always coast across the Jump Area. A fused nip (power cord) was kept

The ditch digger was known to stop part way through the Jump Area, requiring the use of the dc power cable (nip). Interviews with ditch digging machine operators indicated that the normal practice when using a nip to cross the Jump Area was to set the brake, turn the power switch to the off position, and then connect the nip by connecting to the machine first followed by connection to the trolley wire. Interviews also revealed that other track mounted equipment would sometimes be used to push the ditch digger across the Jump Area.

With the control settings as described, the machine would suddenly tram forward with the application of dc power. No “man-in-place” switch or other controls were incorporated or interlocked to prevent movement of the machine upon the application of power.

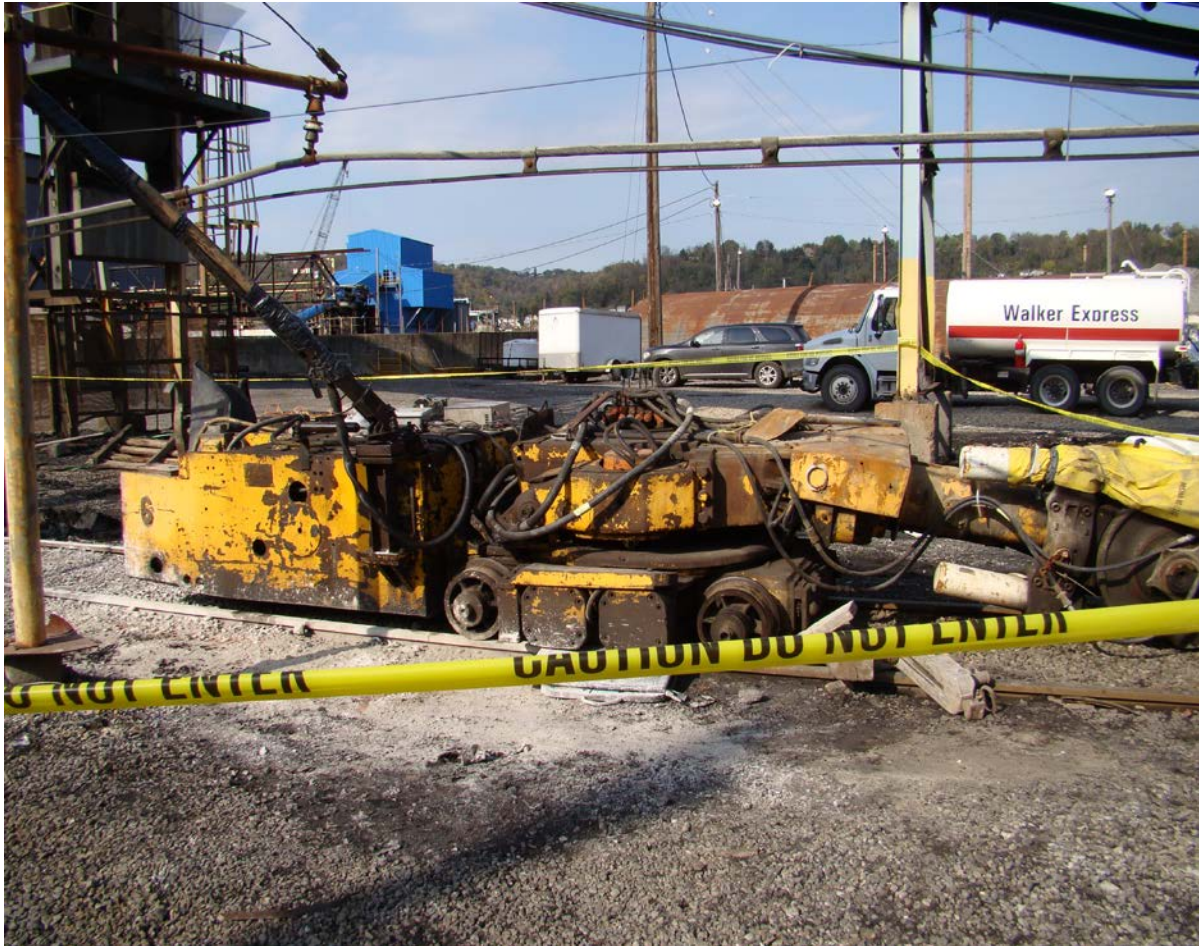
**APPENDIX D**  
**Photo of Accident Scene**

The victim did not place the machine controls in the proper position to prevent movement of the machine. When the victim placed an energized nip onto the machine trolley pole, while he was standing in close proximity to the machine, the machine surged forward, striking and dragging him.
