REPORT OF INVESTIGATION  
Underground Coal Mine

Fatal Powered Haulage Accident  
November 7, 2011

Mine No. 9  
Hubble Mining Company LLC  
Eolia, Letcher County, Kentucky  
I.D. No. 15-18984

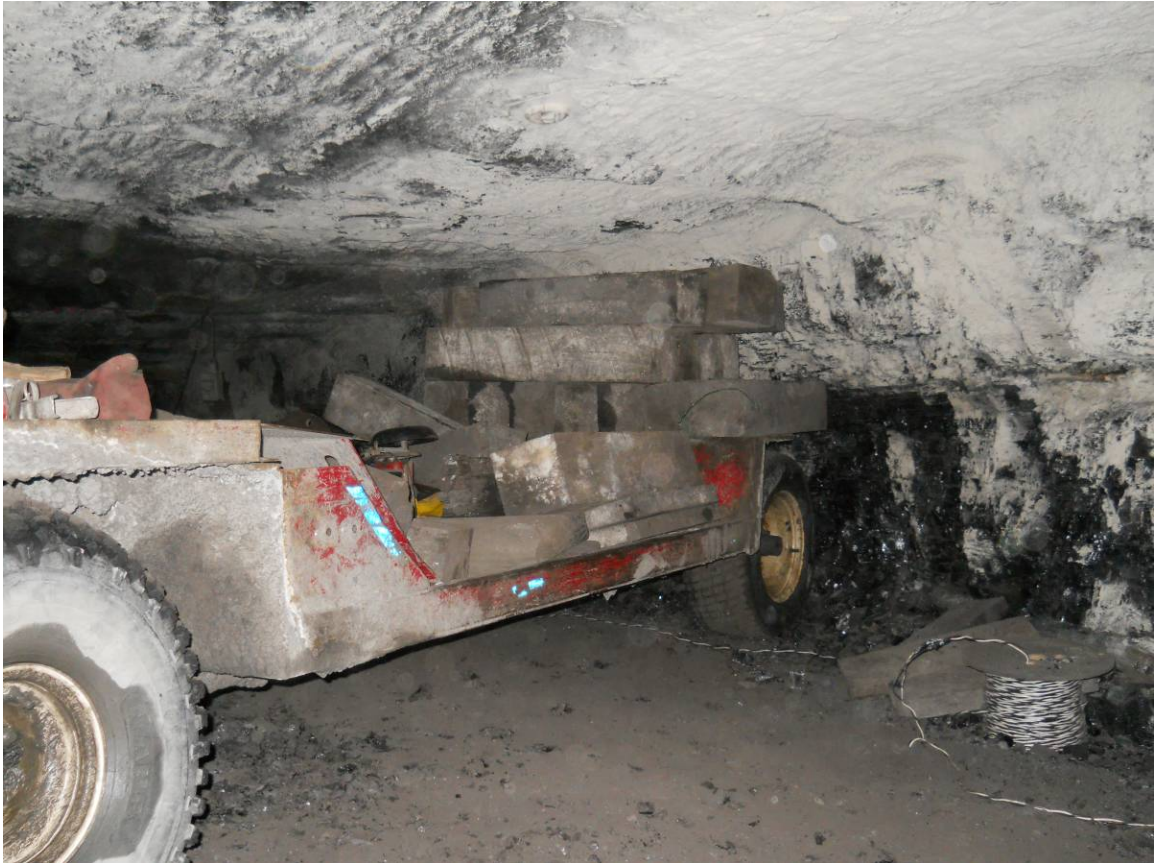
PHOTOGRAPH OF RECONSTRUCTED ACCIDENT SCENE

The investigation team determined that as the personnel carrier moved forward, the crib blocks loaded on the front of the personnel carrier struck the Victim in the head, causing severe head trauma. As the forward motion of the machine and the load continued, at least 2 crib blocks were pushed back into the operator compartment of the personnel carrier as the crib blocks pinned the Victim’s head against the mine rib. The assessment by the attending physician in the emergency room, and the coroner involved, indicate that the Victim had crushing injuries to the head. Minor superficial injuries were present on the chest wall. These injuries do not support the witness testimony that the personnel carrier had pinned the Victim against the mine rib, through his torso.

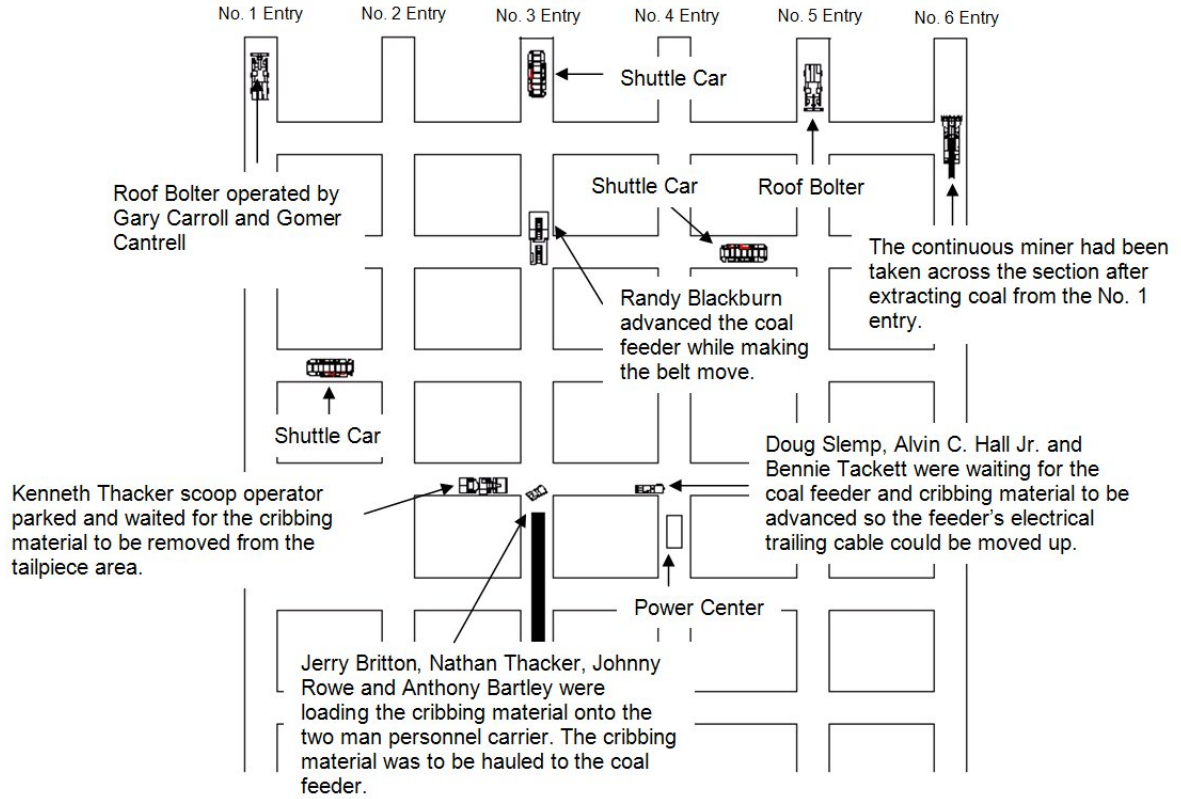
**SKETCH NO. 1  
BEFORE THE ACCIDENT  
NOT TO SCALE**

Britton instructed Nathan Thacker, Shuttle Car Operator/Continuous Mining Machine Helper, to take the loaded personnel carrier up the No. 3 Entry to where the feeder was being set. As N. Thacker began to drive away, Britton stopped him to get his dinner bucket off the personnel carrier. N. Thacker stated that he waited while Britton got his dinner bucket and that Britton then moved away from the machine and out of sight around the crib blocks, which blocked N. Thacker's forward view. Witnesses stated that Britton moved from the side of the personnel carrier, to the left rib of the No. 3 Entry, beside the mine phone (See Appendix F). Britton kneeled near the mine phone, reportedly to get chewing tobacco from his dinner bucket. Britton normally called outside on the mine phone to Ervin Bartley, Outside Man, to tell him when the belt move had begun. This placed Britton in front of the personnel carrier, which was backing away from him.

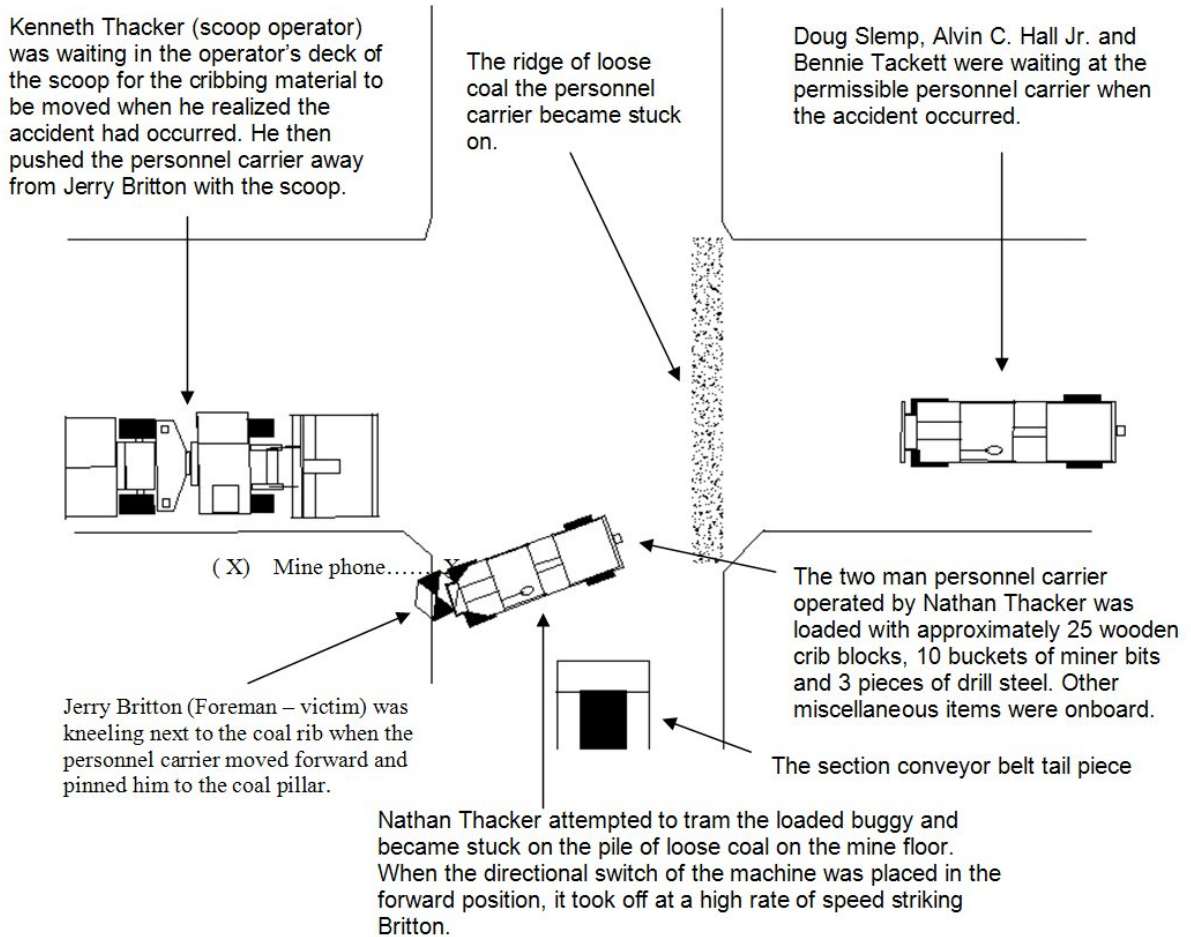
**SKETCH NO. 2  
AFTER THE ACCIDENT  
NOT TO SCALE**

All witnesses testified that the personnel carrier had Britton pinned to the mine rib. Anthony Bartley, Ventilation Man; Doug Slemple, Superintendent; Bennie Tackett, Repairman; and Alvin "Chet" Hall, Shuttle Car Operator, attempted to push the personnel carrier back to free Britton. Slemple and Tackett were in the crosscut

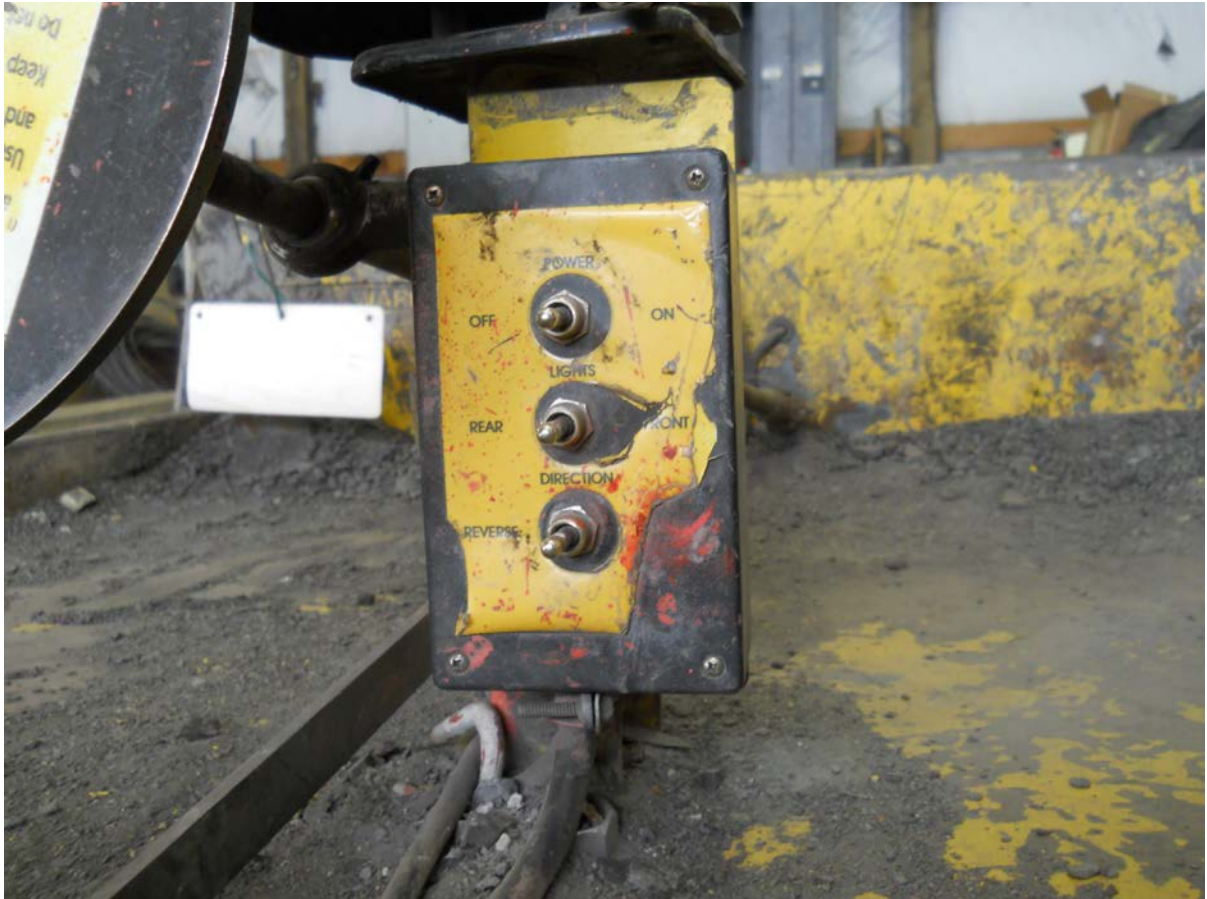
## Appendix H Personnel Carrier's Control Switch Orientation

Johnson Industries has used the Curtis controllers in some personnel carriers for at least 15 months, according to the usage list furnished by the company. Johnson Industries programs the controllers they install. The program input into the Curtis Controller and the wiring scheme used on this installation created a hazard to miners.

Appendix H depicts the personnel carrier's control switch orientation. The top switch serves as the on/off switch for the controller. The forward and reverse travel direction switch was located on the bottom. It had three positions, reverse/neutral/forward.

Corrective action: The personnel carrier has been removed from service. Following an analysis by MSHA's Technical Support Branch and the manufacturers, changes to the equipment design and to the controller program have been implemented to prevent a recurrence. The original equipment design would have prevented the accident by having a neutral start safety feature on the accelerator. The mine operator also provided personnel carrier operators with Task Training for machine operation, including proper operation characteristics of controls, switches, and accelerators.
