UNITED STATES
DEPARTMENT OF LABOR
MINE SAFETY AND HEALTH ADMINISTRATION

REPORT OF INVESTIGATION

Fatal Machinery Accident
November 2, 2011

Mill Branch
Nally & Hamilton Enterprises, Inc.
Closplint, Harlan County, Kentucky
ID No. 15-17821

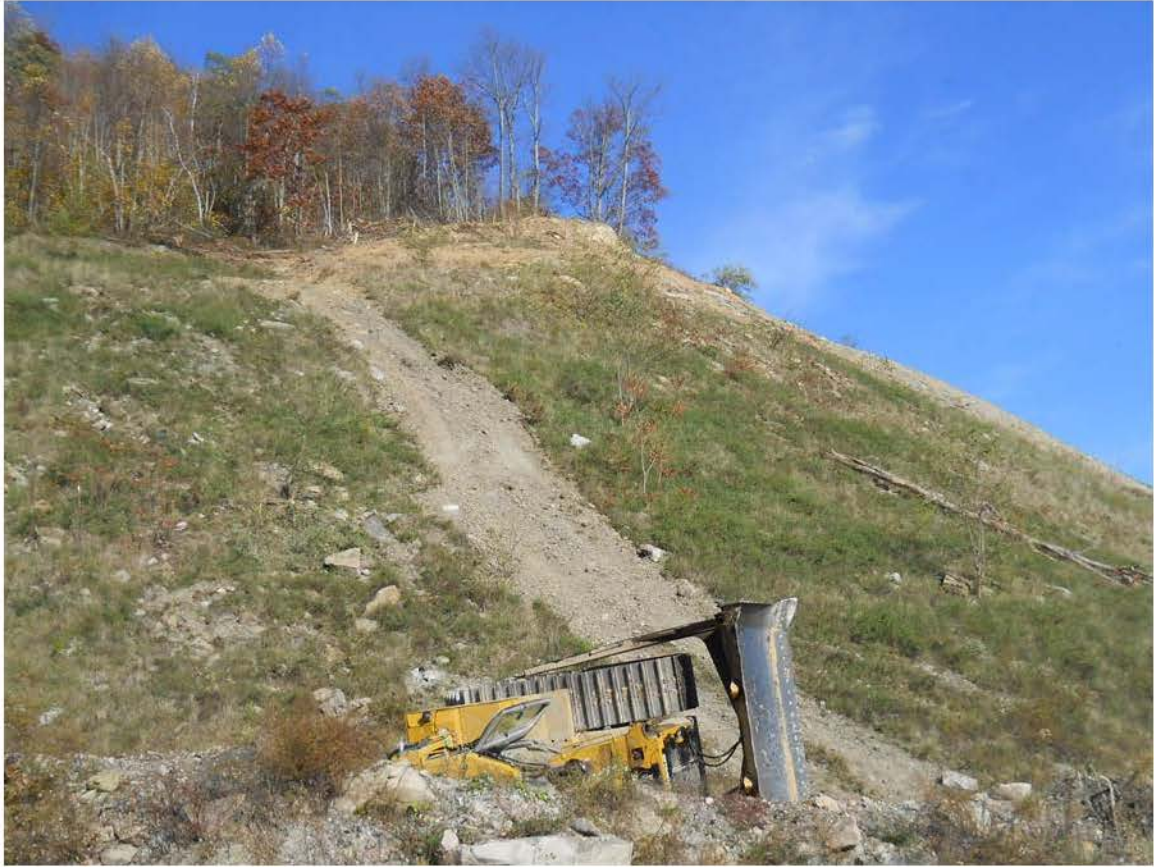
PHOTOGRAPH OF ACCIDENT SCENE

The investigation team determined that while conducting reclamation work along the top of the slope, the bulldozer's right side track encountered a large rock in unconsolidated material. The rock slid off the edge of the working area while underneath the right side tracks of the bulldozer, causing the bulldozer to slide over the edge and begin overturning.

The accident occurred while Middleton, operating a Caterpillar D6T bulldozer, was pushing spoil material to an excavator along the top of a steep (28 degrees) slope. Middleton encountered a large rock approximately 48 inches in width, 40 inches in length, and 30 inches thick in the center of the bulldozer path. While attempting to remove the rock from the bulldozer's path, the bulldozer's right side track encountered another large flat rock 60 inches in width, 80 inches in length, and 9 inches thick in unconsolidated material on the outer edge of the bulldozer push area. The large rock slid off the edge of the working area, while underneath the right side tracks of the bulldozer. The rock acted like a sled, causing the bulldozer to slide over the edge and overturn. The bulldozer rolled several times while traveling down the slope a distance of approximately 289 feet.

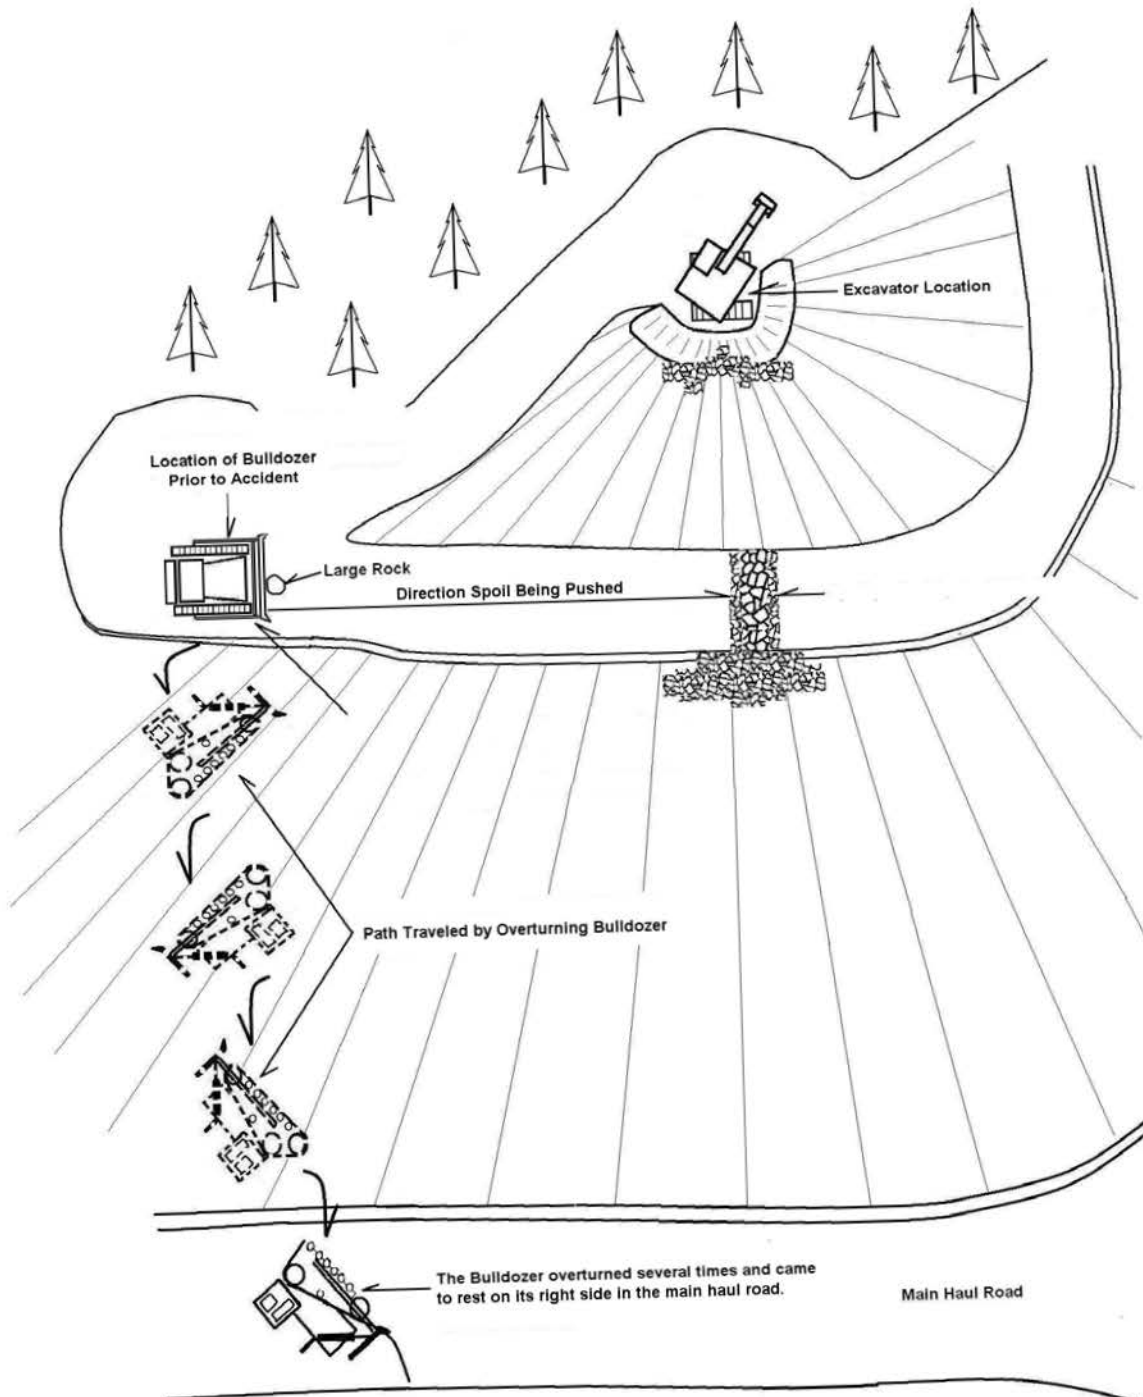
APPENDIX D
Sketch of Accident Scene

On Wednesday, November 2, 2011, at approximately 9:45 a.m., a machinery accident occurred at the Nally & Hamilton Enterprises, Inc., Mill Branch mine, located near Closplint, Harlan County, Kentucky. The bulldozer operator, David J. Middleton, who was 28 years old and had 8 years of mining experience, received multiple injuries when the Caterpillar D6T bulldozer he was operating overturned along the top of a reclaimed slope. The bulldozer traveled approximately 289 feet, overturning several times before coming to rest on its right side on the mine access road. (See Appendix D for sketch). The victim died November 14, 2011, from injuries sustained in the accident.
