REPORT OF INVESTIGATION

**Fatal Machinery Accident
December 3, 2011**

**Oxford Mining #3
Oxford Mining Co LLC
New Lexington, Perry County Ohio
MSHA ID No. 33-04336**

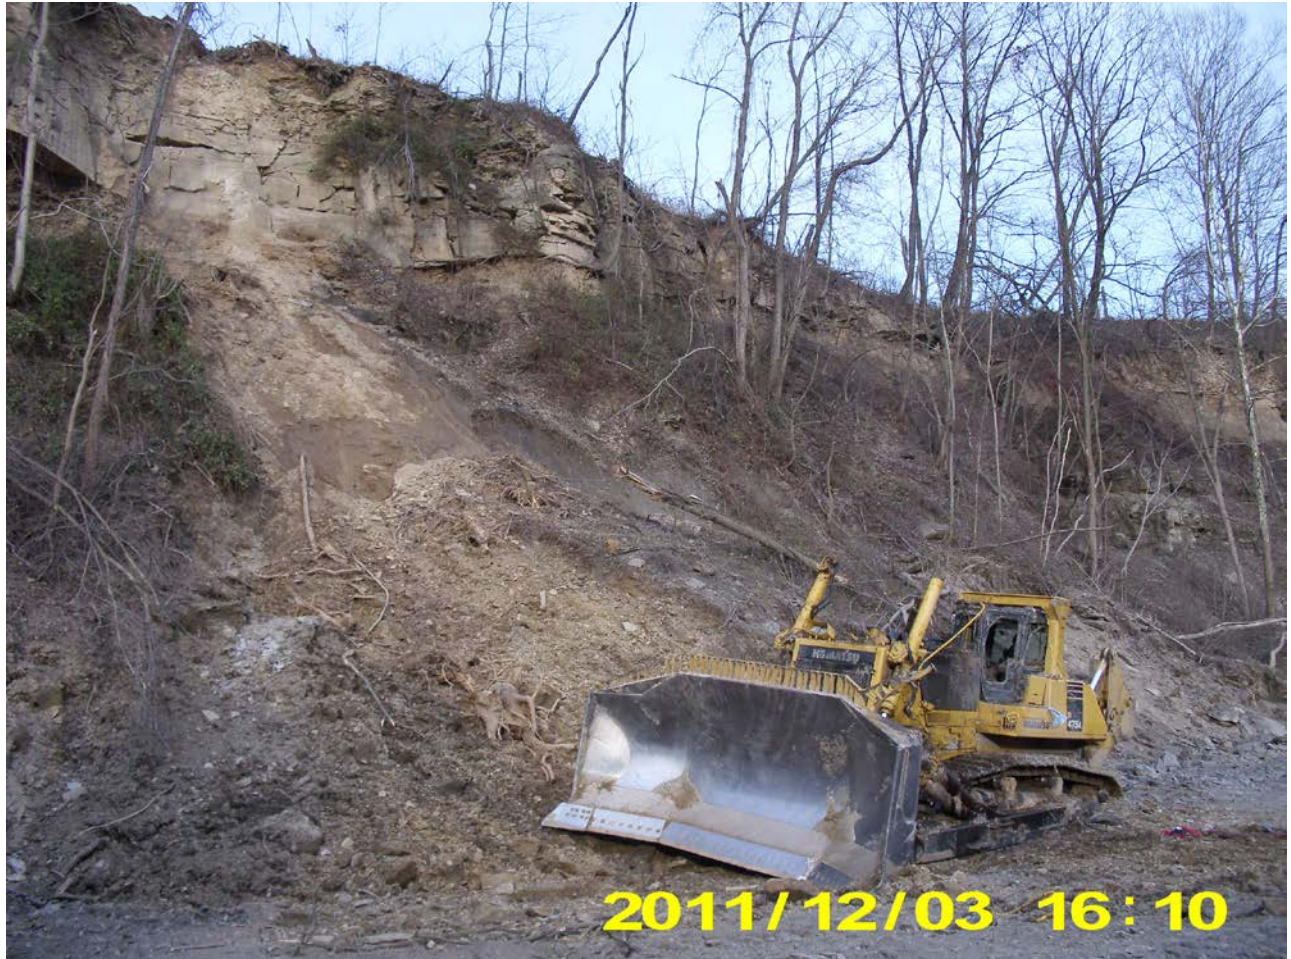
PHOTO OF ACCIDENT SCENE

The bulldozer came to rest at the base of the highwall in an upright position, parallel to the highwall, with the blade of the dozer facing west. The victim was ejected from the

cab on the South side of the dozer opposite from the highwall. The seat belt in the dozer was in the retracted position, with the male end of the belt tucked into the plastic sleeve at the base of the belt. There was no evidence to indicate the victim was wearing the seat belt.

The loose material at the base of the highwall, where the dozer came to rest after the fall was excavated to determine if a ground failure occurred that would have contributed to the accident. The material was a loose soil without any substantial rock, indicating a ground failure did not occur.
