REPORT OF INVESTIGATION

Surface Coal Mine

Fatal Fall of Highwall Accident
December 7, 2011

Fairbanks No. 4
Fairbanks Coal Company, Inc.
Appalachia, Wise County, Virginia
I.D. No. 44-07256

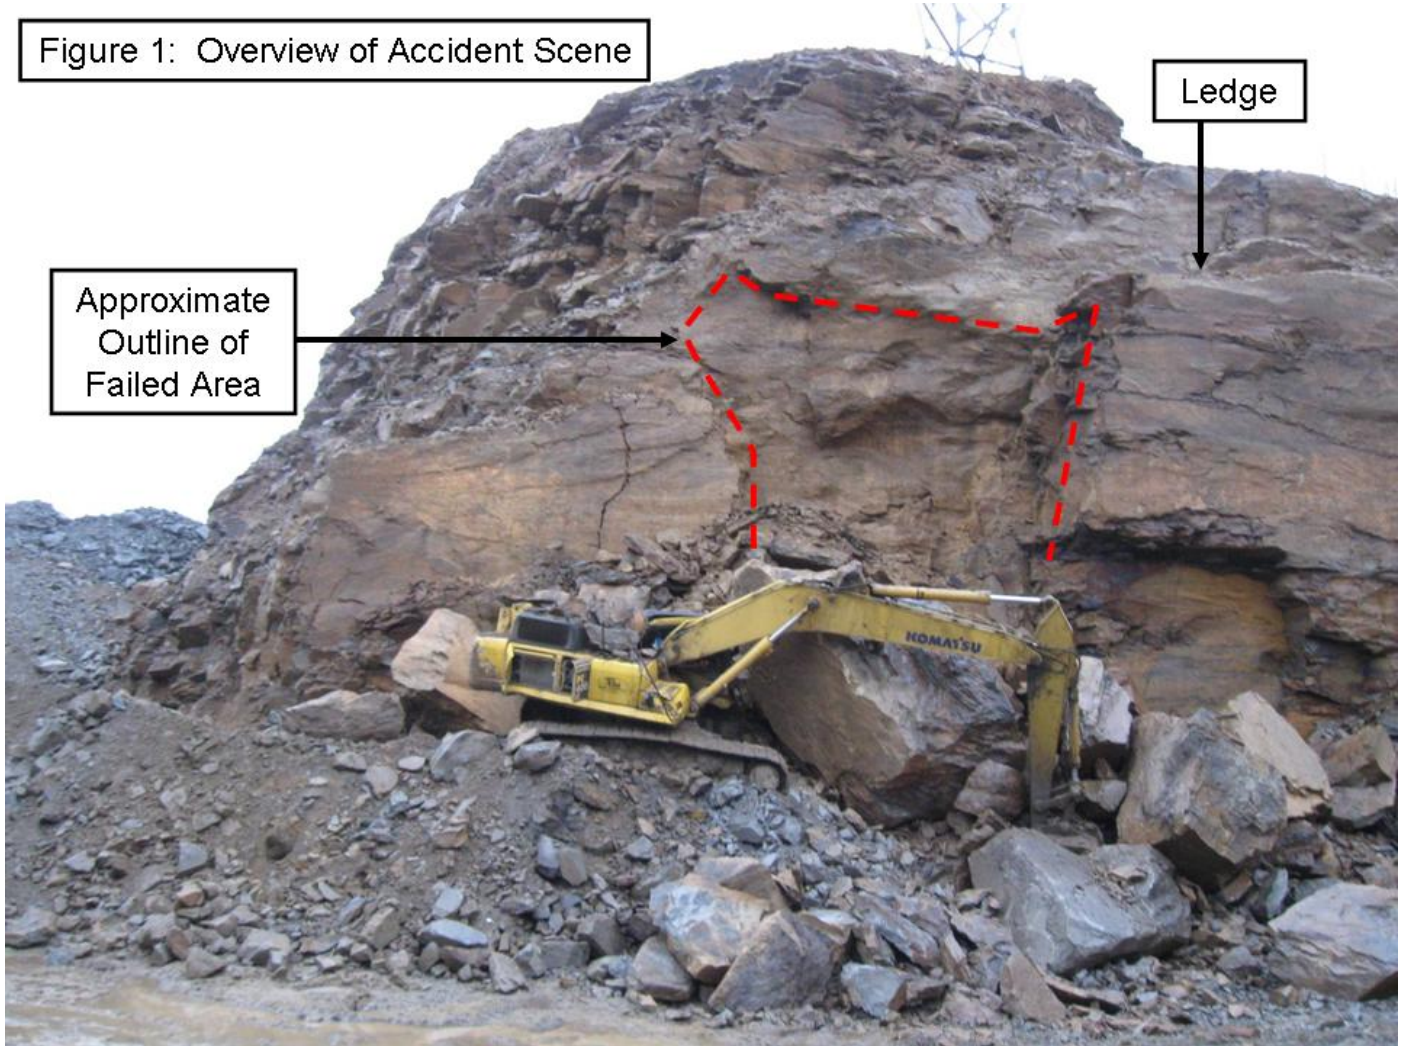
Sketch of the Accident

The east-facing highwall was mainly comprised of sandstone. The highwall height varied from approximately 80 feet near the south end, and decreased to approximately 60 feet at the north end. The highwall slope angle varied between 70 and 80 degrees. Small ledges/benches existed along the upper portions of the north end of the wall. The most significant ledge was approximately 15 feet wide and was located approximately 40 feet above the pit floor. Prior to the highwall failure, this ledge was approximately 120 feet long and extended from where the excavator had been positioned to the north end of the pit. The highwall slope below this ledge was slightly steeper at approximately 85 degrees. The highwall failure involved a section of rock that had been part of this ledge. An overview of the accident scene is shown in Appendix C.

The highwall failure involved the hazardous area identified by the second shift employees on the previous shift. The failed area was approximately 30 feet high, 25 feet wide, and 15 feet thick (based on comparing the thickness of the remaining ledge portion of the highwall). The corresponding volume of failed material was approximately 417 cubic yards. The failed material included several large rock slabs and boulders, with the largest estimated to be 20 feet high, 20 feet wide, and 15 feet thick. This largest rock boulder weighed approximately 450 tons. This large slab appeared to have directly struck the excavator's cab and boom.

The highwall failure appeared to be a toppling-type failure. Given the witness statements, the vertical fracture or joint likely ran parallel and behind the face and intersected with another vertical fracture or joint, thereby forming a partially detached column or slab of rock that had the potential to fall with very little
