REPORT OF INVESTIGATION
Underground Coal Mine

Fatal Handling Material Accident
March 3, 2012

Parton Bros. Contracting, Inc.
Timber Tree #9
Cumberland, Harlan County, Kentucky
I.D. No. 15-19051

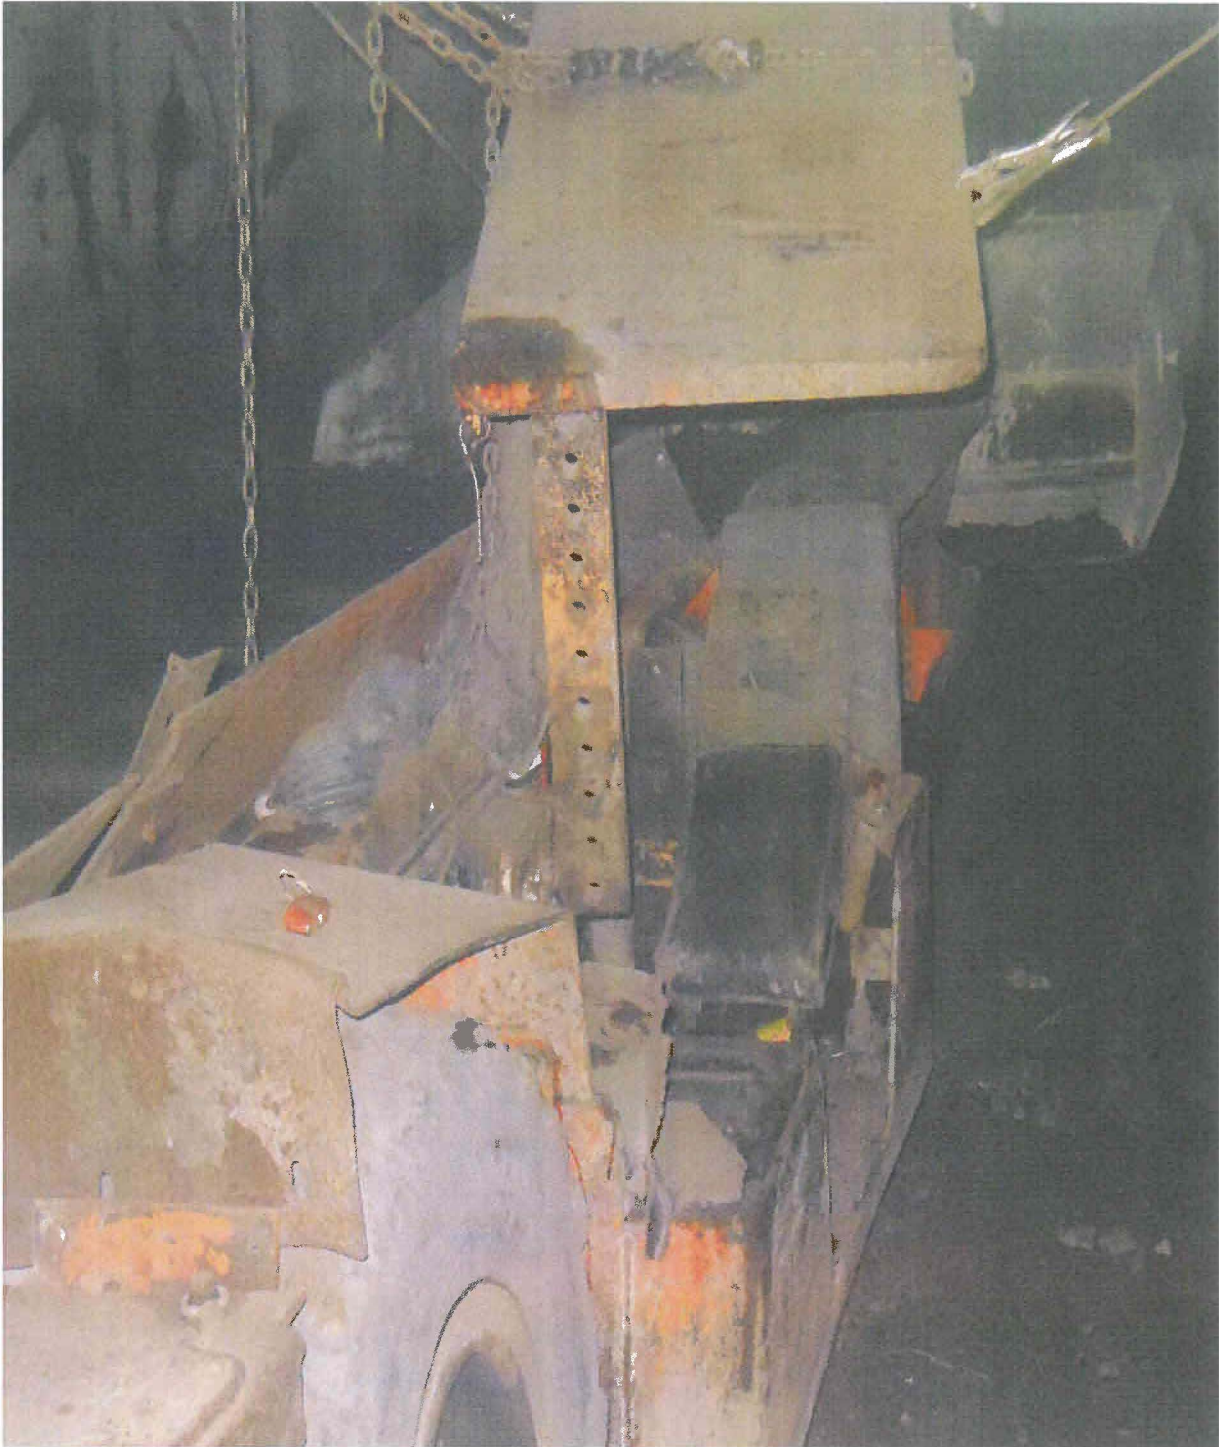
PHOTOGRAPH OF ACCIDENT SCENE POST VICTIM RECOVERY

The investigation determined that on the morning of the accident, Bailey positioned himself underneath a raised shuttle car canopy that was not securely blocked in position. He was attempting to align the canopy and shuttle car so that the protective canopy could be installed on the shuttle car. While located in the operator's compartment of the shuttle car, the suspended canopy became dislodged, striking Bailey and causing fatal, crushing injuries. Interviews conducted with miners, and an agent of the operator, indicated that no one was a witness to the accident. The mine operator failed to ensure that equipment was blocked securely in position prior to work being performed underneath.

Investigators concluded that while installing a canopy for the JOY shuttle car, the victim was most likely tramping the equipment to align the canopy posts, while sitting in the operator's compartment beneath the suspended canopy. While moving the shuttle car for alignment, the front wheel area inadvertently came into contact with the suspended canopy, causing the canopy to become dislodged and strike the victim.

- Bailey was found sitting in the shuttle car operator's compartment, facing in the direction of travel, when struck by the canopy.
- The canopy was wedged tight between the mine roof and the shuttle car, requiring the shuttle car to be pushed back approximately 10 inches to free the victim prior to recovery.

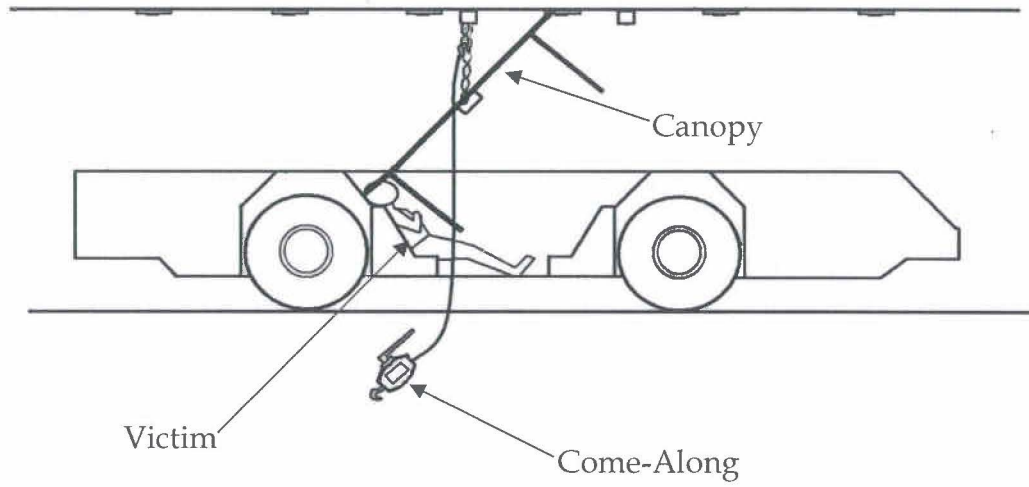
Drawing of the Accident Scene

The accident occurred in the intersection of the No. 3 entry (belt entry) on the 001 section, approximately 60 feet outby survey station number 483. This area was dry at the time of the accident and the mine height throughout the intersection ranges from 76, to 79 inches.
