Fatality #19 - November 30, 2012
Other (Impoundment) - Surface of Underground - West Virginia
Consolidation Coal Company - Robinson Run No 95

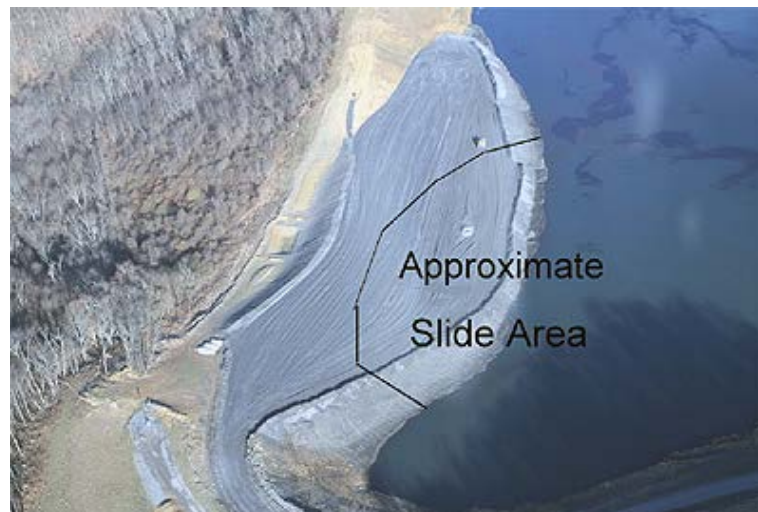
COAL MINE FATALITY - On Friday, November 30, 2012, a 58-year old bulldozer operator with 37 years of experience was killed when an upstream slope failure occurred at a coal slurry impoundment. The victim was grading the upstream slope at the time of the accident. The bulldozer was carried into the pool area during the slide and sank with the victim on board.

- Provide hazard training to all personnel working on or near an impoundment for recognition of hazards associated with the impoundment and pushout work, such as surface cracks or bubbling in water/slurry.

- Review safety precautions for upstream construction with equipment operators, along with material handling safety policies and designated storage areas for safety equipment.

- Provide oversight by knowledgeable personnel at the work site. Assure that a person is present who is familiar with the mechanics of upstream construction and can recognize and have unsafe work practices and conditions corrected immediately.

- Remove all personnel to a safe location when unsafe impoundment conditions are present.
- Prior to initiating push-outs, expose the slurry delta by pumping excess surface water down to the maximum extent possible, and for as long as possible.

- Use two-way radios or similar devices on all equipment during impoundment related construction, so that potential hazards can be communicated quickly with equipment operators and personnel.

- Maintain a work skiff with oars and life jackets near the pushout area.
