REPORT OF INVESTIGATION

**Underground Coal Mine
Fatal Exploding Vessel under Pressure Accident
January 11, 2012**

**Buchanan Mine #1
Consolidation Coal Company
Mavisdale, Buchanan County, Virginia
ID No. 44-04856**

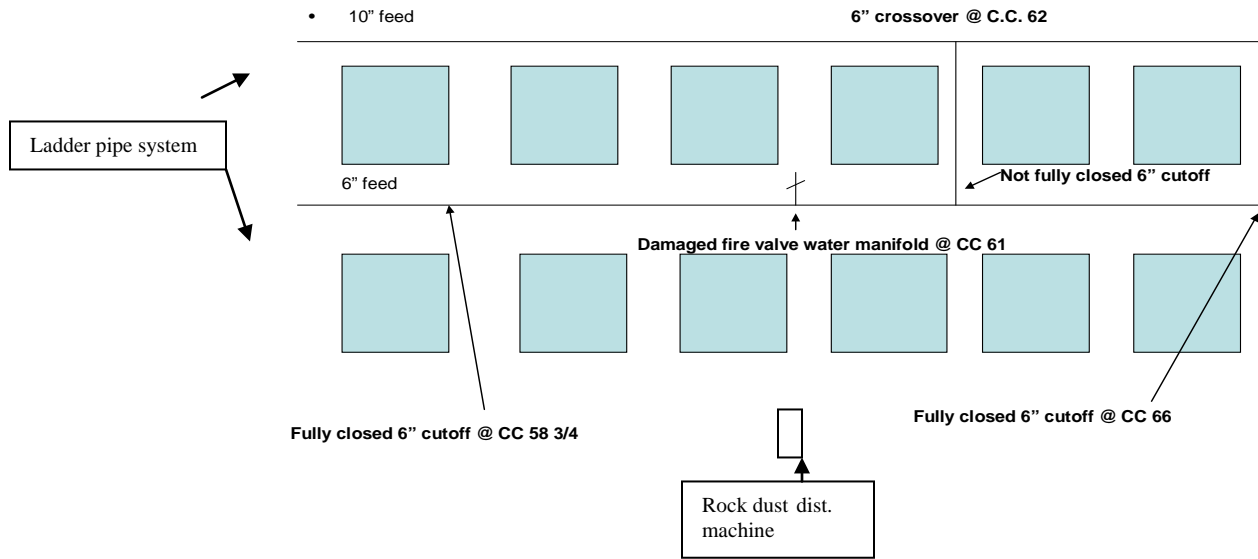
Accident site C.C. 61 of 3 East Mains

| APPENDIX A - Drawing of crosscut #61 including ladder type pipe system, with location of 6-inch closure valves and damaged fire hose outlet manifold | 21 |

The location of the fire hose outlet and manifold prior to being damaged was in the #5 entry in the center of the #61 intersection. The manifold traveled approximately 23 feet 4 inches from its original position, after striking the victim.

The water supply system in the Buchanan Mine #1 consists of a dual supply line system, referred to as a ladder system. This system depicts a layout design which has a 6-inch supply line coursed through the mine's belt/track entry and a 10-inch supply line coursed through the adjacent entry. These two supply lines are connected routinely by 6-inch crossover lines forming an overall design resembling a ladder. This system is necessary to supply the required water supply volume needed for dust suppression and fire protection in the mine (see APPENDIX A).

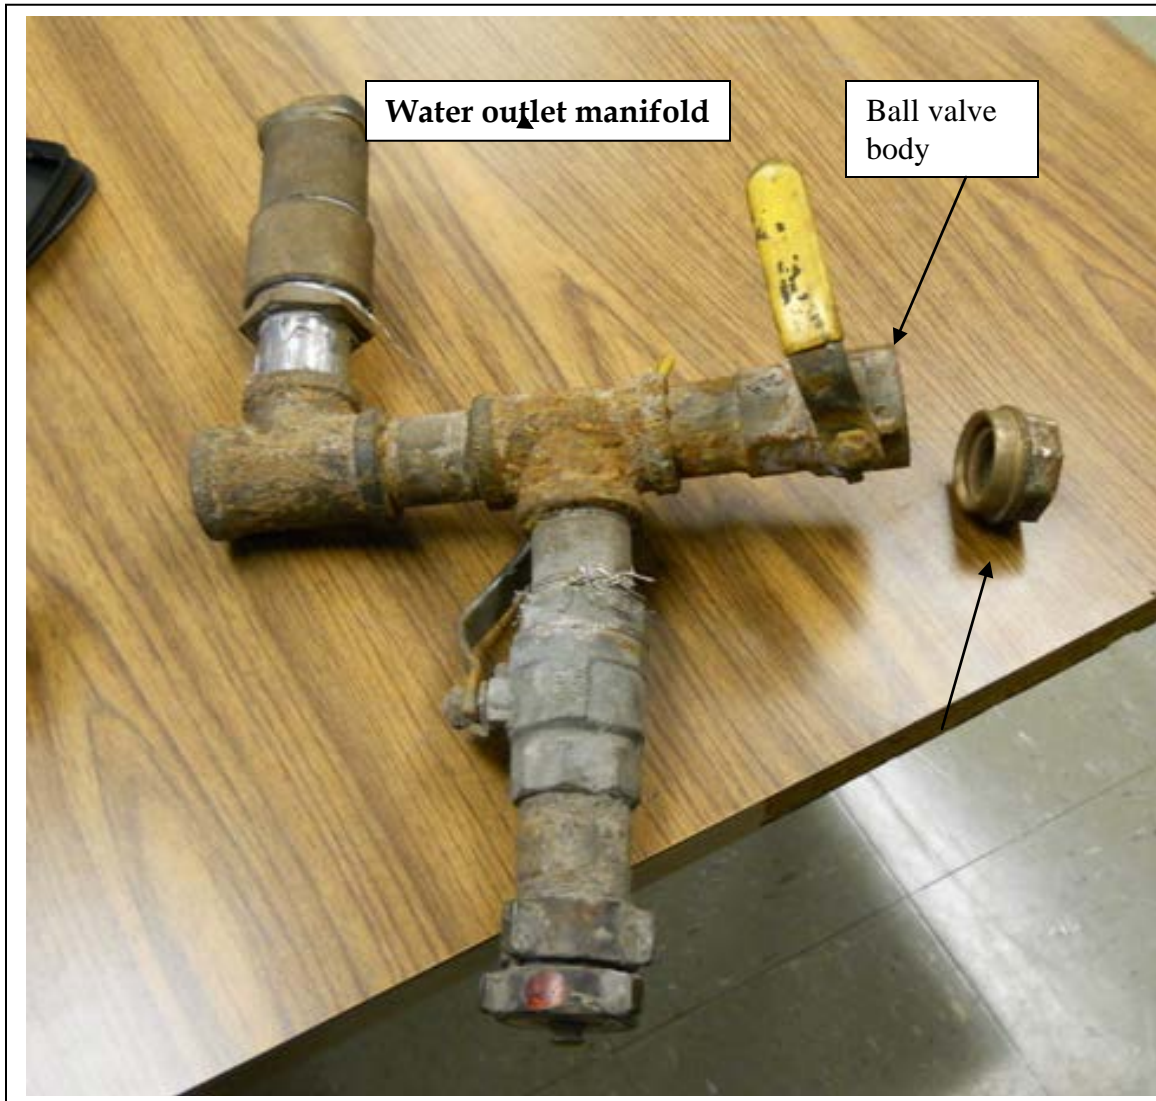
| APPENDIX B - Picture Water manifold with fire hose outlets. 1½-inch ball valve separated..... | 22 |

threaded into the body portion, which compresses the outer seal and the rotating ball into position. These two pieces of the valve body are connected using fine machined threads. The tailpiece threads into the female portion of the valve body, completing the valve assembly (see APPENDIX B).

The female threads where the tailpiece would normally thread into the valve body appeared damaged and worn. The National Pipe Thread (NPT) threads appeared to be undamaged, but the male threads of the tailpiece, which would have threaded into the valve body, were damaged. The straight threads connecting the two sections together was the location where the valve separated when impacted by the piece of mobile equipment prior to the accident. Upon examining the straight threads on the tailpiece and comparing those to the threads on an exemplar valve, it appeared the crest of the accident valve threads were rounded, as well as gouges and cuts were noted. The tailpiece of the accident valve could be inserted into the valve body without rotating or threading the tailpiece into the valve body. These normally must be threaded together to achieve proper thread engagement. The accident valve was damaged by the impact of the mobile equipment, resulting in the male tailpiece threads to pull through the female threads of the valve body, which caused damage to both the female and male threads. Both outside diameter (OD) and inside diameter (ID) measurements were taken of the accident and exemplar valves. The OD measurement was 2.212 inches on the accident tailpiece and 2.246 inches on the exemplar tailpiece. The ID measurement was 2.215 inches on the accident valve body and 2.194 inches on the exemplar valve. The manufacturer recommends that the two-piece valve assembly not be disassembled once placed in service. These type and model of valves are considered “throw away” valves and should be replaced if any damage is suspected according the manufacturer’s written recommendations.

Magnified photographs were taken of the threads at the separation point between the valve body and tailpiece. Photographs illustrated the damage sustained by both the male threads of the tailpiece and female threads of the valve body. The thread heights of the tailpiece threads of the accident valve were less than the same measurements on the new exemplar valve. The threads

were noticeably rounded resulting in approximately 25 per cent reduction in thread height, when compared to new tailpiece. The damage to the female threads of the accident valve body consisted of threads not running parallel with one another, threads cut, gouged or no longer straight, and pieces of brass threads broken off and deposited into the root of the thread layout.

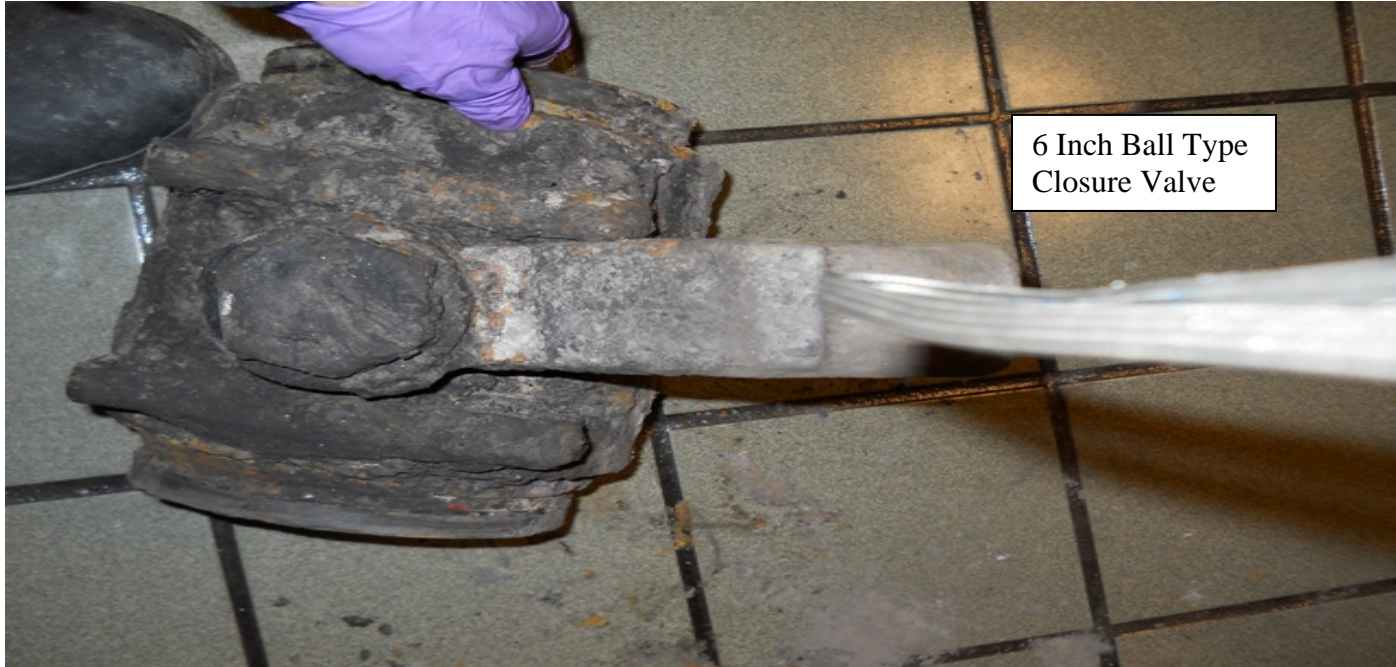
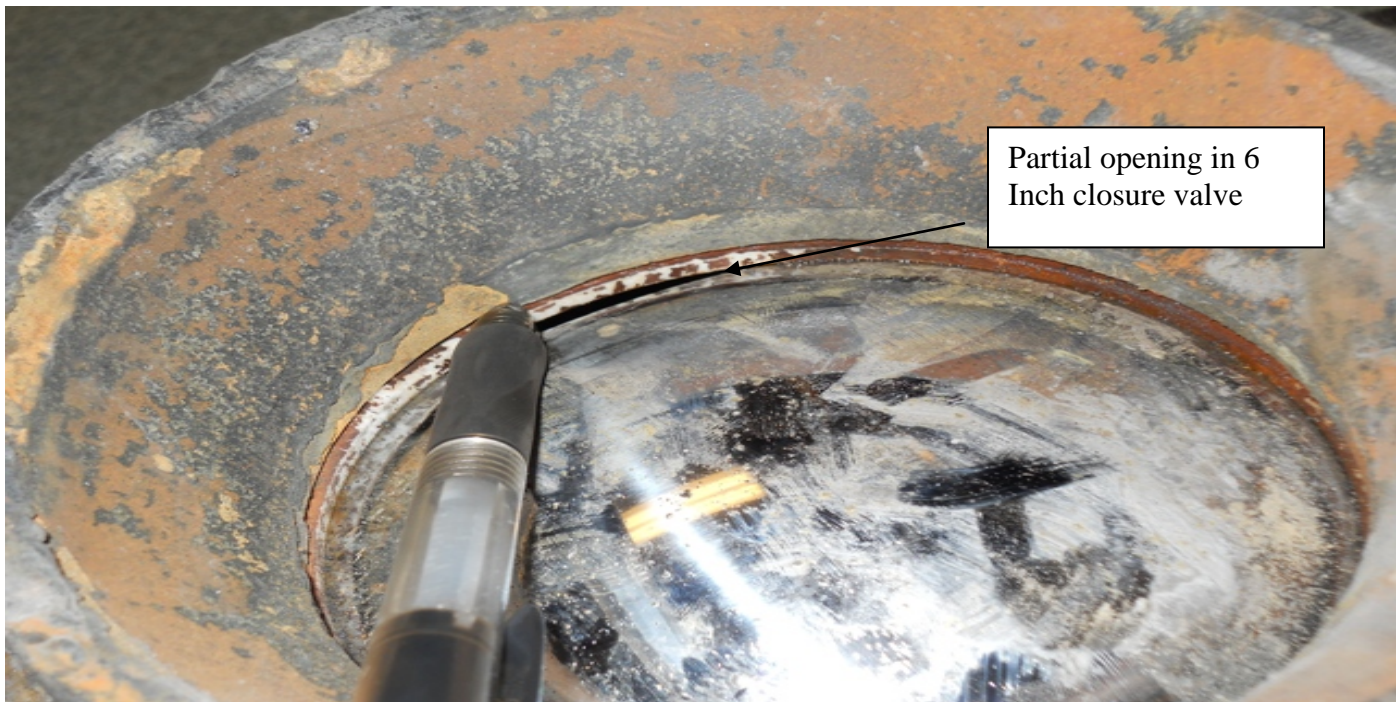
APPENDIX C

| APPENDIX C-Picture of 6-Inch Ball type closure valve..... | 23 |

These 6-inch ball type closure valves were provided with a 22.5-inch removable leverage handle when originally purchased. The manufacturer of this ball type closure valve designed this handle to be inserted into the short receiver handle on top the valve and to be secured in place with a cartridge pin, also provided from the manufacturer. Inserting this 22.5-inch handle into the receiver handle gives the person turning the valve a total leverage handle surface of 28.13 inches. This leverage handle is necessary to give the person turning the valve the proper leverage needed to turn the large heavy gauged steel quarter turn closure ball and stem. Also, this handle being of a length that would extend perpendicular to the valve when closed, would enable a person to determine if the valve is setting in a 90 degree angle and therefore fully closed. The 6-inch ball valve, located at crosscut #62, was not provided with the leverage bar to provide proper use of the valve.

isolate the area and stop water flow from entering the portion of the 6-inch supply line being repaired. When the miners turned the valve at CC 62 to stop the water flow, the valve failed to close completely. There remained an opening in the valve as large as 12 mm wide through which water was allowed to flow.

The failure of this 6-inch valve to close completely resulted in the water bypassing this valve and pressure building up in the 6-inch supply line after the damaged 1 ½ inch water valve assembly was re-attached. It was determined during testing and investigation that this 6-inch valve failed to close as a result of two factors. First, the track by which the quarter turn handle connected to the ball and stem within the valve was clogged with mine dust and grime which added a resistance for the handle to travel through to completely turn and stop the water flow. Second, this valve was not maintained with the leverage bar provided by the manufacturer for turning the handle and ball stem. This 6-inch valve consists of a short fabricated steel handle that remains connected to the ball stem exiting the valve. This handle is constructed with a circular opening in the end which allows a long steel extension bar to be inserted into the handle to provide leverage to turn the valve. As a result of the leverage handle not being available, miners had to use less effective means of turning this handle. Statements provided during witness interviews indicated that a hammer was used to strike the short handle in an attempt to close the ball valve.

The operator has taken the defective #62 crosscut 6-inch ball-type closure valve out of service and replaced it with a new ball type closure valve and leverage bar capable of properly closing to prevent bypass water flow.
