REPORT OF INVESTIGATION

Surface River Coal River Loading Facility

Drowning Accident

February 26, 2012

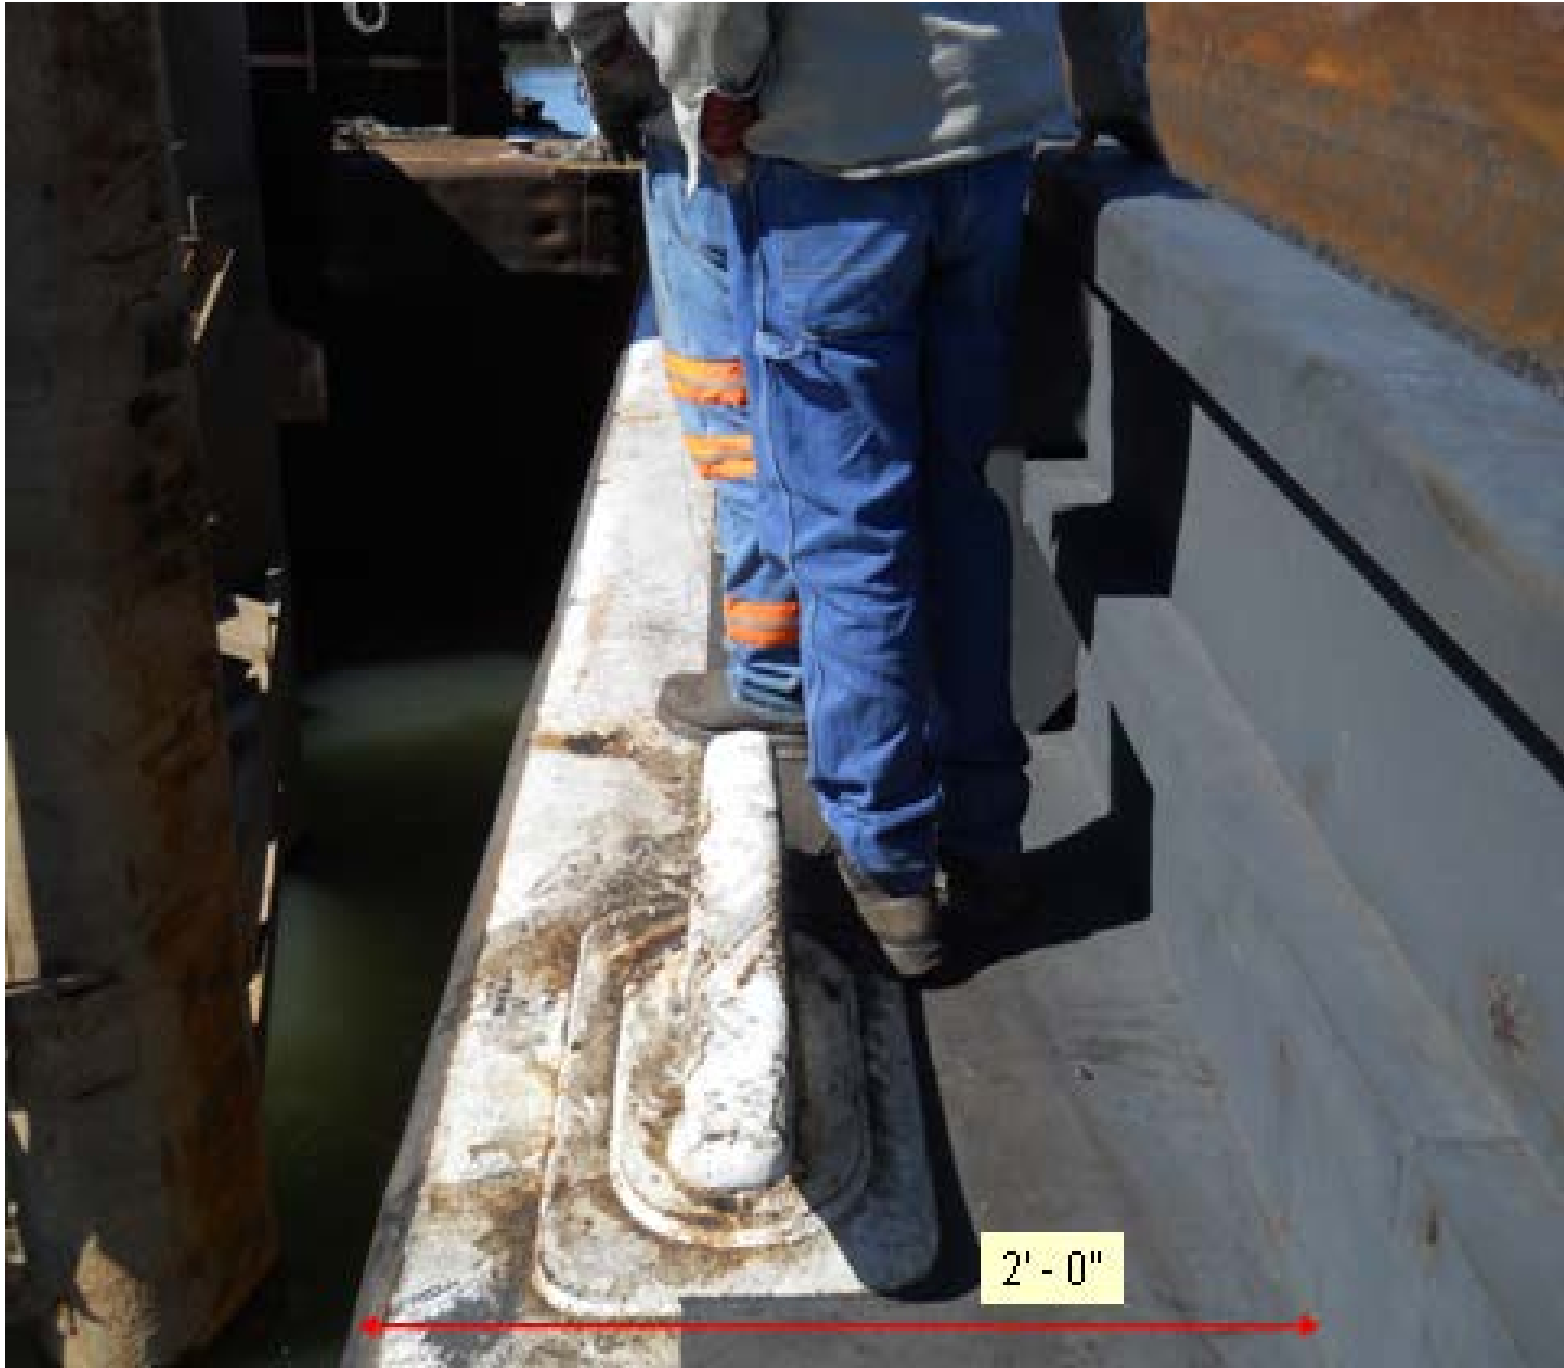
Exhibit 1 (found in Appendix B) shows the relatively narrow walkways (24") and several protrusions in the walkway. These include manholes and gunwales. When empty, the barge protrudes from the water approximately 11 feet. The barges are approximately 195 feet long and 35 feet wide. One end of the barge is vertical and the other end has a sloped end, which is called the rake. The rake is designed to help the barge move through the water. The victim was last observed on the rake end of the empty barge, where he was to take the draft reading. It cannot be determined specifically when or how the victim entered the water. According to the Coroner's Report, the victim died from drowning.
