UNITED STATES
DEPARTMENT OF LABOR
MINE SAFETY AND HEALTH ADMINISTRATION

REPORT OF INVESTIGATION

Fatal Rib Roll Accident
March 10, 2012

Kingston Mining, Inc.
Kingston Number 2 Mine
Scarbro, Fayette County, WV
I.D. Number 46-08932

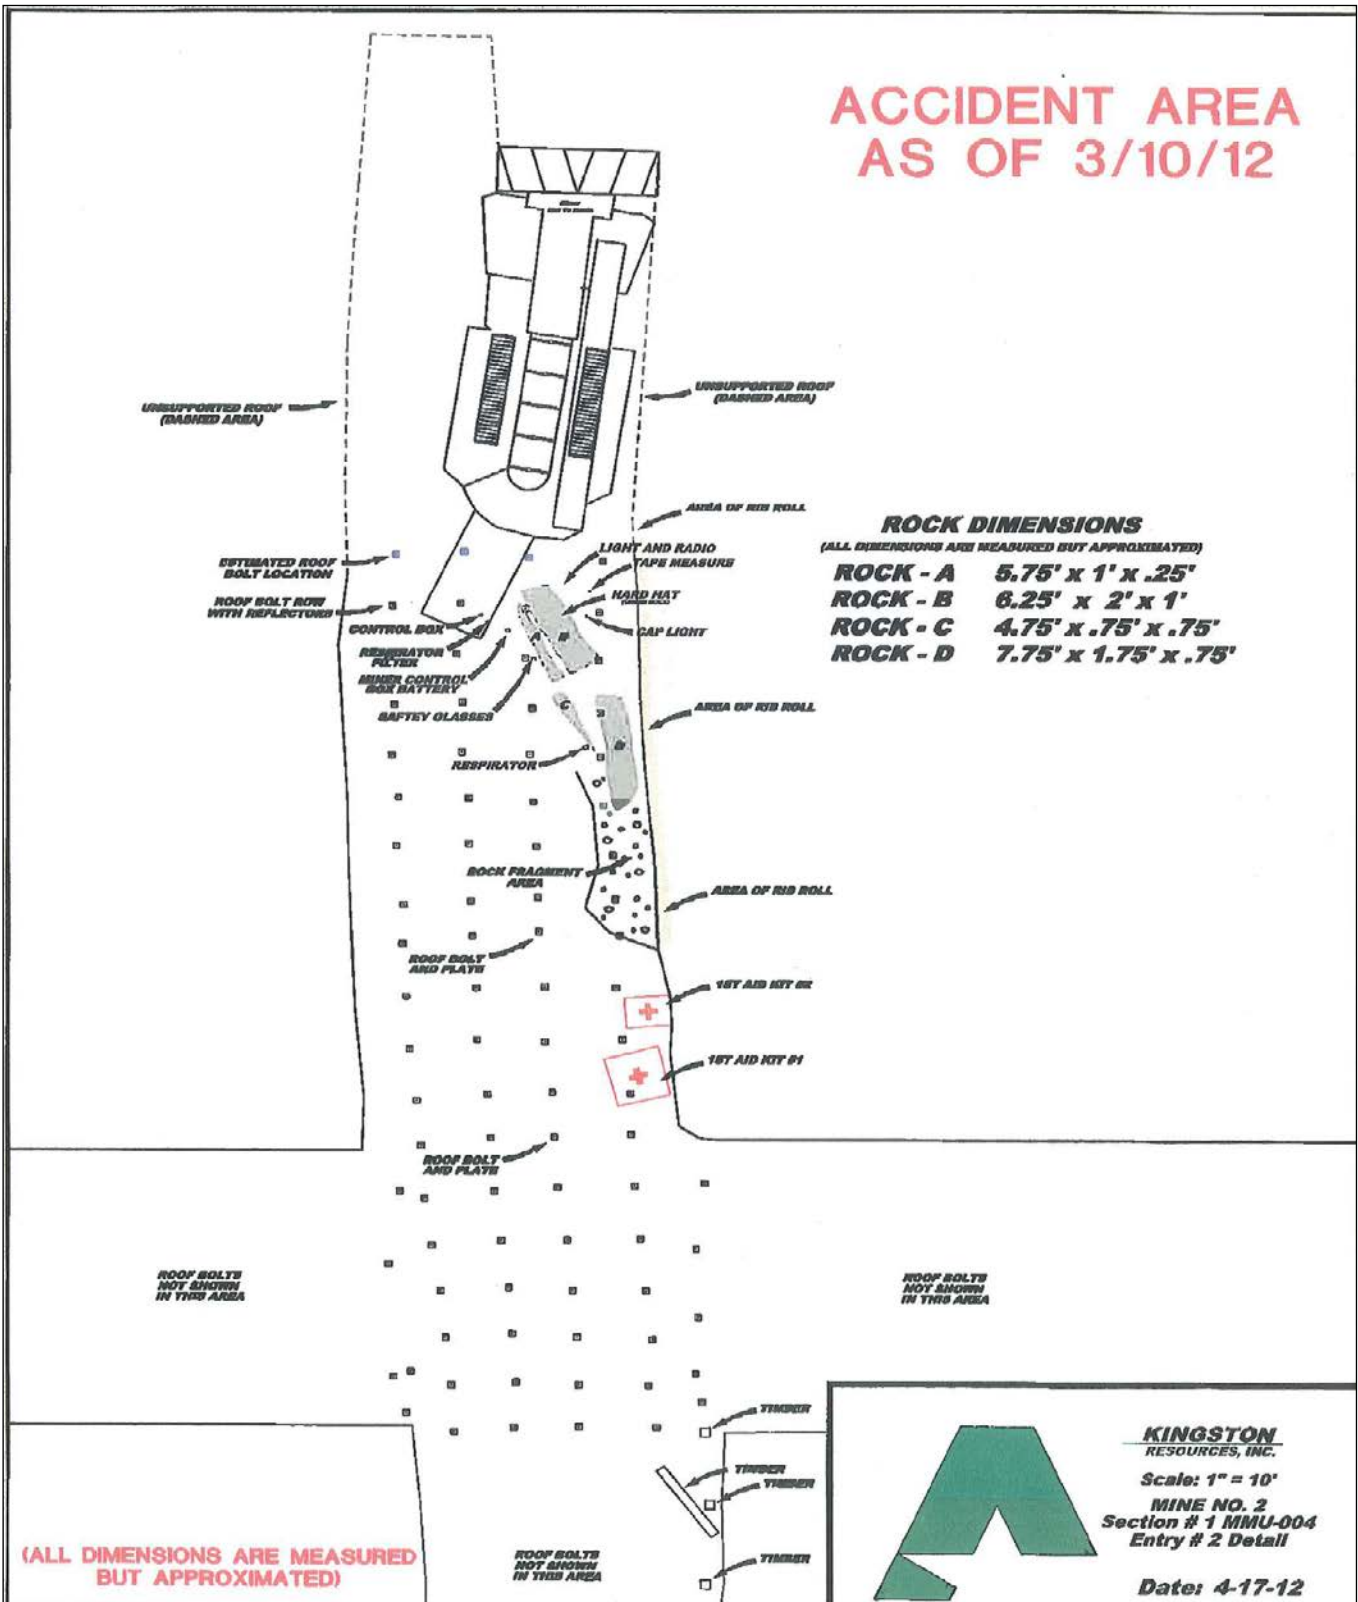
APPENDIX C
Sketch of the Accident

mined to provide clearance for mining equipment and personnel. A drawing of the accident scene is located in Appendix C.

The victim's hard hat was located under the portion of rib rock, which likely struck him as it fell from the rib. A respirator, cap light, tape measure, mine light, radio, and safety glasses were all present at the scene, but were most likely moved when CPR was administered. Sigler's lunch box and an aluminum clip board were found later on the continuous mining machine. The aluminum clip board contained the following plans: Roof Control plan, dated February 25, 2010, Methane and Dust Control plan for MMU-001 (for right side of the Number 1 Section), dated February 28, 2012, and the current Methane and Dust Control plan for MMU-004 (for left side of the Number 1 Section), dated January 5, 2012.

The rib rock that struck Sigler measured 6 feet 7 inches long, 40 inches wide and varied in thickness from 1 to 10 inches. The entire length of the section of rib which fell was approximately 30 feet 6 inches.

The left side of the face of the number 2 entry, which was being mined when the accident occurred, was mined to a depth of 36 feet 6 inches, and the right side of the face of the number 2 entry was mined to a depth of 28 feet 2 inches, as measured from the last row of permanent roof supports. The mine's approved Methane and Dust Control plan for MMU-004 (for left side of the Number 1 Section), only allowed a maximum distance of 20 feet from the end of the line curtain to the deepest point of penetration into the coal seam. Therefore, the approved cut depth was exceeded when the accident occurred. The additional time involved with mining the deeper cut increased the victim's exposure to a hazardous rib condition in the number 2 entry, thereby contributing to the fatal accident.
