REPORT OF INVESTIGATION

Electrocution Accident

March 23, 2012

Shoal Creek Mine
Drummond Company, Inc.
Walker County, Alabama
I.D. No. 01-02901

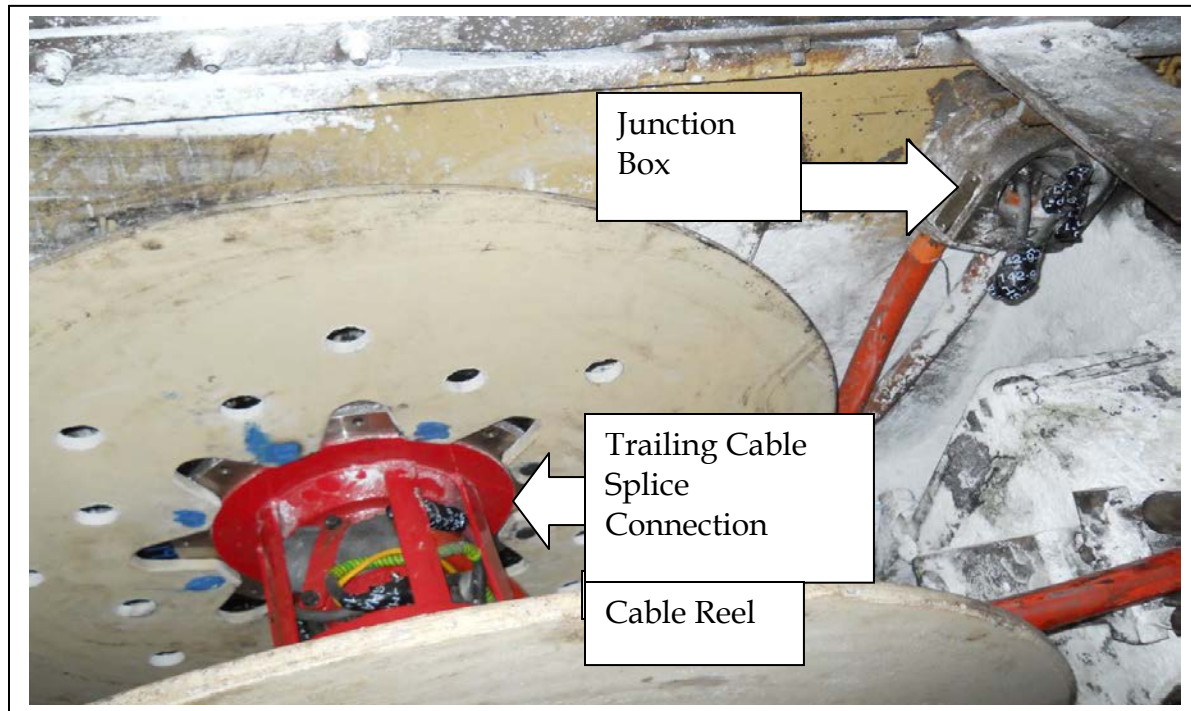
Photo No. 1

At approximately 9:30 p.m. on Friday, March 23, 2012, a 37-year old male electrician (victim) was electrocuted after receiving electric shock from an energized 950-volt shuttle car inner machine cable. The victim was positioned inside the cable reel compartment (see photo No. 1), removing insulation from a temporary inner machine cable connection when the accident occurred. The victim had 1 year, 8 months experience as an electrician. The accident occurred because the shuttle car trailing cable was not de-energized, locked, and tagged out at the power source, while the electrical work was being performed.

The accident occurred because mine management did not assure that Shuttle Car No. 17441 was de-energized and locked/tagged out before electrical work was performed. The victim received fatal electrocution injuries when he made contact with one phase of the energized 950-volt inner machine cable. A contributing factor was that the victim did not use an individual lock and tag on the power disconnect device.

Corrective Action: All mine personnel who perform electrical work were re-trained on the requirements of 30 CFR § 75.511, lock and tag out procedures. A record of the training was made and provided to MSHA.
