REPORT OF INVESTIGATION

Surface of an Underground Coal Mine

Fatal Slip/Fall of Person Accident  
April 25, 2012

McCoy Elkhorn Coal Corp.  
KC #1 Mine  
Mousie, Knott County, Kentucky  
15-18747  
Accident Investigators

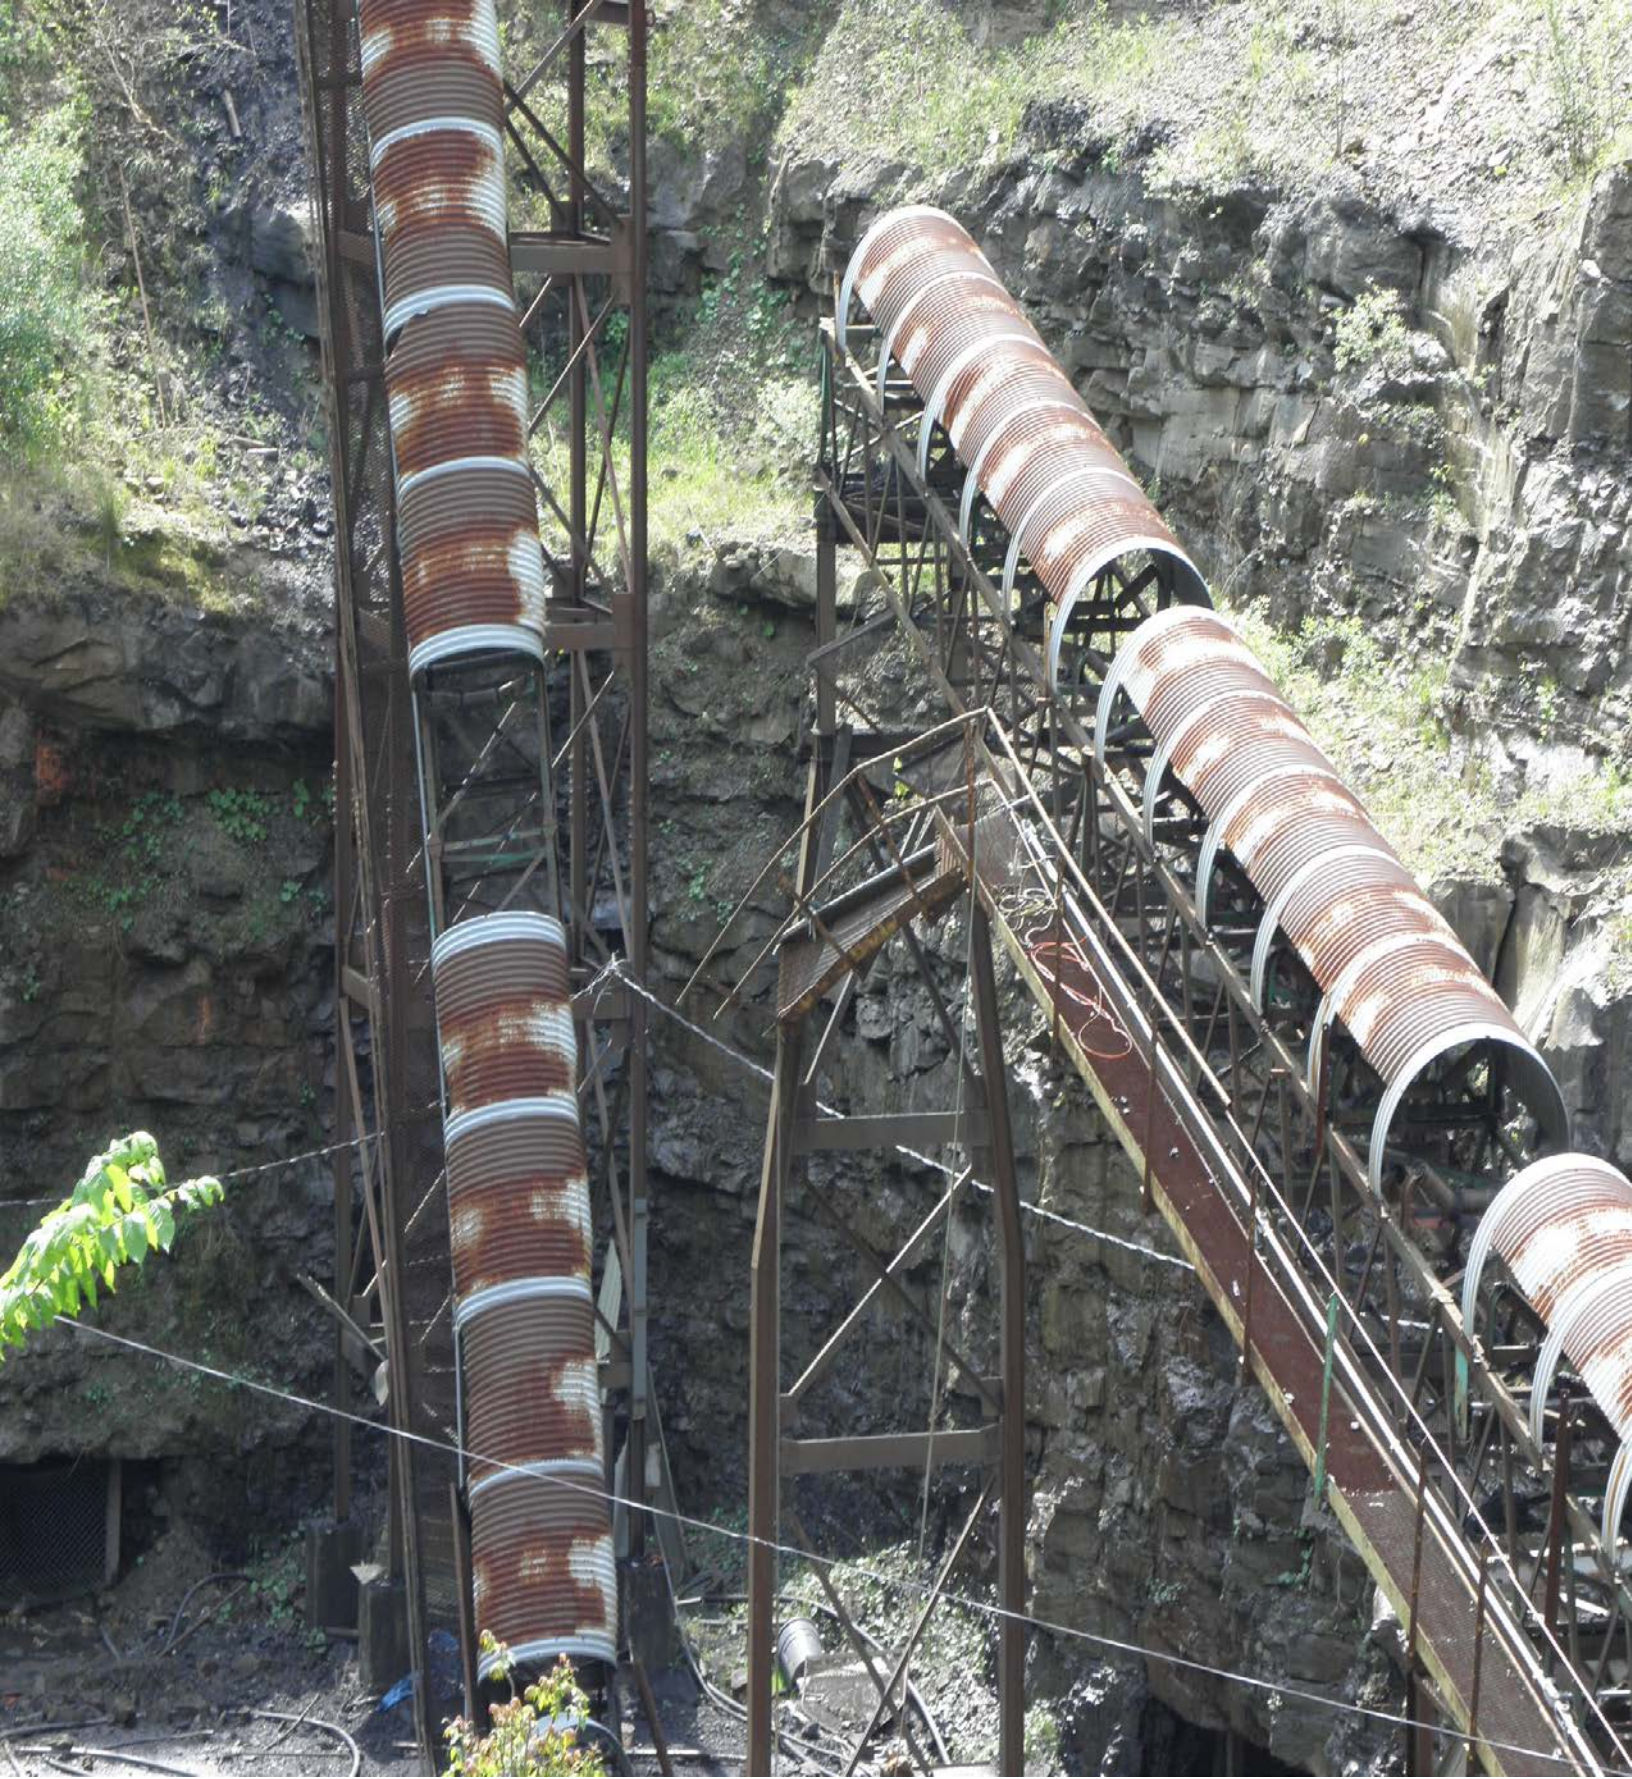
Photograph of accident scene

The elevated conveyor structure, located at the KC #1 mine, extends to the stock pile area approximately 70 feet above the floor of the box cut. The structure was supported by three steel columns on concrete platforms. A catwalk 26 inches wide with a hand rail 46 inches above the floor of the catwalk was provided to traverse the belt structure during maintenance and repairs. The victim began his work dismantling the structure 35 feet from the floor of the box cut. After the final cut of the 55 feet long upslope belt structure was completed, it began to fall, and shift down slope, where it caught the catwalk where the victim was standing. As the upslope section continued to fall, the weight of this structure caused the supporting bolts of the down slope catwalk to fail. As the down slope catwalk gave way and bent downward, it came to a sudden stop at approximately 27 feet. The victim then lost his balance and fell to the box cut floor.

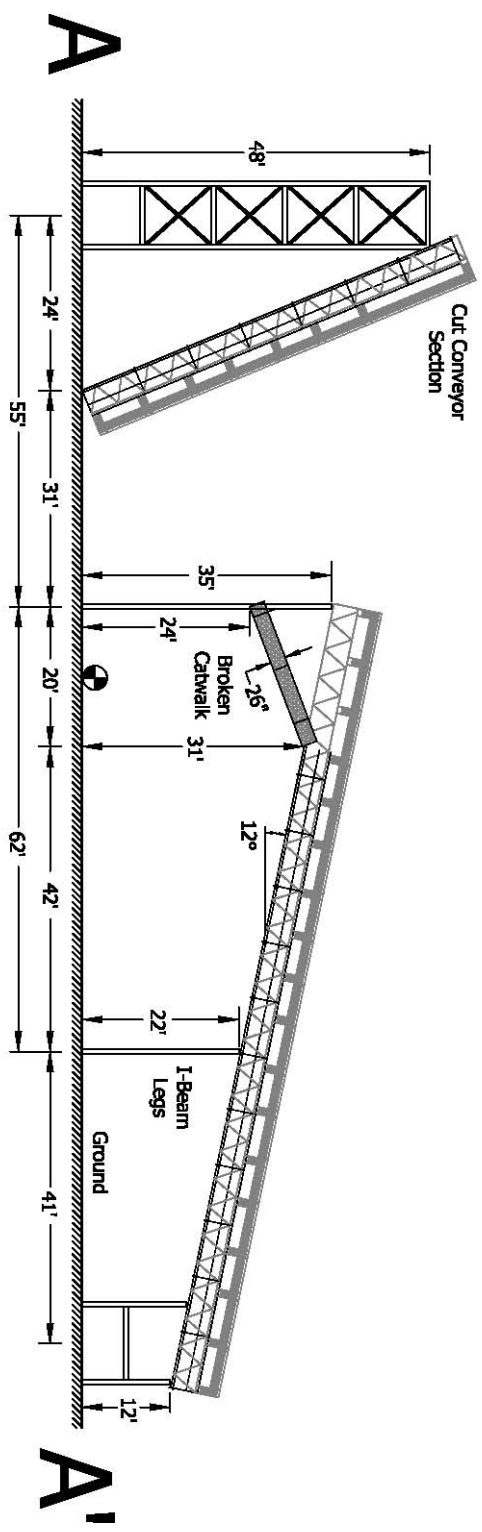
# CONVEYOR BELT STRUCTURE PROFILE (A - A')

**LEGEND**  
 ● Victim Location
