REPORT OF INVESTIGATION

Coal Preparation Plant

Fatal Slip or Fall of Person Accident  
May 17, 2012

Liberty Processing  
Independence Coal Company, Inc.  
Uneeda, Boone County, West Virginia  
I.D. No. 46-03755

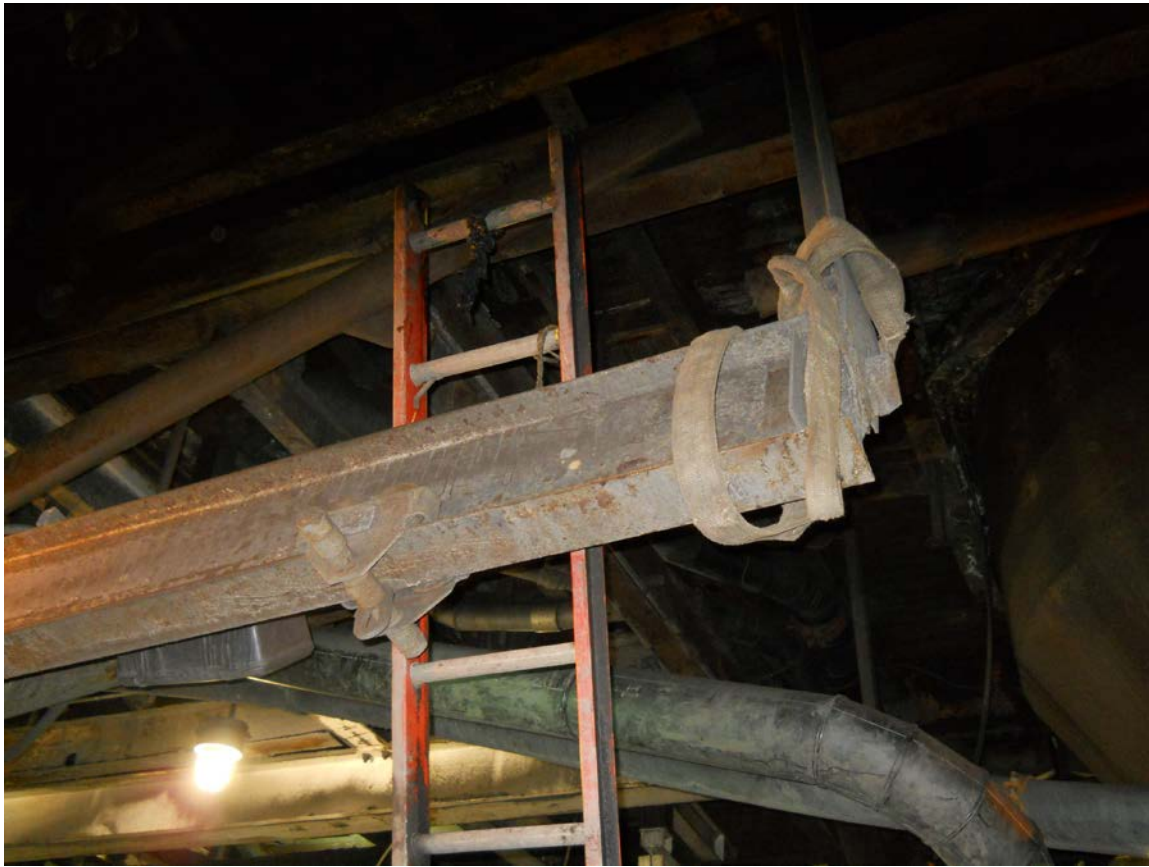
**Photo of Accident Site**

On Thursday, May 17, 2012, at 11:58 a.m., Clyde W. Dolin, a 57-year old mechanic with 39 years of mining experience, was fatally injured when the 14-foot fiberglass extension ladder he was using became unstable and slid across an I-beam, causing him to fall through the preparation plant hoist well to a concrete floor 39 feet below.

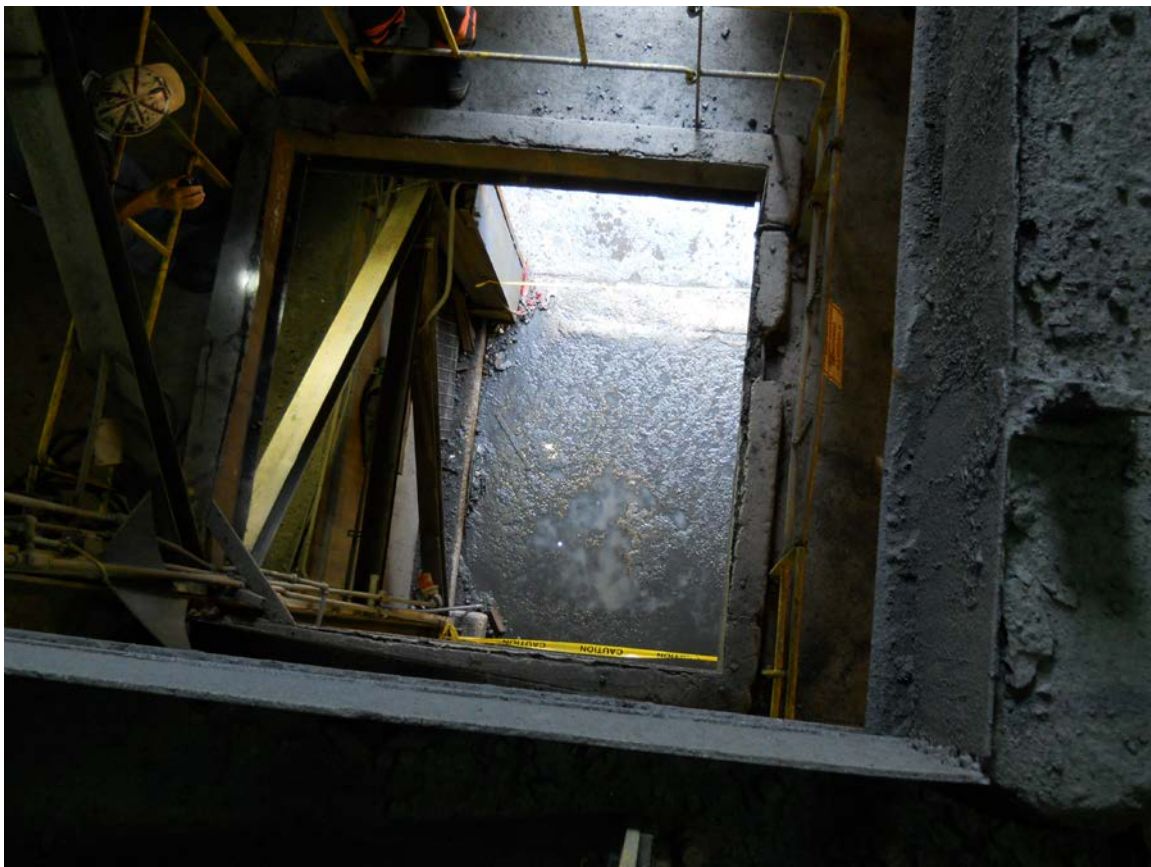
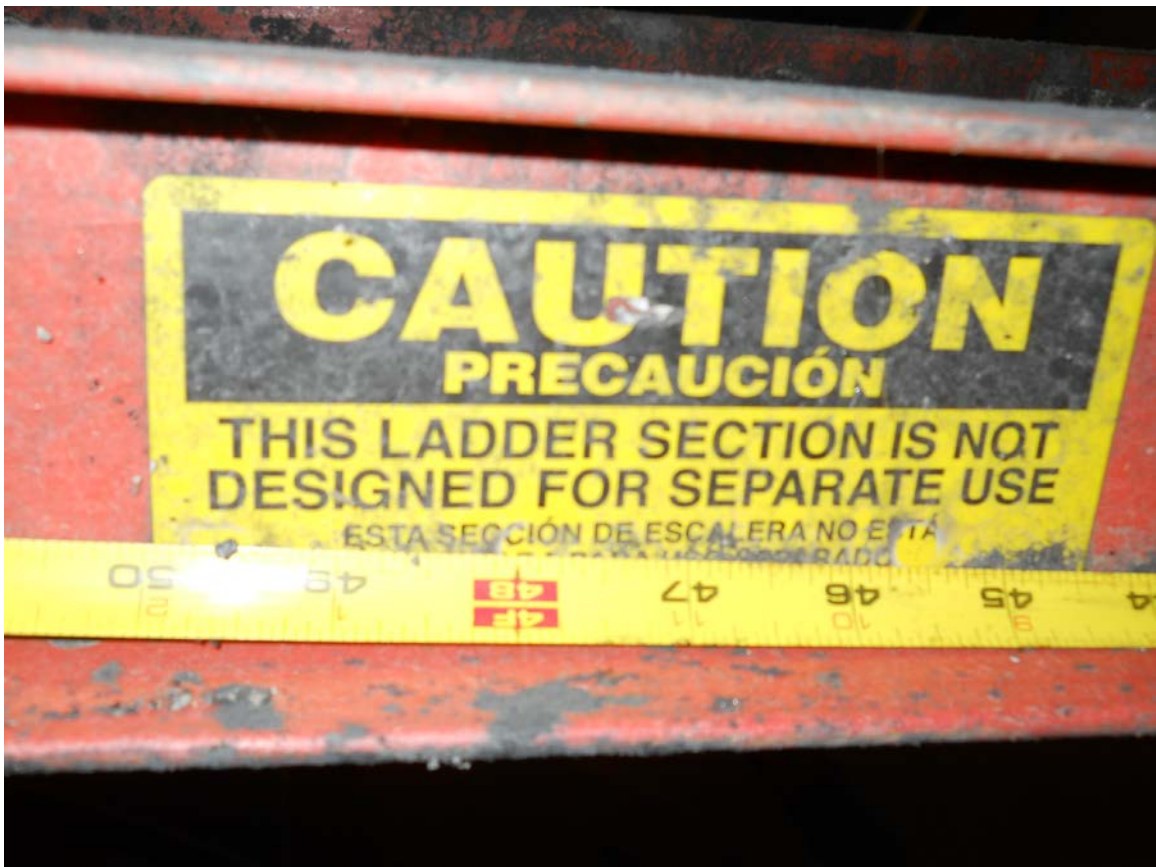
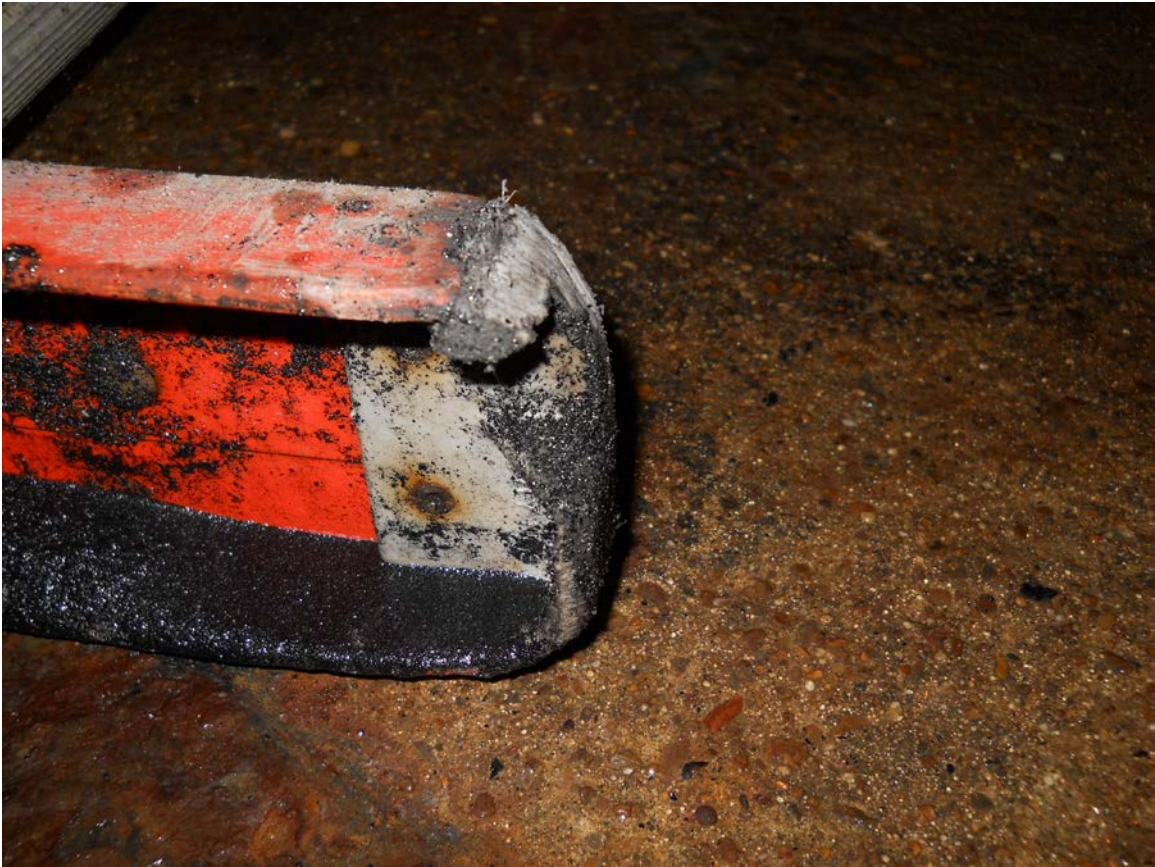
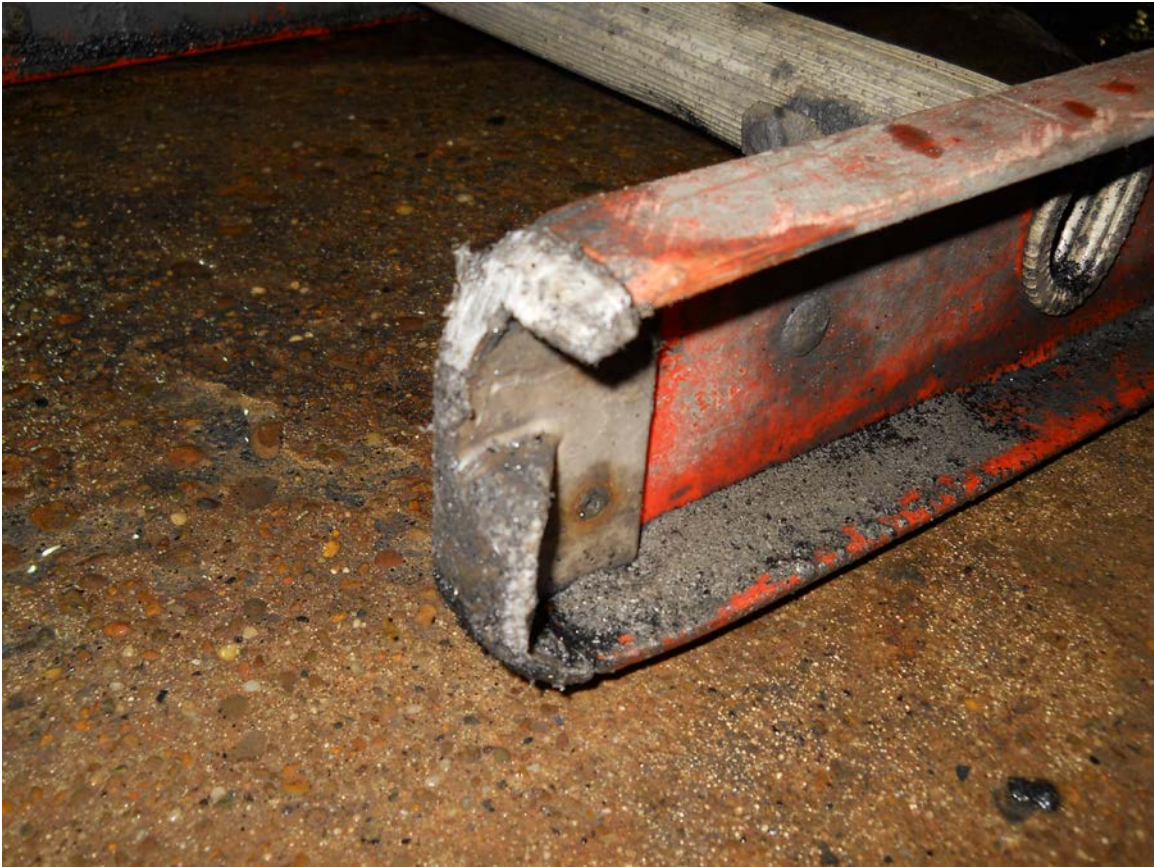
**APPENDIX C**  
**Photographs of the Accident Scene**

The Liberty Processing Plant is composed of two portions, known as the "A" and "B" sides, that are joined together to process coal from two mining operations. The "A" side of the plant, where the accident occurred, consists of seven floors. Each floor is of concrete construction and a hoist well, a vertical opening measuring 8 feet by 7 ½ feet, is present on each floor for the purpose of delivering equipment or materials to each floor. The hoist well opening on the 3<sup>rd</sup> floor had a handrail, measuring 42 inches high, surrounding the opening (see Appendix C).

A 12-inch I-beam (trolley beam) extended slightly out into the hoist well at a distance of 10.2 feet above the 3<sup>rd</sup> floor. The upper section of a 14-foot fiberglass extension ladder had been placed parallel to the hoist well with the top of the ladder positioned against the trolley beam and the base of the ladder was positioned 4 feet from vertical. Scratch marks on the back side of the ladder matched the slide marks found on the trolley beam where the ladder section was positioned prior to the accident. According to testimony, the plan was to secure the end of the beam being cut off by attaching the hoist hook and strap. A strap was found wrapped around the end of the trolley beam. An oxygen/acetylene torch was laying 4 feet from the base of the ladder.

Folding ladders and extension ladders of various sizes are used in the preparation plant. The ladder in use at the time of the accident was a 14-foot orange fiberglass extension portion of a 25-foot extension ladder. A yellow and black warning sticker attached to the side of the extension warns, "Caution. This

ladder section is not designed for separate use” (see Appendix C). The extension does not have leveling feet for additional stability and the rail ends of the ladder extension are rounded and damaged, creating a very small area of contact with the floor (see Appendix C). These factors, combined with the fact that the base of the extension section of the ladder was placed on a concrete floor and because the upper portion of the extension rested on a metal beam, created a slipping and sliding hazard. Additional ladder extensions were found in the plant and appear to have been used separate from the original ladders. A 7-foot 3-inch extension section, which had been cut off from the main portion of the ladder, was leaning against the wall on the 5<sup>th</sup> floor. On the 6<sup>th</sup> floor, a 7-foot 8-inch aluminum ladder extension section was leaning against the wall and a 12-foot 2-inch extension section was found at the motor control center (electrical room). A 12-foot 2-inch extension section was leaning against the heavy media vessel sump. All these ladder extensions were available for use by the miners. The procedure for using and working from ladders (in this case, an extension section of a ladder) was to tie off the ladder section and to use properly secured fall protection, consisting of a harness and lanyard. None of the ladder sections which were removed from the original ladders had leveling feet. The edges of the fiberglass ladder extension sections were rounded off, and the aluminum ladder sections were pointed at the end.

*Corrective Action:* Extension sections of ladders, which were found separated from the bases, were removed from the plant. A formal fall protection training program was developed and submitted to MSHA. The affected miners were given training in the selection, inspection, and safe use of ladders. New ladders in proper working order were purchased and placed into service.
