REPORT OF INVESTIGATION

Fatal Fall of Rib Accident  
June 25, 2012

McCoy Elkhorn Coal Corp.  
Mine #23  
Pike County, Pikeville, KY  
I.D. No. 15-18721

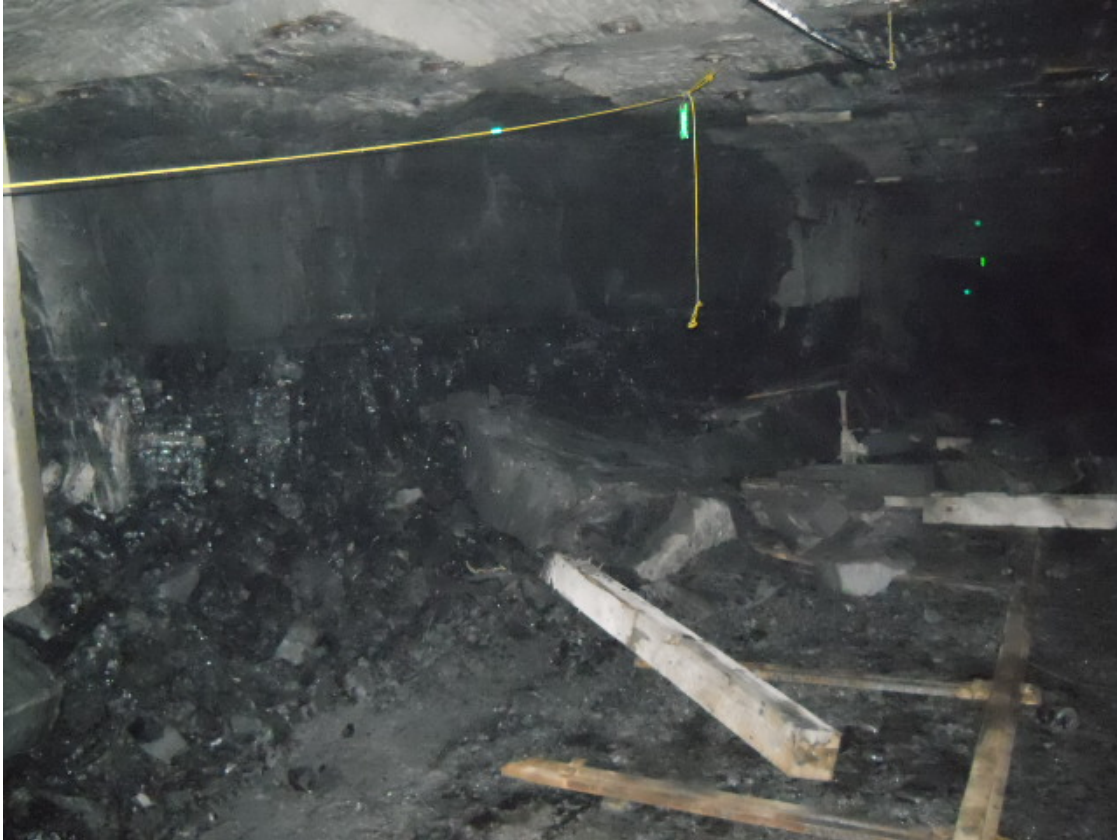
Photo of Accident Scene

At approximately 11:30 A.M. on Monday, June 25, 2012, a fatal accident occurred at the McCoy Elkhorn Coal Corporation, Mine #23. Farley Sargent, a 33-year-old outby foreman for McCoy Elkhorn Coal Company received fatal, crushing injuries when a section of the mine wall (rib) fell on top of the victim. The section of fallen rib measured approximately 26.5 feet long, 52.5 inches wide, and 17 inches thick. Farley was in the process of laying track, approximately 63 feet outby survey station No. 6080 in the No. 5 track/belt entry, and was installing a timber for rib support when the accident occurred (See Sketch of Accident Scene, Page 2).

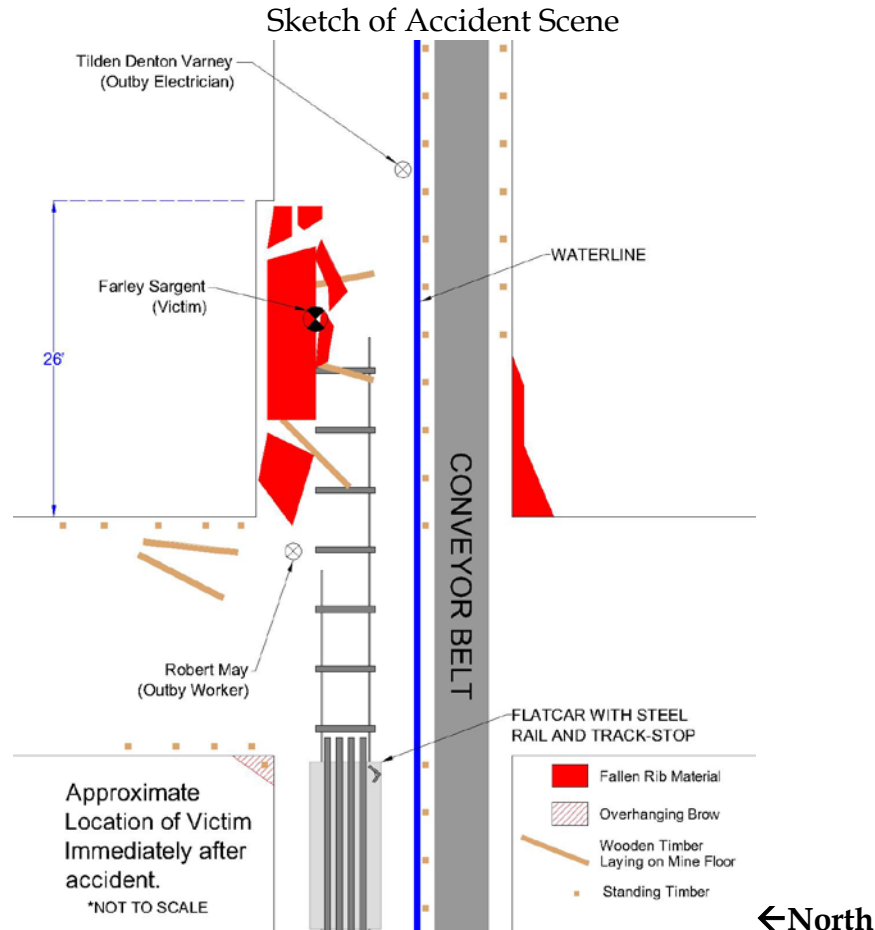
The area of the accident scene measured approximately 8.5 feet in height and 22 feet in width. The operator increased the mining height in the area of the accident in order to raise the height of the conveyor belt to allow mining equipment to travel under the belt to gain access to and from the primary escapeway. Forty-eight to 52 inches of shale roof was mined up to the sandstone beginning approximately 50 feet outby the accident scene. The strata (rib) measurements at the scene of the accident from the bottom of the coal seam upwards were approximately: 11.5 inches of coal, 7.5 inches of gray shale rock, 28 inches of coal, and 52.5 inches of brown laminated shale. The No. 5 belt/track entry was mined 22 feet wide to allow for the belt and track to be installed in the same entry. The entry had two rows of timbers, one row between the conveyor belt and the track, and one row located along the right rib (facing inby).

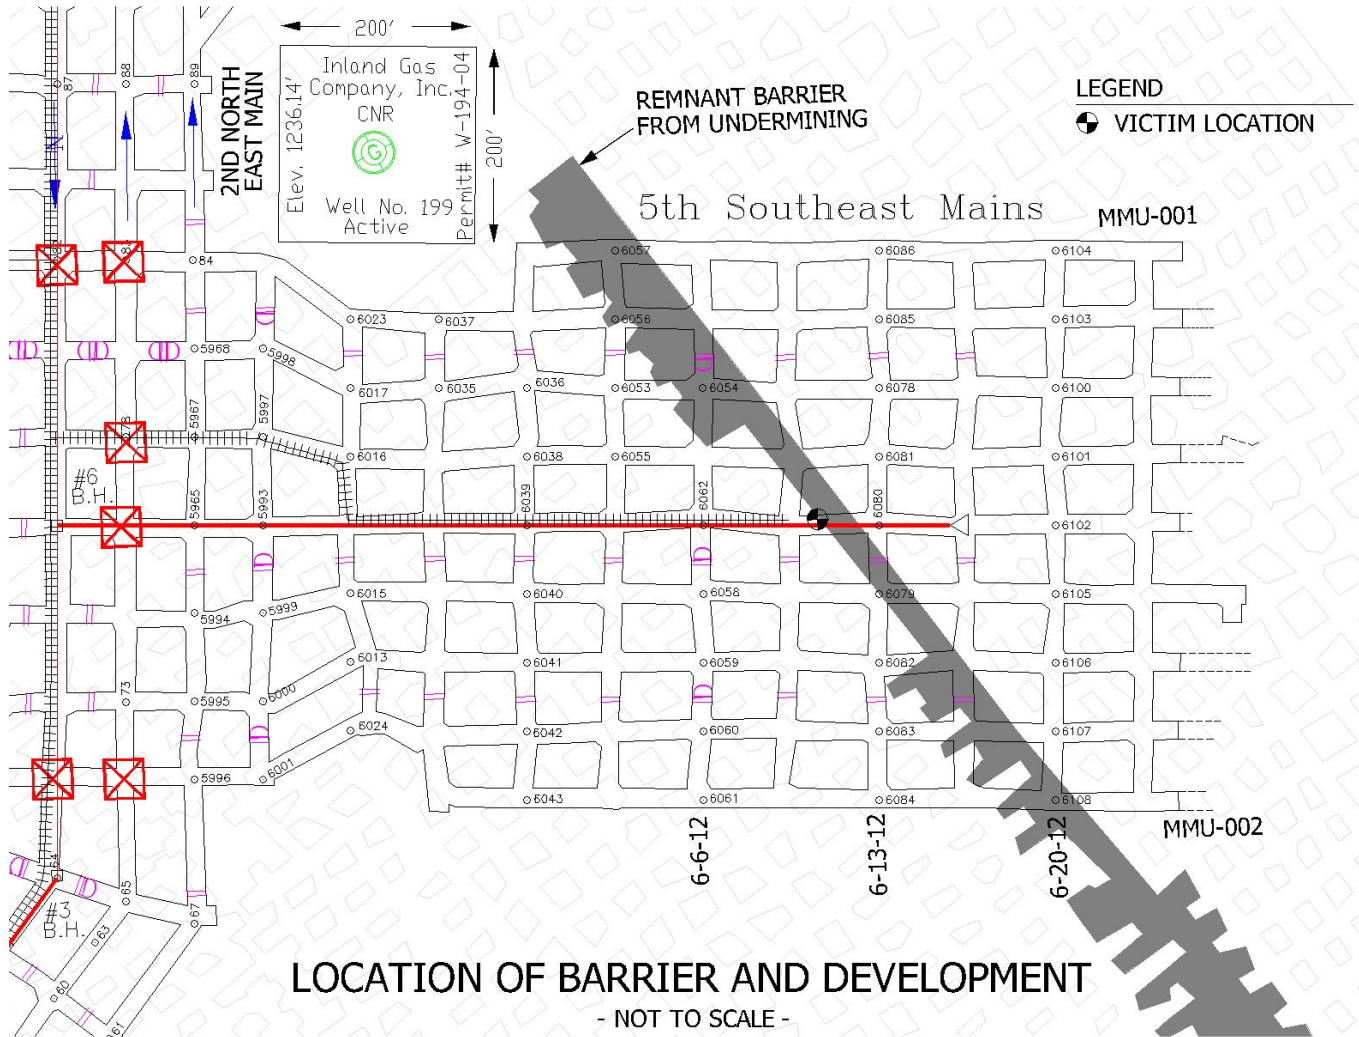
LOCATION OF BARRIER AND DEVELOPMENT  
- NOT TO SCALE -

Abandoned mine workings exist below the accident location in the No. 2 Elkhorn coal seam (See Appendix A). As the section advanced over a remnant barrier (unmined solid coal) the stress created from the barrier was greater than previously encountered or anticipated due to its narrow width. Sloughage of the ribs began to occur and progressed as mining advanced. This condition exists in entries and crosscuts 1 thru 9 beginning approximately 100 feet outby survey station 6057 in the No. 1 entry and extends inby diagonally to the No. 9 entry, approximately 12 feet inby survey station 6108, a distance of approximately 562 feet. This area is consistent with a remnant barrier from undermining. The lower mine appears to have mined on forty feet by fifty feet centers which may have caused the weight to re-distribute toward the barrier block.

Approximately 45 feet of interburden is present between the active mine and the nearest underlying mine workings. The operator increased the center sizes to address the under mining and barriers that were present in the No. 2 Elkhorn coal seam. The center sizes were increased from the required 70 feet by 70 feet centers to 70 feet entry centers and 90 feet crosscut centers on the 001-0/002-0 MMU. The 001-0/002-0 MMU is a super section with nine advancing entries located approximately 3,400 feet from the mine portal. The roof was supported with 48 inch fully grouted resin bolts; four, eight foot cable bolts in the intersections and two, eight foot cable bolts every third row of primary support.

An examination of the rib conditions in the mine (compare Appendix A and Appendix B) indicates that the rib sloughage resulted from stress created by a narrow remnant barrier and small centers of the underlying mine. The 7.5 inches of gray shale rock parting, approximately 11.5 inches from the bottom of the coal seam, is soft and deteriorates first. This causes the coal above to deteriorate and roll, or slough off, creating an overhang in the laminated shale above the coal seam. The more the coal deteriorates, the larger the overhang. The weight of the increased rock overlying the coal seam along with stress exerted from underlying works created unstable rib conditions.

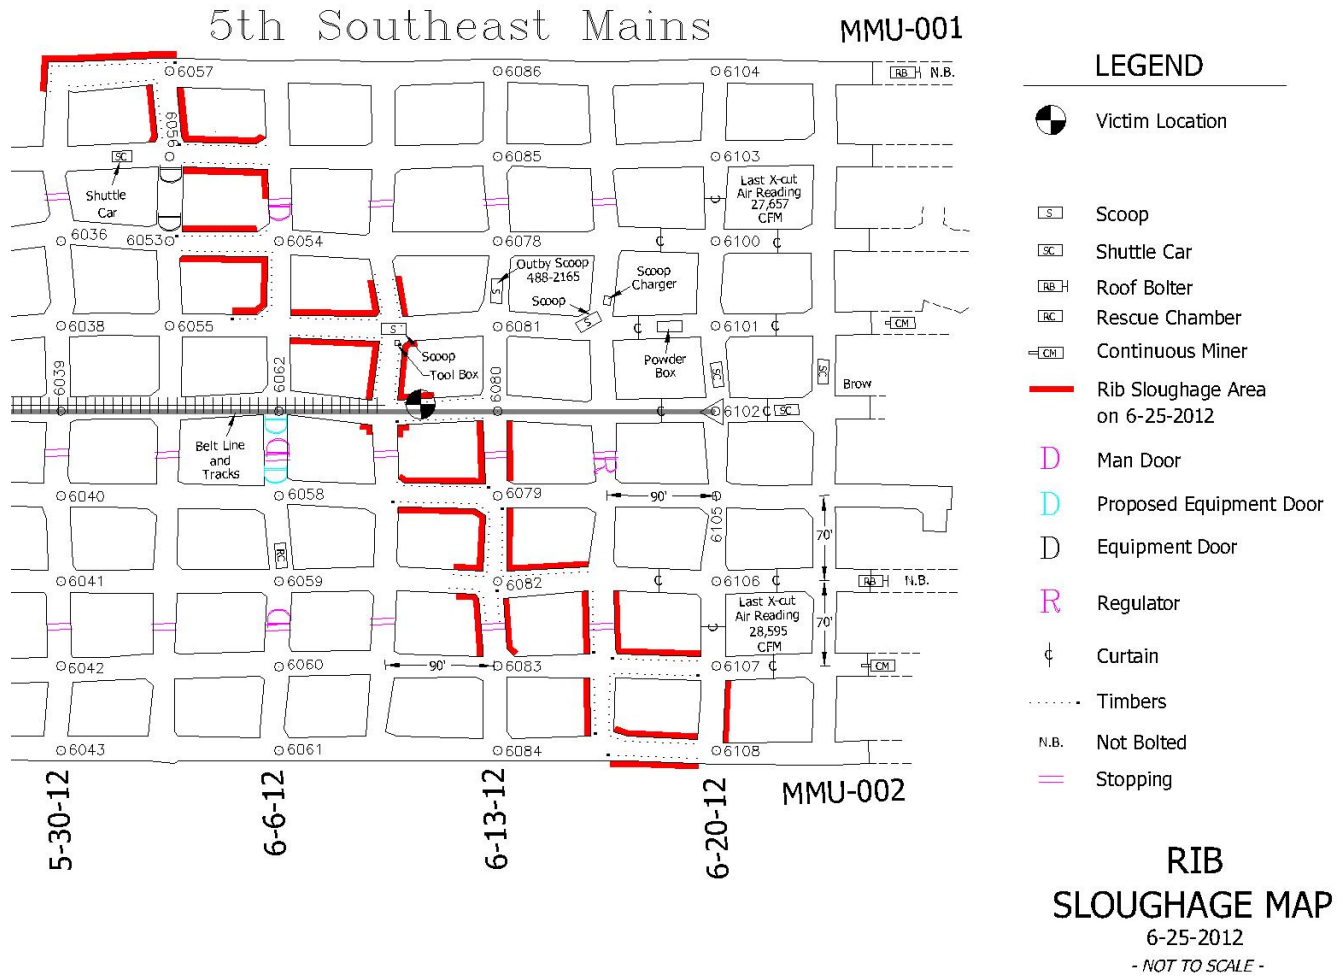
Because of the sloughage of the ribs that was present in the areas shown in Appendix B, the operator installed timbers for rib support when the condition became apparent from approximately May 30, 2012, to June 25, 2012, when the accident occurred. The timbers were sufficient at the time of installation and subsequently, the ribs deteriorated to the point where the timbers installed would not adequately support the ribs. This condition was not recognized by the examiner.

Corrective Action: The operator installed rib supports that adequately control the ribs and protect persons from the hazards of falling material in the accident and adjacent areas. In addition the roof control plan was revised to require specific measures to be taken when mining within 150 feet before, during, and 150 feet after crossing barriers. The new plan requires: 80 feet entry centers, 90 feet crosscut centers, 18 feet entry and crosscut widths, 20 feet maximum cut depth, separate track and belt entries, and the installation of rib angle brackets four feet apart with a bracket to install lashing (nylon strap rated at 22,000 lbs. breaking strength) on every other support. Support brackets will extend 4 feet down the block. Belt and track will be installed in the middle of the entries. Six inch by six inch timbers will be installed within 24 hours of the belt being moved up, two (2) feet off each rib between the angle supports. The operator installed the aforementioned support in the affected areas.
