UNITED STATES
DEPARTMENT OF LABOR
MINE SAFETY AND HEALTH ADMINISTRATION
COAL MINE SAFETY AND HEALTH

REPORT OF INVESTIGATION
Surface Coal Mine
Fatal Powered Haulage Accident
July 14, 2012

Colowyo Mine
Colowyo Coal Company LP
Meeker, Moffat County, Colorado
Mine ID No. 05-02962

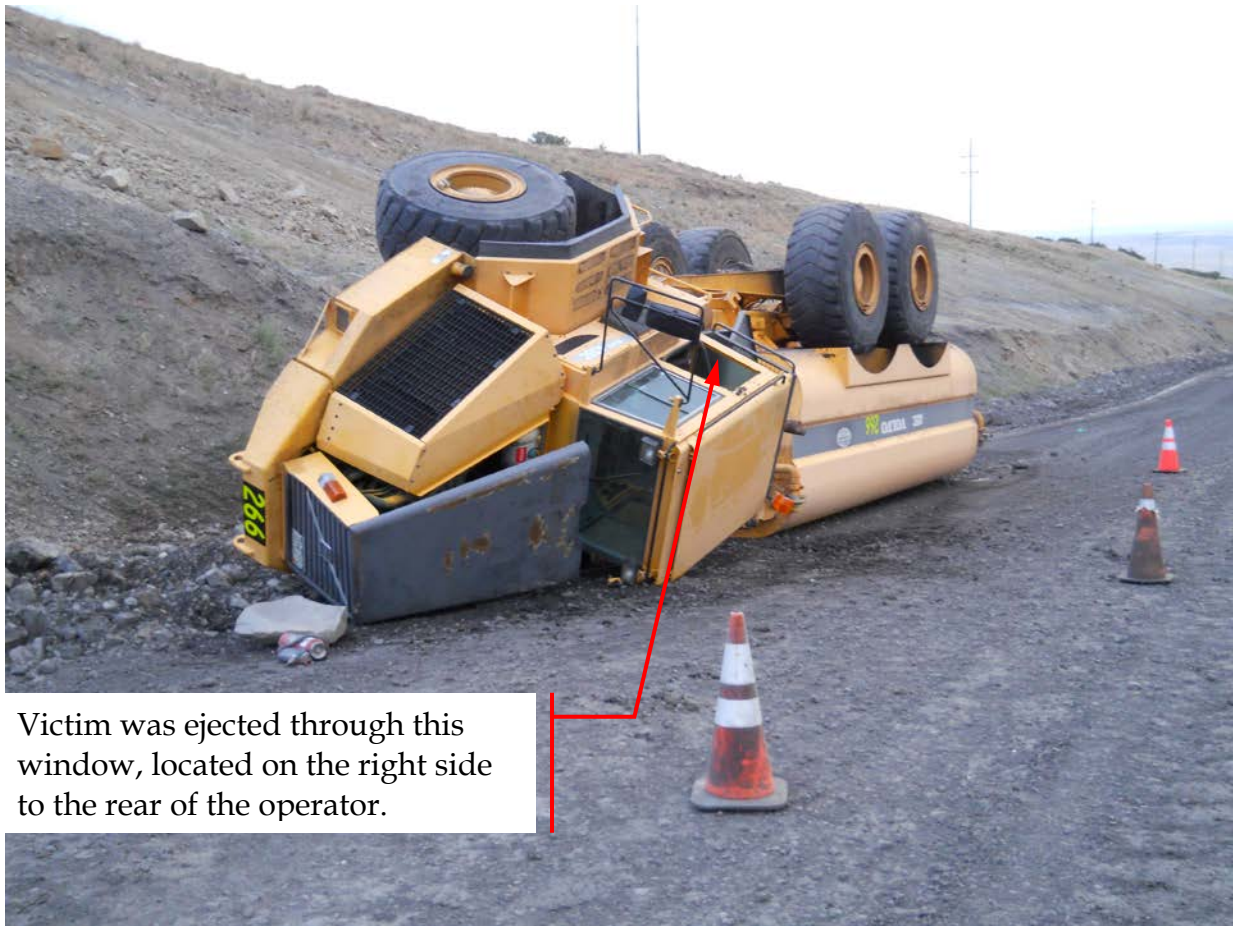
Figure 1: Overturned articulating water truck.

Victim was ejected through this window, located on the right side to the rear of the operator.

2) Damage From the Accident: The tractor portion of the water truck was found overturned on its left side and the water tank unit was upside down. The water tank had one dent in the upper-left quadrant of the tank. The left side fender and engine cover on the tractor unit were bent and the air cleaner housing was partially crushed. The right rear side window in the truck's cab was knocked out as a result of the accident and the left side mirror was broken. The interior and exterior of the cab were not damaged. The missing cab window was on the right side of the cab, opposite the door, and was 17 inches wide at the top, 27½ inches long, and 21 inches wide at the

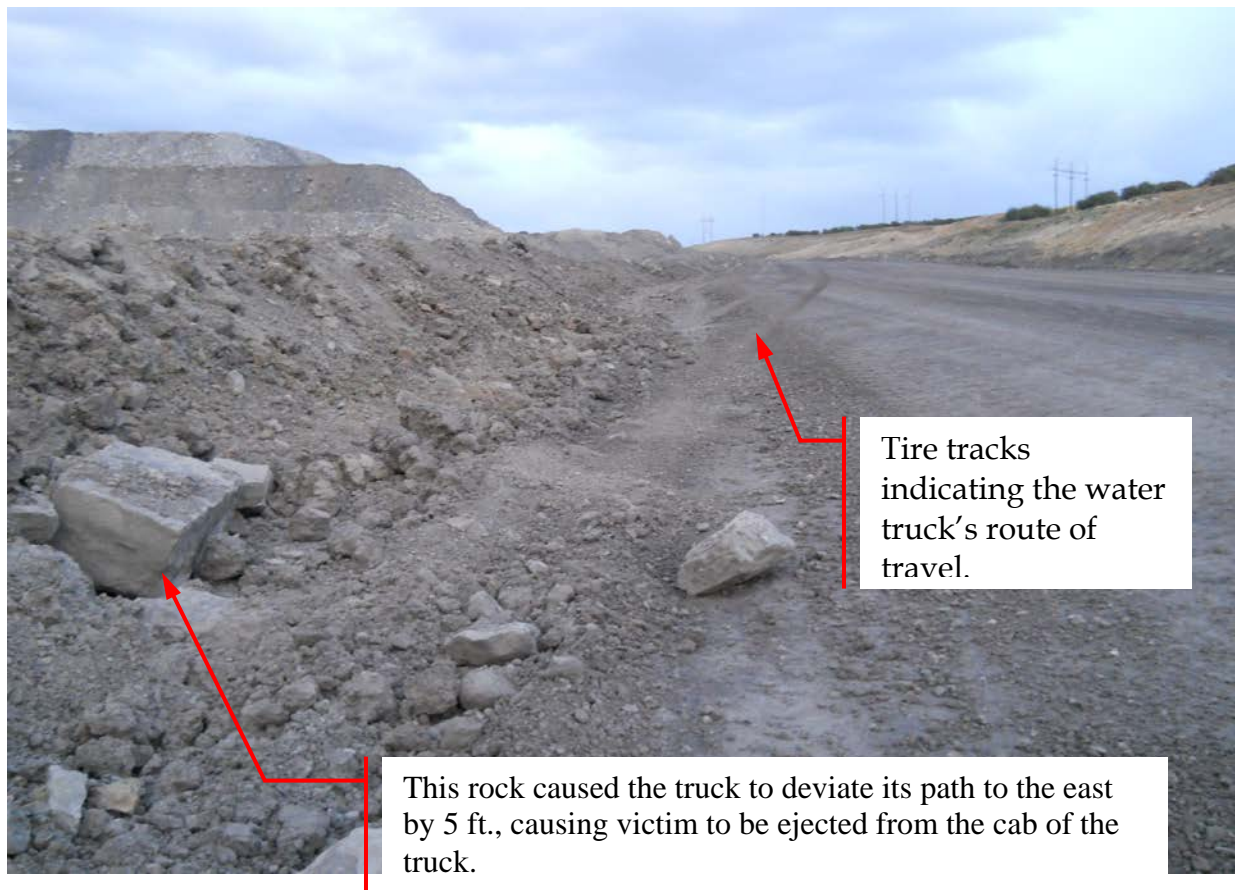
Figure 2: Site evidence of truck travel and cause of truck deviation.

At 5:40 p.m., Kawcak lost control of the water truck while ascending the haul road known as Ridge Road. The accident investigators believe that Kawcak shut off the truck because the "engine stop" was pulled when rescuers reached the truck. Moreover, investigators found that the truck was not running when it overturned. The truck lost power after being shut off. Ridge Road is a perimeter haul road, with a varying grade that averages 9.6 per cent. After losing power, Kawcak's water truck traveled backwards and downhill for 6 tenths of a mile, until the water truck contacted the berm along the east side of Ridge Road. Eighty-one feet after initial contact with the berm, the water truck struck a large rock, causing the water truck to deviate its path by five feet. Kawcak was ejected from the water truck. The water truck continued downhill, with the left side tires on top of the berm for 66 additional feet, until the truck dropped off the berm. Dropping off the berm caused Kawcak to be ejected from the water truck and run over with the right front tire of the water truck. The water truck continued downhill for another 300 feet, until it struck the west side slope, causing the truck to roll over and come to rest. Kawcak was not wearing a seatbelt during the accident.

The haul road where the accident occurred is known as Ridge road. Ridge road is a perimeter haul road that runs in a north/south direction along the west perimeter of the mine, between the West pit and South Taylor pit. The accident occurred in line with the West pit. The road is cut into the side of the mountain with a berm on the east side and the slope of the mountain serving as a barrier to the west. This road is one and one half miles in length. The road has an average grade of 9.6 per cent. This road is maintained by the mine and was dry and in good condition at the time of the accident. Temperatures were in the mid 90 degree range. The berm and slope kept the water truck from leaving the road, as designed. All aspects of the haul road were found to be in compliance. The haul road condition and maintenance of the road was ruled out as a direct causal factor in this accident. The maintenance and physical condition of the haul road did not contribute to the cause of the accident.

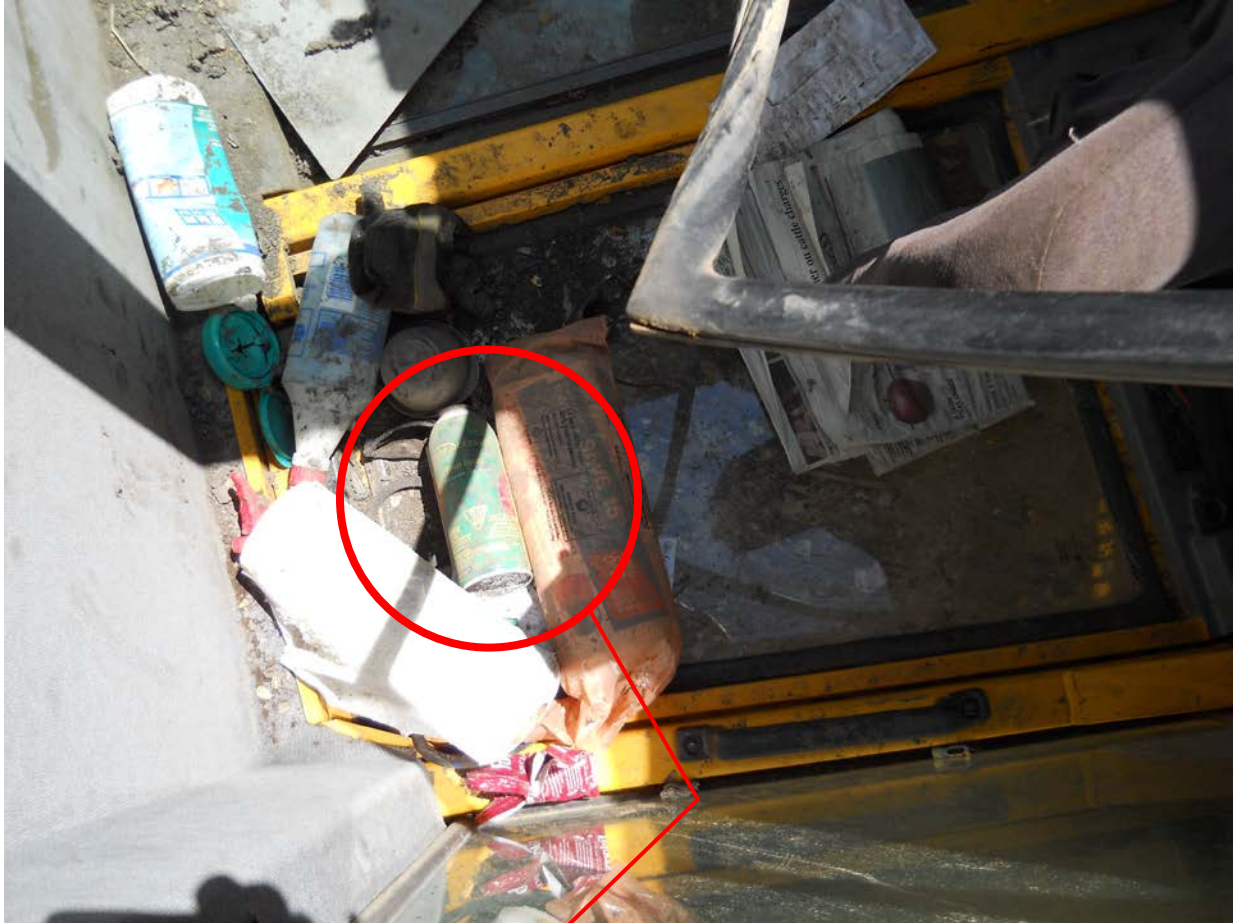
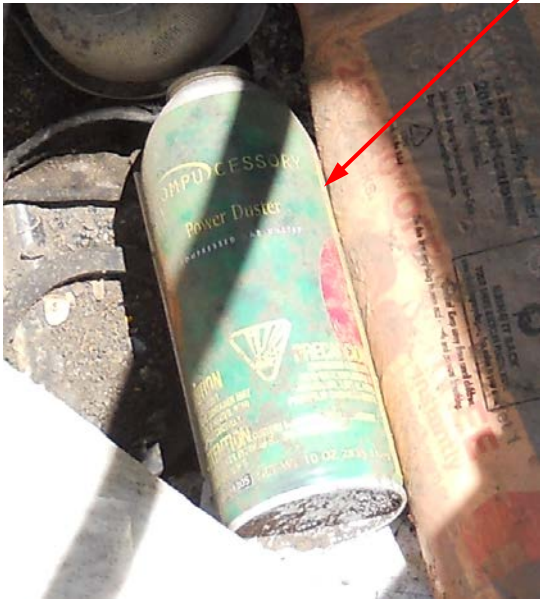
Figure 3: Can of 1,1- Difluoroethane found in vehicle.

An autopsy found the presence of the chemical 1,1-Difluoroethane in the victim's body, as a result of "Intentional Inhalation." The only source of this chemical present in the victim's water truck was a can of Compucessory Power Duster, which is a computer accessory. The chemical's material safety data sheet (MSDS) Section 2. states, the hazard of inhalation as "Excessive intentional inhalation may cause respiratory tract irritation and central nervous system effects (headache, dizziness). Vapors may cause dizziness or suffocation." MSDS Section 7. Handling and Storage, lists the directions for safe handling as "Avoid breathing mists or aerosols of this product. Use good industrial hygiene practices in handling this material." The MSDS Section 8., Exposure Controls/Personal Protection, has these items listed; Engineering controls, "Use only under good ventilation conditions or with respiratory protection." Respiratory protection, "Where exposure guideline levels may be exceeded, use an approved NIOSH respirator." The can of Compucessory Power Duster was the only source of the chemical 1,1-Difluoroethane present in the cab of the water truck.

The 1,1-Difluoroethane can showed no punctures or damage, which could have caused a discharge from the can. Accidental inhalation, such as from an unplanned discharge from the can, would be very unlikely as 1,1-Difluoroethane is heavier than air and would have settled toward the floor of the cab, near the victim's feet. The truck's air conditioner selector levers were set to intake fresh air into the cab, which could have diluted the concentration of 1,1-Difluoroethane.

Corrective Action: The mine was required to provide specific training on the use of any hazardous chemical present at this mine, as per the Hazardous Communication Plan in effect at the mine. The miners were trained in the hazards of 1,1-Difluoroethane.
