REPORT OF INVESTIGATION  
Underground Coal Mine

Fatal Machinery Accident  
July 27, 2012

Coal River Mining LLC  
Fork Creek No. 10 Mine  
46-09325

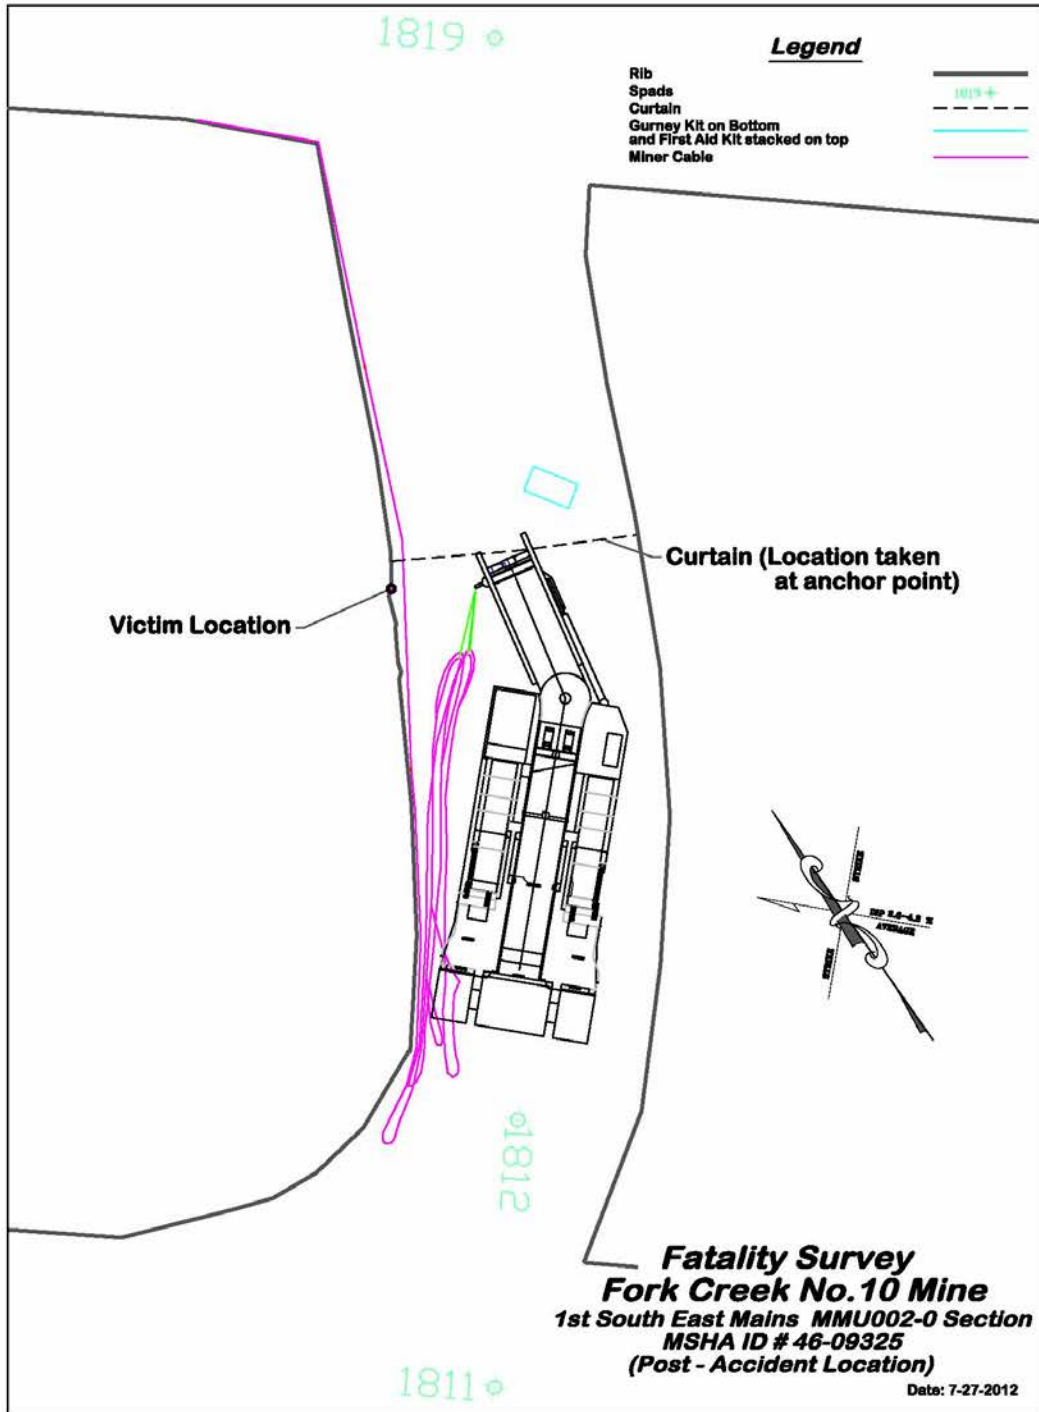
APPENDIX C  
Sketch of the Accident Scene

The No. 2 Section is located approximately 8,400 feet from the surface on the 1st South East Mains. The accident took place one crosscut outby the face area in the connecting crosscut between the Nos. 4 and 5 entries, approximately 35 feet from the Survey Spad No. 1819 located in the No. 4 entry. This was the first complete crosscut on the new panel setup. The mining height in this area was approximately 10 feet. No notable conditions regarding roof, floor or rib conditions existed in the area. An off-white opaque curtain was located approximately 30 feet from the edge of the right crosscut off of the No. 4 entry. This curtain obstructed the view of persons located on the other side of the curtain. The curtain was in place to provide ventilating air current to the No. 4 entry. A survey of the accident scene is included in Appendix C of this report.
