REPORT OF INVESTIGATION

Fatal Powered Haulage Accident
July 31, 2012

Beckley Pocahontas Mine
ICG Beckley LLC
Eccles, Raleigh County, West Virginia
ID No. 46-05252

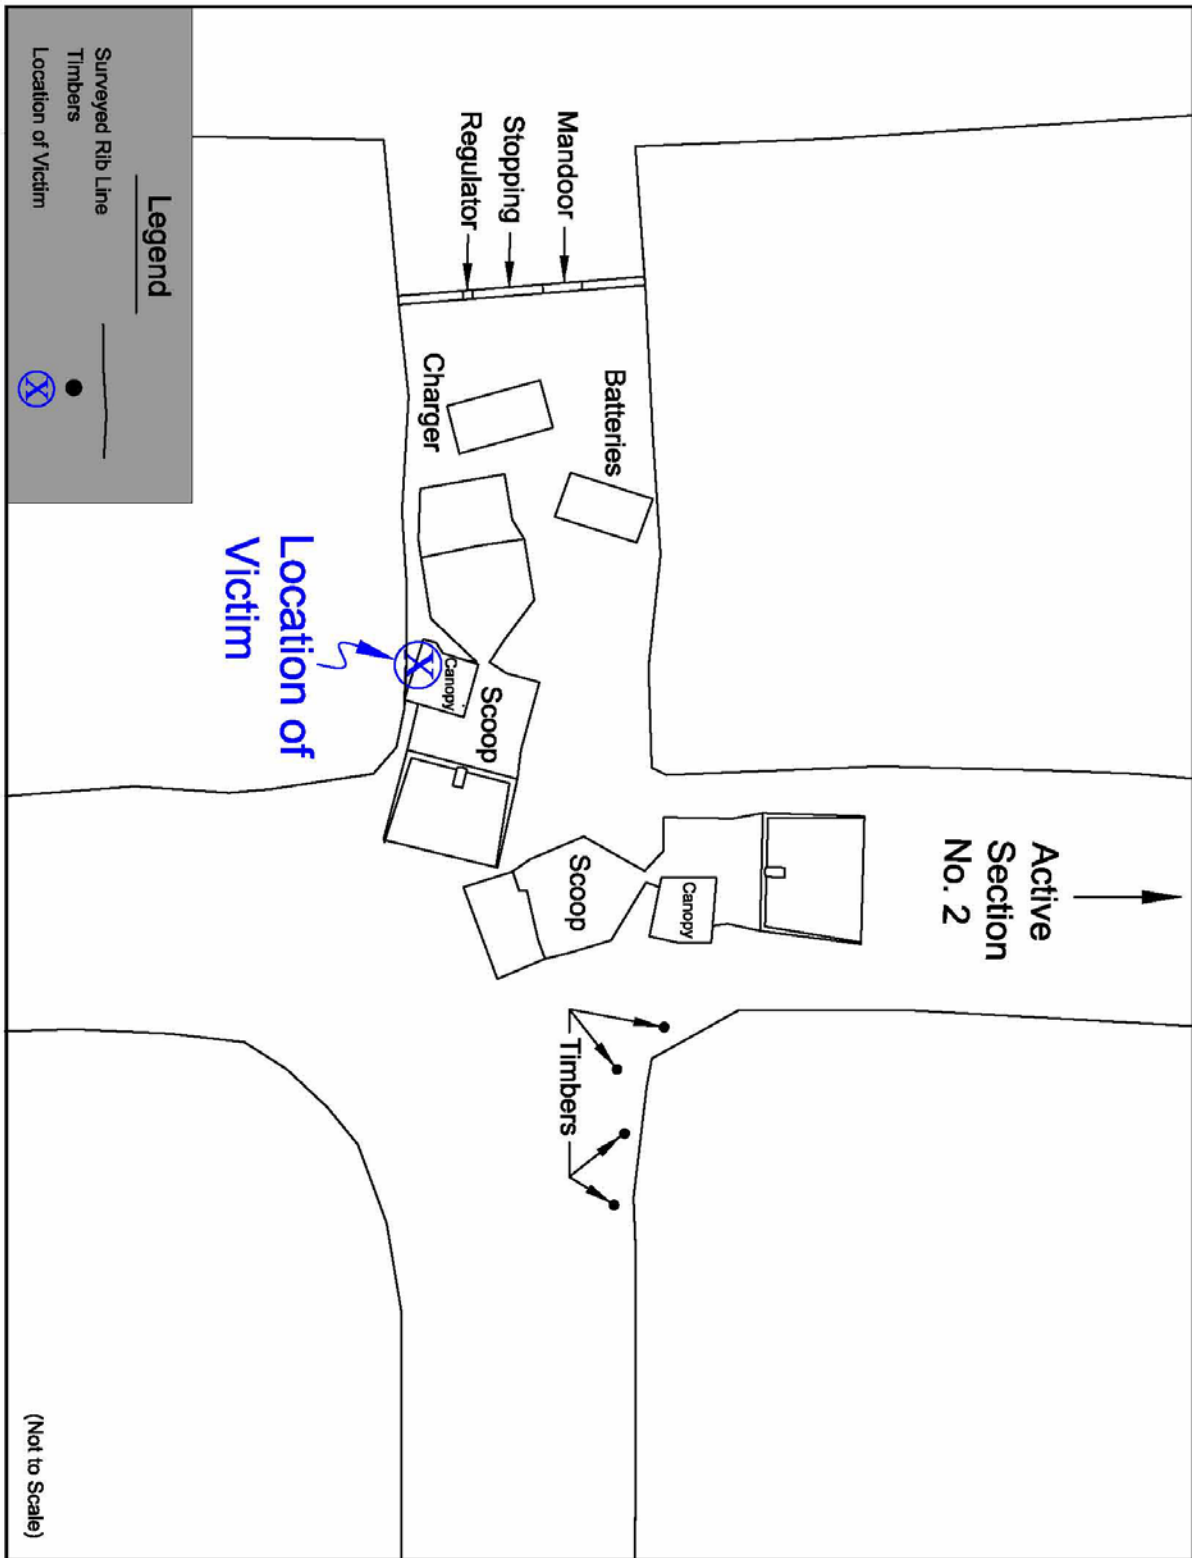
APPENDIX D
Sketch of Accident Scene
Scale is Approximate

A reenactment of the accident was conducted on August 1, 2012, with representatives of MSHA, WVOMHST, and the mine operator, to determine the positions of both scoops and any contributing factors associated with the accident. The reenactment determined that the configuration of the battery charging station and the extraneous material that was stacked on the frames of the machines were contributing factors in the accident. The scoop battery charger was installed in a manner that allowed the bucket of the scoop to extend 7 feet into the adjacent entry while batteries were being changed. In addition, rock dust, stacked 8 inches high on the frame of the No.11 scoop, impaired the scoop operator's visibility during operation the machine in reverse. A drawing was made showing the location and position of both scoops after the reenactment and is included in Appendix D of this report.

2. A 314(b) Safeguard No. 8139320 was issued to ICG Beckley LLC, on August 01, 2012. Due to the configuration and location of the scoop charging station, the bucket of the parked scoop projected out into the entry (No. 3) or roadway for a distance of approximately (7) feet. This is a notice to provide safeguard(s) that this battery charging station and all other battery charging stations at this mine, which are established and located in crosscuts adjacent to travelways or roadways, be configured such that sufficient space is available to prevent any part of the machine or equipment from projecting into the adjacent roadway or travelway.

Corrective action: All battery charging stations at this mine, which are installed in crosscuts off of travelways or roadways, are now configured such that sufficient space is available to prevent any part of the machine or equipment from extending into the adjacent roadway or travelway. MSHA required stoppings and battery charging stations to be relocated physically to address this hazard.
