REPORT OF INVESTIGATION

Fatal Powered Haulage Accident
September 11, 2012

Shoal Creek Mine
Drummond Company, Inc.
Oakman, Walker County, Alabama
I.D. No. 01-02901

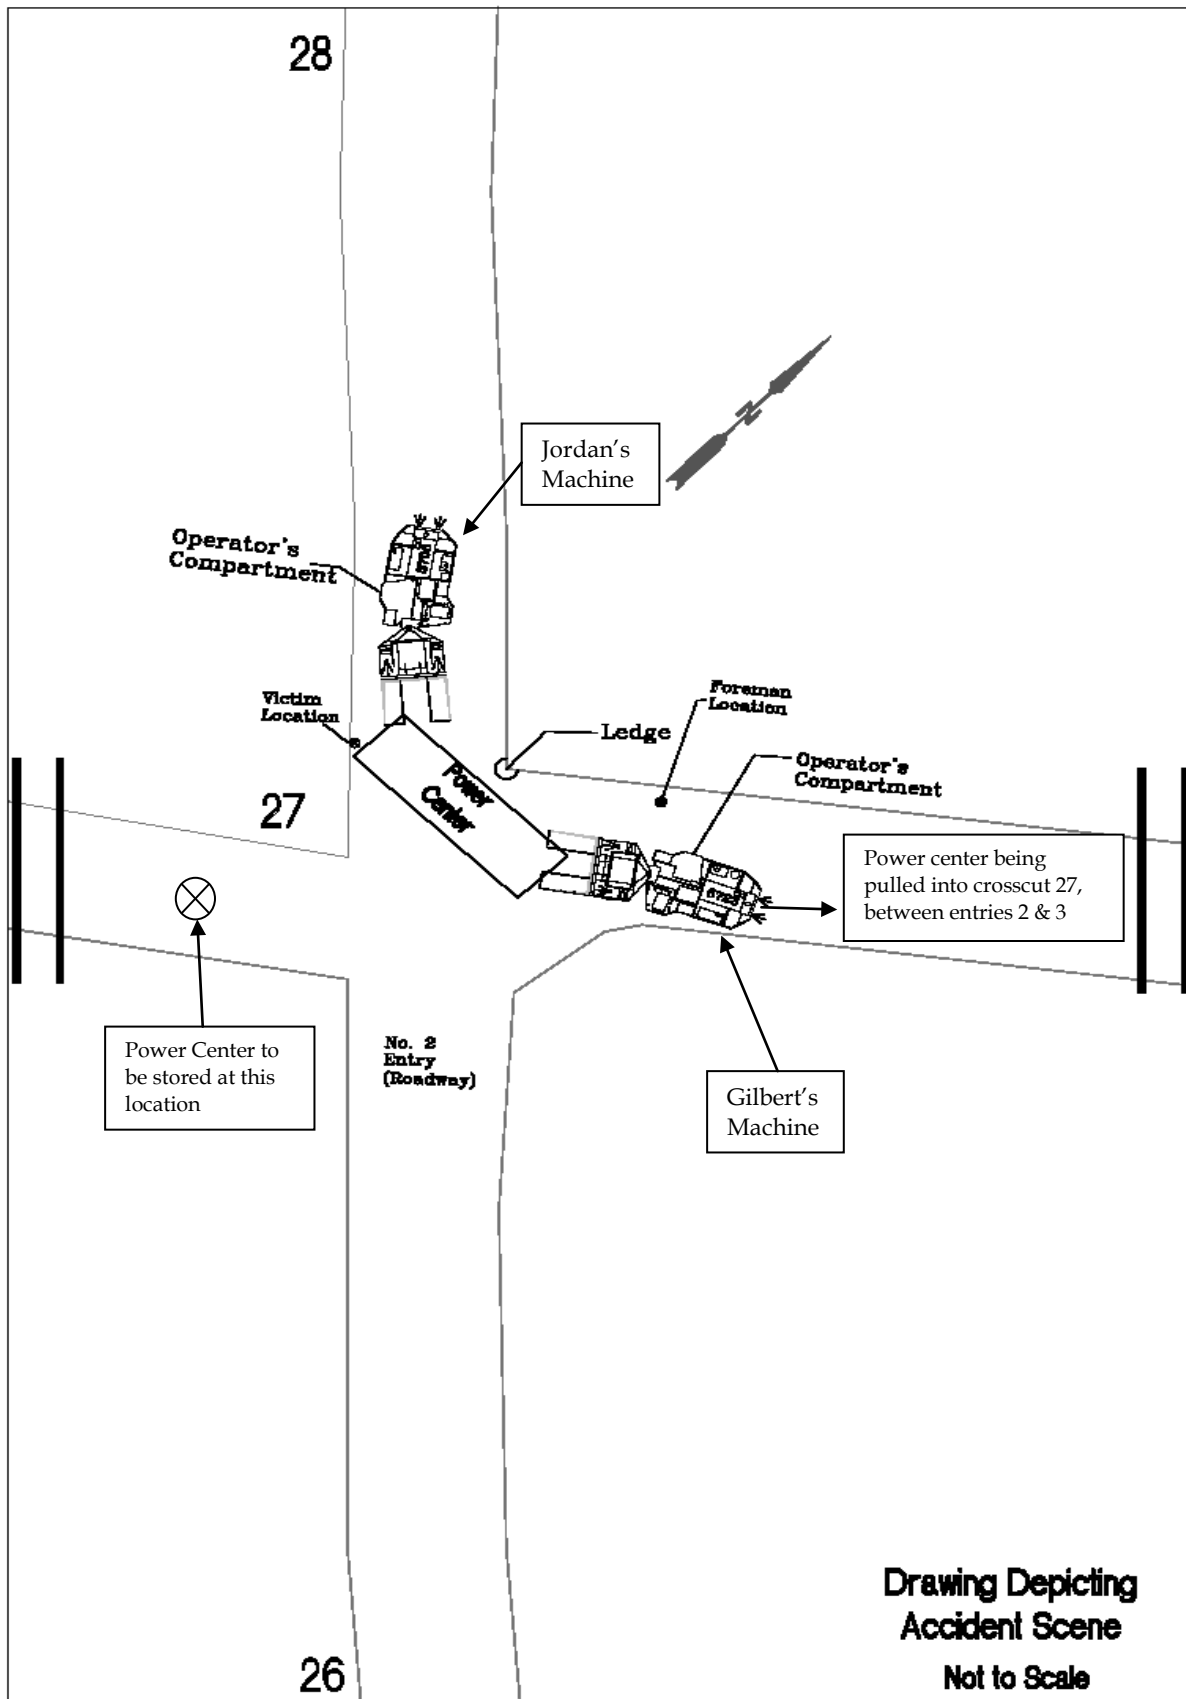
SKETCH OF THE ACCIDENT

The accident occurred on the I-0 Longwall section roadway (#2 entry) at crosscut #27. The accident location was near the crest of a hill with an uneven mine floor at the entrance to the crosscut from the roadway. The roadway and crosscut floor was relatively dry, with no areas of water or mud which would reduce the traction of the forklifts. (Refer to Drawing, pg. 3)

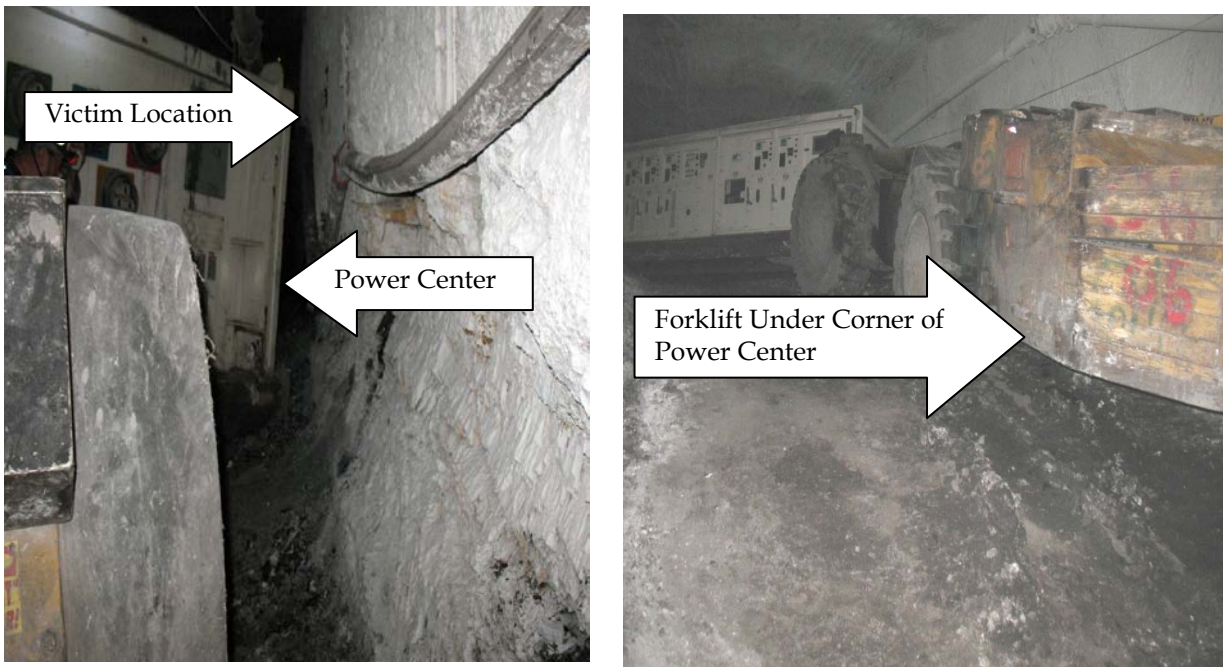
Accident Investigation Photos Depicting Accident Scene

On Tuesday, September 11, 2012, at approximately 10:23 a.m., a 28-year-old miner was fatally injured when he was crushed between a large power center and the coal rib. The power center was being moved by two large, articulating diesel forklifts, one pulling and the other pushing. While the lead forklift was being repositioned with the use of hydraulic lifting and steering controls, the victim was located between the power center and the coal rib. This process caused unexpected sliding movement of the power center, pinning the victim against the coal rib. The size of the power center prevented the fork lift operators and a foreman, positioned near the operator's compartment of one of the forklifts, from seeing the victim's location. Verbal communication was also hampered by noise from the diesel engines on the forklifts. Mine management had a General Equipment Operation Procedure in place at the time of the accident to follow when moving large mining equipment/components in the mine.
