REPORT OF INVESTIGATION

Fatal Fall of Roof or Back
September 26, 2012

Double Mountain Mine
Kopper Glo Mining, LLC
Clairfield, Claiborne County, TN
ID No. 40-03365

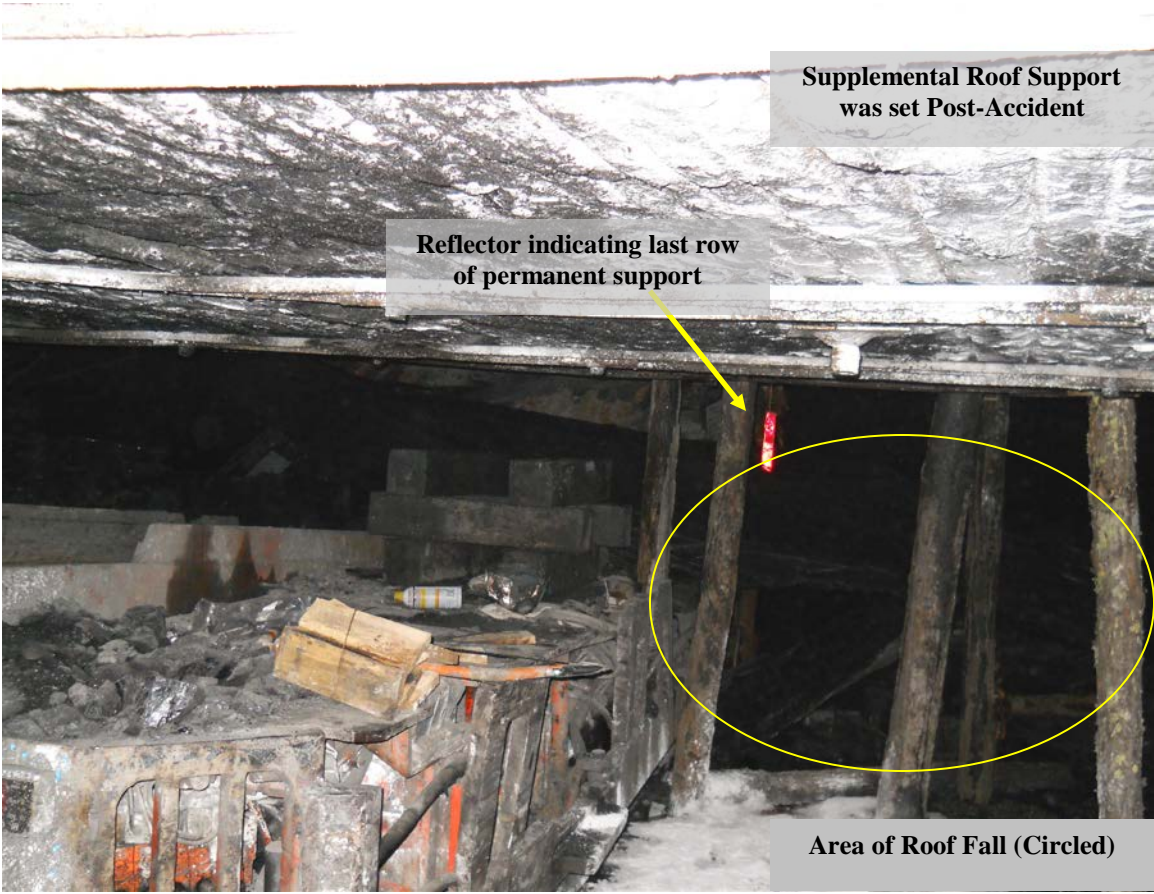
**Appendix C
Accident Scene Photograph**

The investigation determined that at the time of the accident, the victim was located seven feet and four inches in by the last row of permanent support. The remote control for the continuous mining machine was found under the roof fall eight feet and five inches in by permanent support. The fall consisted of two pieces of rock. The rock that was directly on top of the victim measured 6 feet 6 inches long by 6 feet wide and ranged up to 8 inches in thickness. Another rock which was lying on the rock which pinned the victim, measured 14 feet, 7 inches long, by 4 feet 8 inches wide, and ranged up to 3 feet in thickness. This second rock slid down the boom of the mining machine and came to rest upon the rock

which first pinned the victim. A photograph of the accident scene is provided in Appendix C.

In areas where the roof was supported, there was no roof instability observed by MSHA's Technical Support Roof Control Division personnel during the accident investigation. The medium hard, dark gray, thin bedded shale formed an acceptable roof when roof bolts were installed. At the accident site, as the continuous mining machine excavated into the mine roof to develop a location for a future belt head drive, it intersected the bedding planes, allowing large slabs of shale to fall.
