REPORT OF INVESTIGATION

Fatal Machinery Accident
November 17, 2012

Willow Lake Portal Mine
Big Ridge, Inc.
Equality, Saline County, Illinois
I.D. No. 11-03054

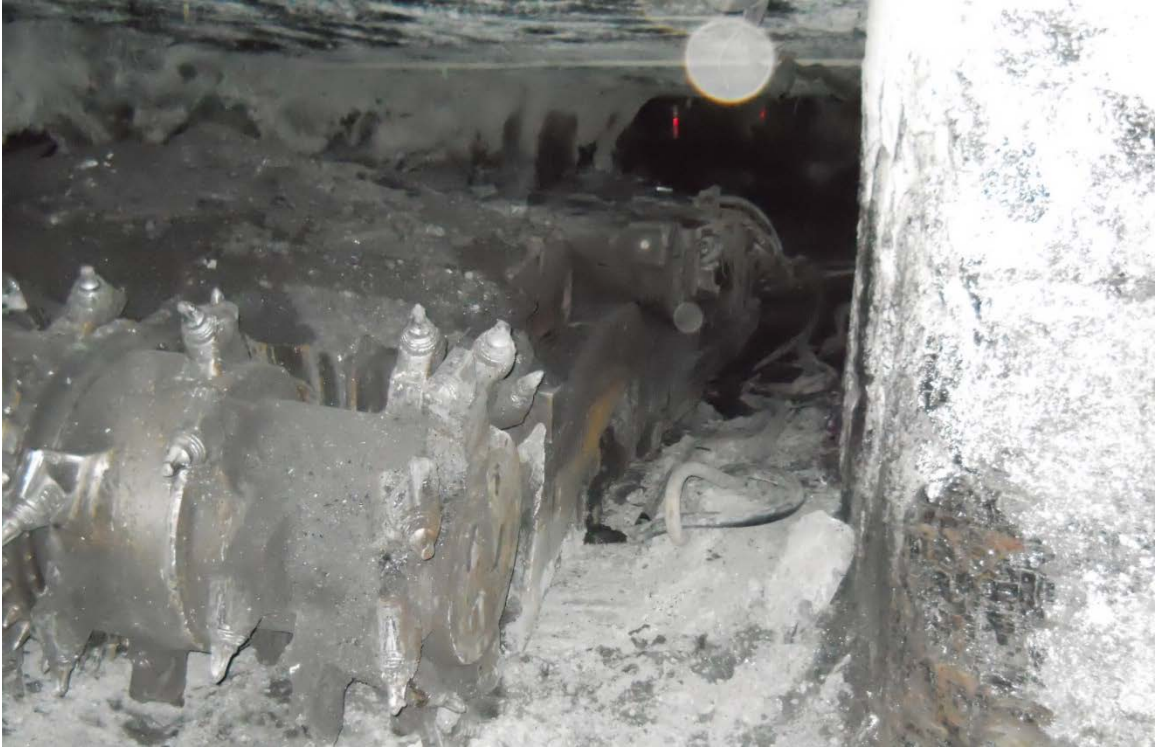
Photograph Of Accident Scene Showing Continuous Mining Machine And Coal Rib

When investigators arrived at the accident scene, the continuous mining machine was located in the crosscut between No. 3 and No. 4 entries, with the head toward the No. 4 entry. The left side of the cutter head was approximately 34 inches from the outby rib of the crosscut. When Duty operated the continuous mining machine to free the victim, he activated the right tram in reverse just enough to free the victim. Using the tracks in the mine floor as reference, investigators repositioned the continuous mining machine to its approximate location before it was moved to free the victim. The distance between the left side of the cutter head and the coal rib measured approximately 14 inches.

The outby rib of the crosscut was angled inby from No. 4 entry toward No. 3 entry. When the victim backed the continuous mining machine out of the cut, the machine contacted the outby rib of the crosscut between No. 4 and No. 3 entries. This was evidenced by a groove, approximately 51 inches long, in the outby rib of the crosscut. The groove appeared to have been made by the trailing cable standoff rubbing the coal rib.

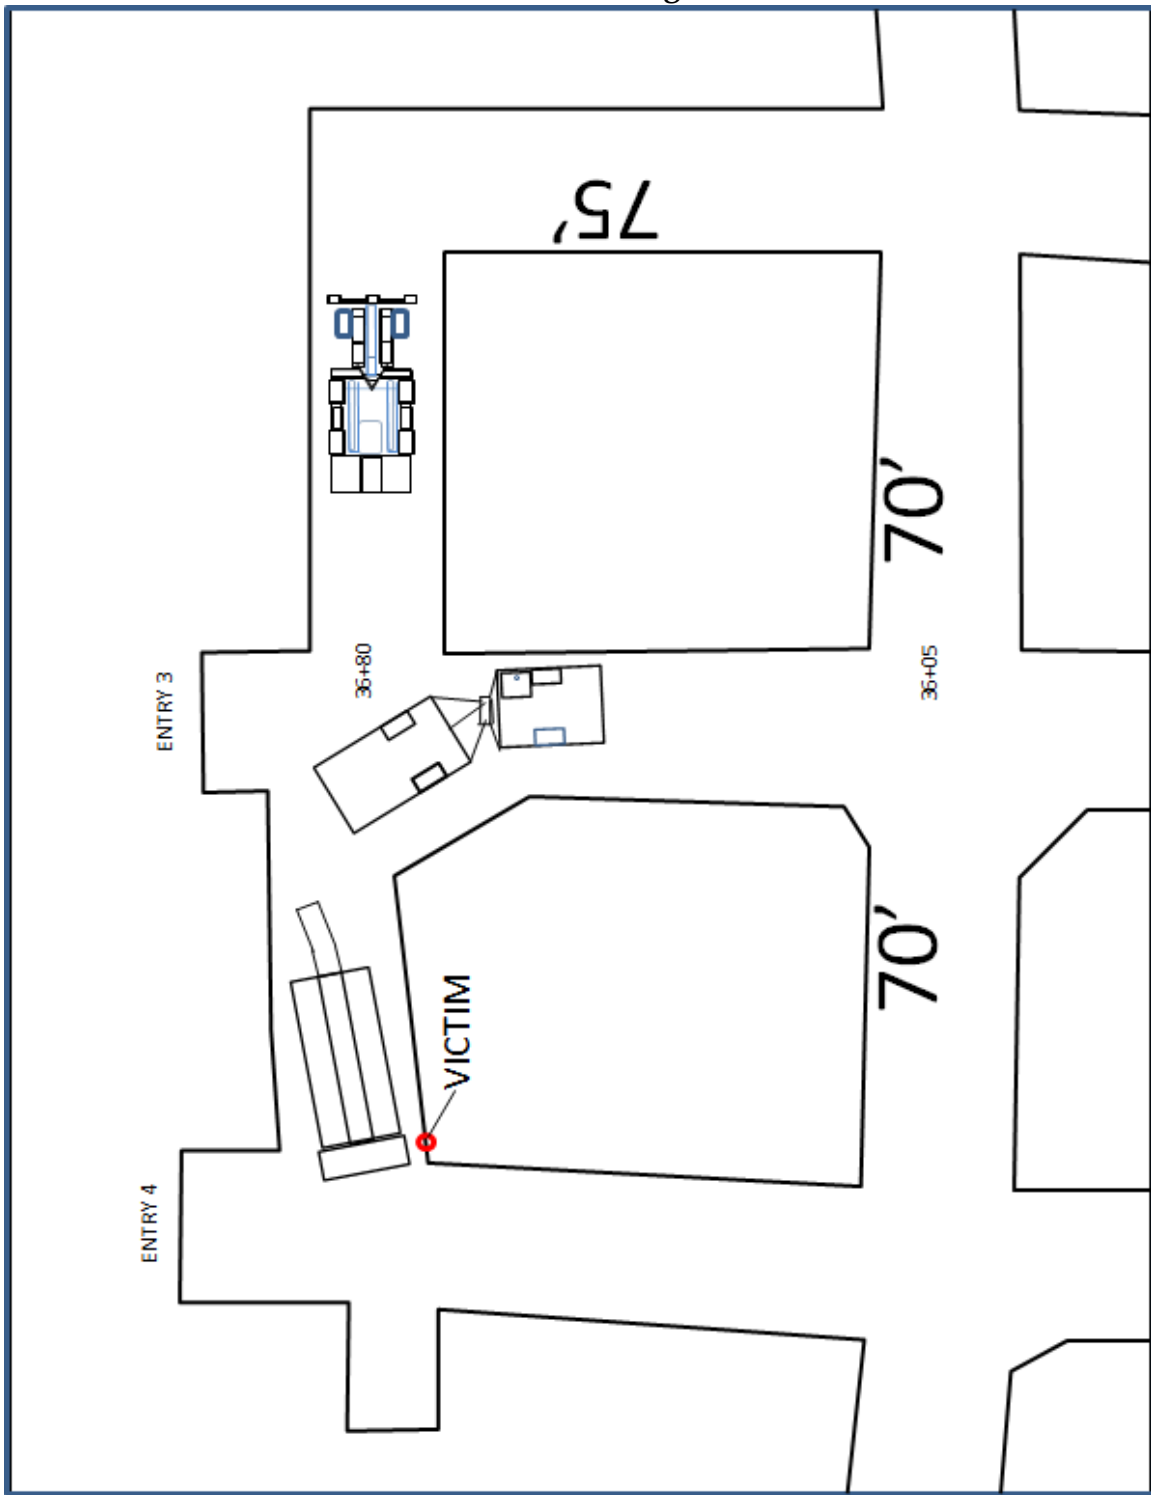
Unit Drawing

On Saturday, November 17, 2012, at approximately 3:25 a.m., Chad Meyers, a 30-year-old continuous mining machine operator, was fatally injured while repositioning a continuous mining machine on the No. 5 working section. Meyers was backing the continuous mining machine out of the first cut of a crosscut being developed to the left of the No. 4 entry. As Meyers was repositioning the continuous mining machine to mine the right side of the crosscut, he was pinned between the continuous mining machine cutter head and the outby coal rib. (See Appendix B.)

The accident occurred in the crosscut between No. 3 and No. 4 entries on the right side of the No. 5 unit at survey station 36+80 (See Appendix B). The victim had just completed the first cut in the left crosscut off of the No. 4 entry. This crosscut was being mined directly or "straight on" from the crosscut between No. 3 and No. 4 entries. The accident occurred as the continuous mining machine was being repositioned to mine the right side of the cut.

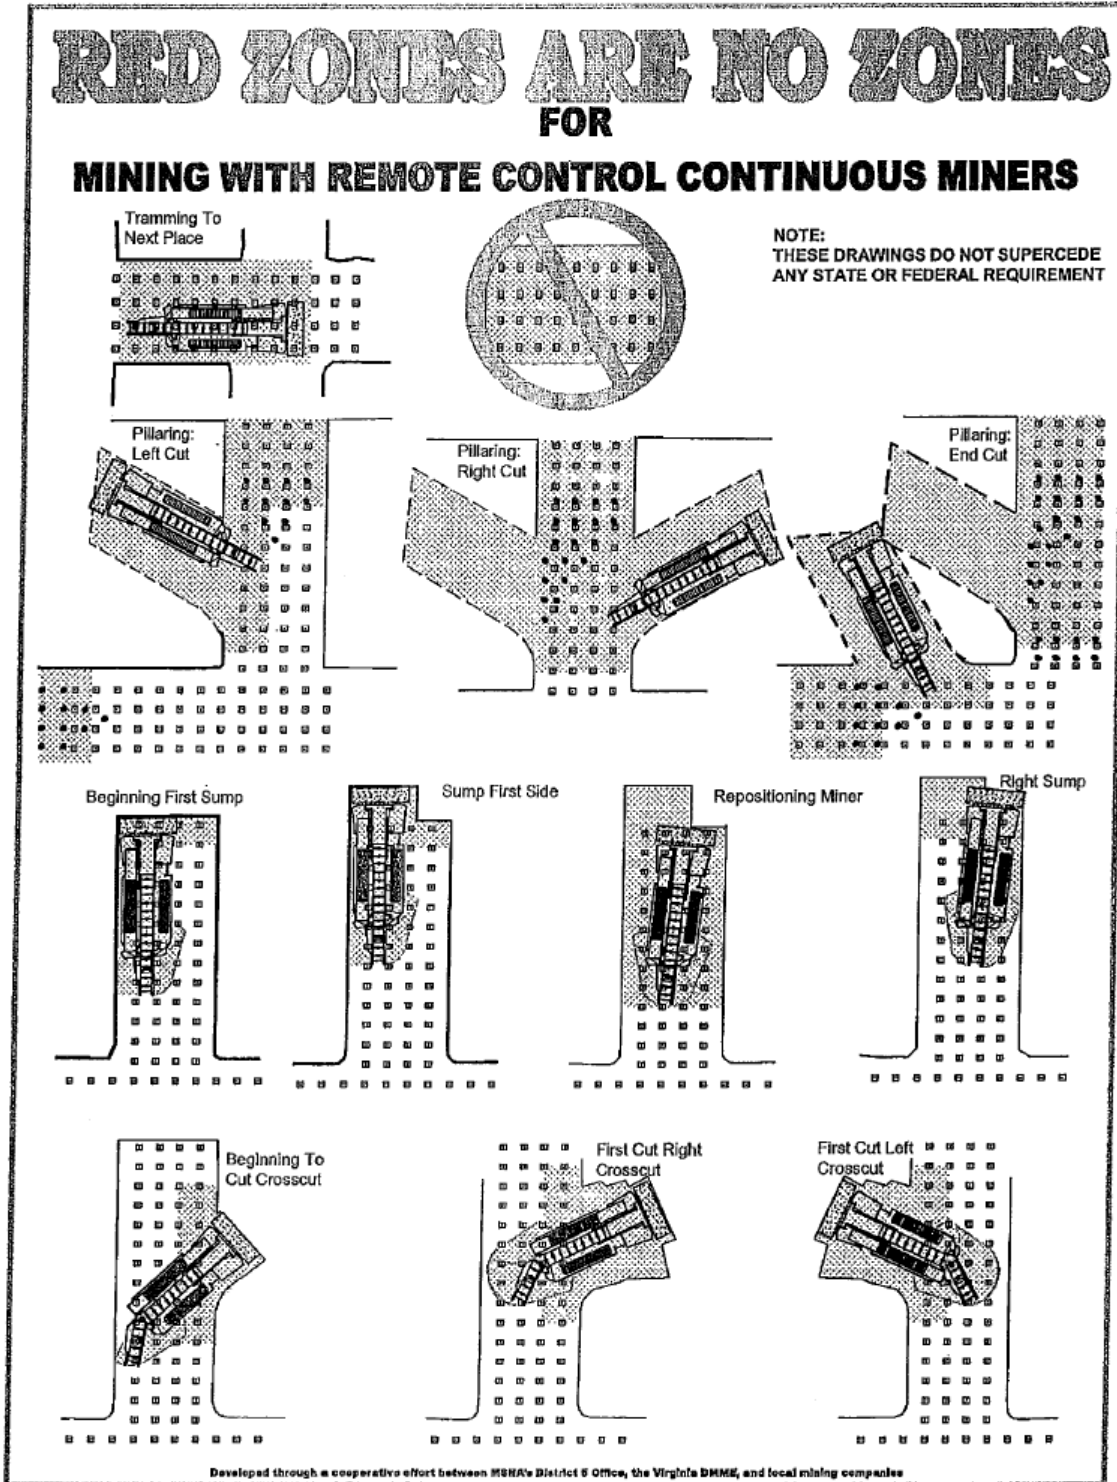
SKETCH No. 23

While repositioning the continuous mining machine within the working place, all persons involved shall be positioned in a safe location away from any part of the continuous mining machine. During place changing, all persons involved with the move shall be

positioned in a safe location away from the continuous mining machine while the machine is being trammed. (See Sketch 23)

Root Cause: The mine operator did not ensure compliance with provisions of the approved roof control plan requiring that all persons be in a safe location away from any part of the continuous mining machine when the machine is being repositioned or trammed. The continuous mining machine operator was located in the “Red Zone” between the continuous mining machine and the coal rib while the machine was being repositioned.

To prevent this type of fatal accident, mine operators must strictly adhere to the requirements of their approved roof control plans, which includes strictly following policies and procedures that keep miners from entering Red Zones. Also, proximity detection systems should be installed on all continuous mining machines.
