REPORT OF INVESTIGATION

Underground Coal Mine

Fatal Powered-Haulage Accident  
November 30, 2012

Pocahontas Mine  
White Buck Coal Company  
Rupert, Greenbrier County, West Virginia  
I.D. No. 46-09154

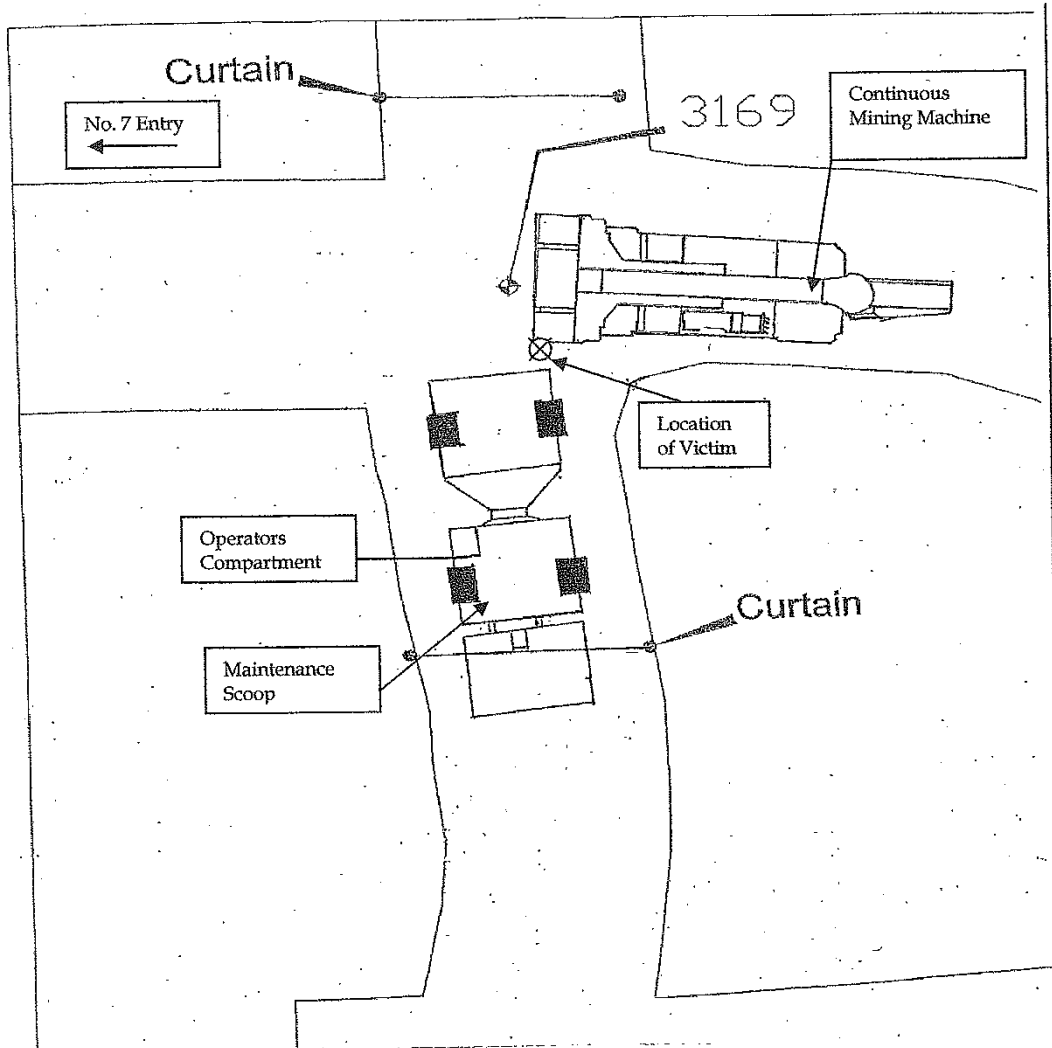
APPENDIX D  
Sketch of Accident Scene  
Not to Scale

The accident occurred in the No. 7 entry, at the second crosscut outby the face of the No. 7 entry, at survey station No. 3169. The mine floor in the No. 7 entry inby the location of the continuous mining machine had been graded by the evening shift crew, which caused a ledge, or drop-off, in the mine floor. Measurements taken by survey indicate that the elevation of the mine's floor in the No. 7 entry was approximately 9 inches lower than the floor elevation in the connecting crosscut between the No. 6 and 7 entries.

A set of translucent and transparent ventilation curtains (fly pads) were installed 23 feet into the crosscut from the inby rib corner of the No. 7 entry, extending across the crosscut, to 24 ½ feet from the outby corner of the No.7 entry, in the second crosscut outby the face area. The condition of the fly pads created visibility problems for the scoop operator, who could not see through the curtains clearly. The ventilation controls were installed in two overlapping layers comprised of white-colored translucent material and another layer comprised of transparent material. The fly pads were muddy, scratched from repeated use, and not maintained in a manner to allow for unobstructed visibility through the curtain.

A drawing showing the relative location and position of the two machines involved in the accident, as determined from the reenactment, is included in Appendix D of this report.
