**REPORT OF INVESTIGATION**

**Surface Impoundment Facility**

**Dam Failure Accident (Drowning)**

**Nolan Run Slurry Impoundment  
Impoundment Site I.D. No. WV03-00161-00  
Robinson Run No. 95 Mine  
Consolidation Coal Company  
Near Lumberport, Harrison County, West Virginia  
Mine ID No. 46-01318**

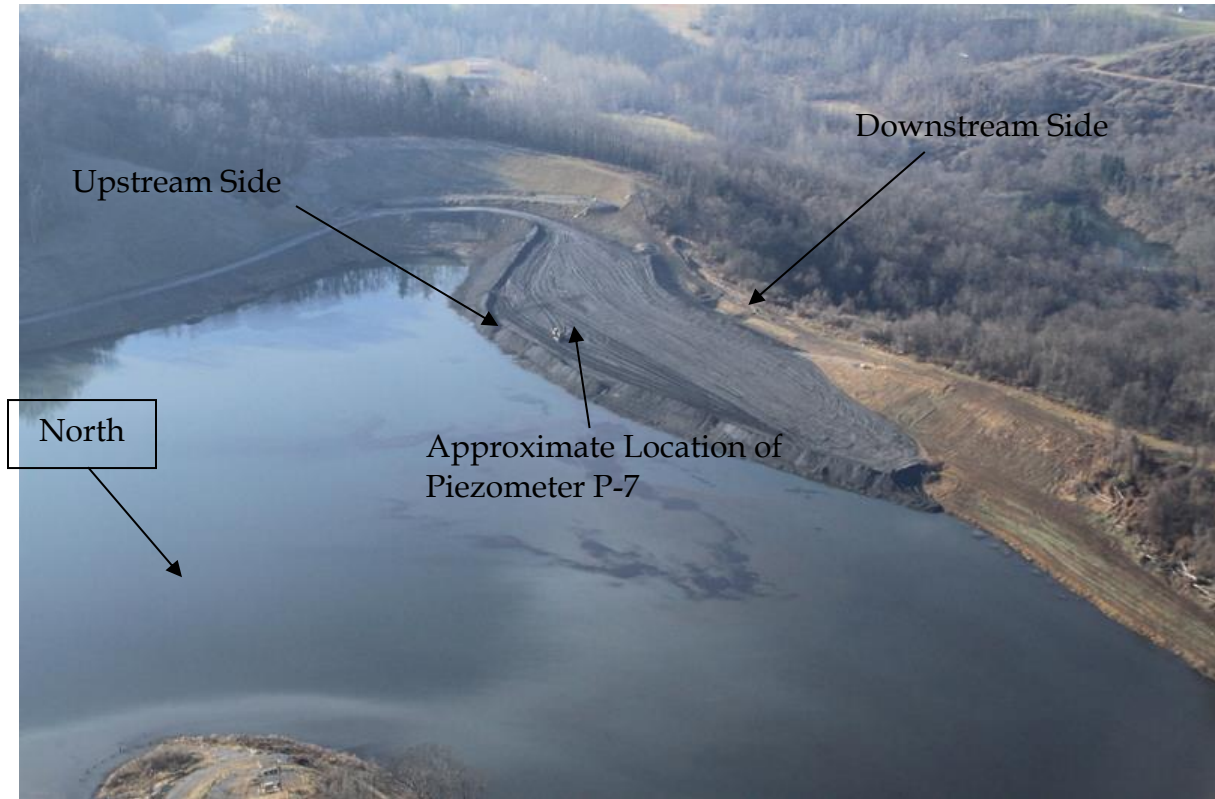
**Photograph 1: Western Saddle Dike prior to failure**

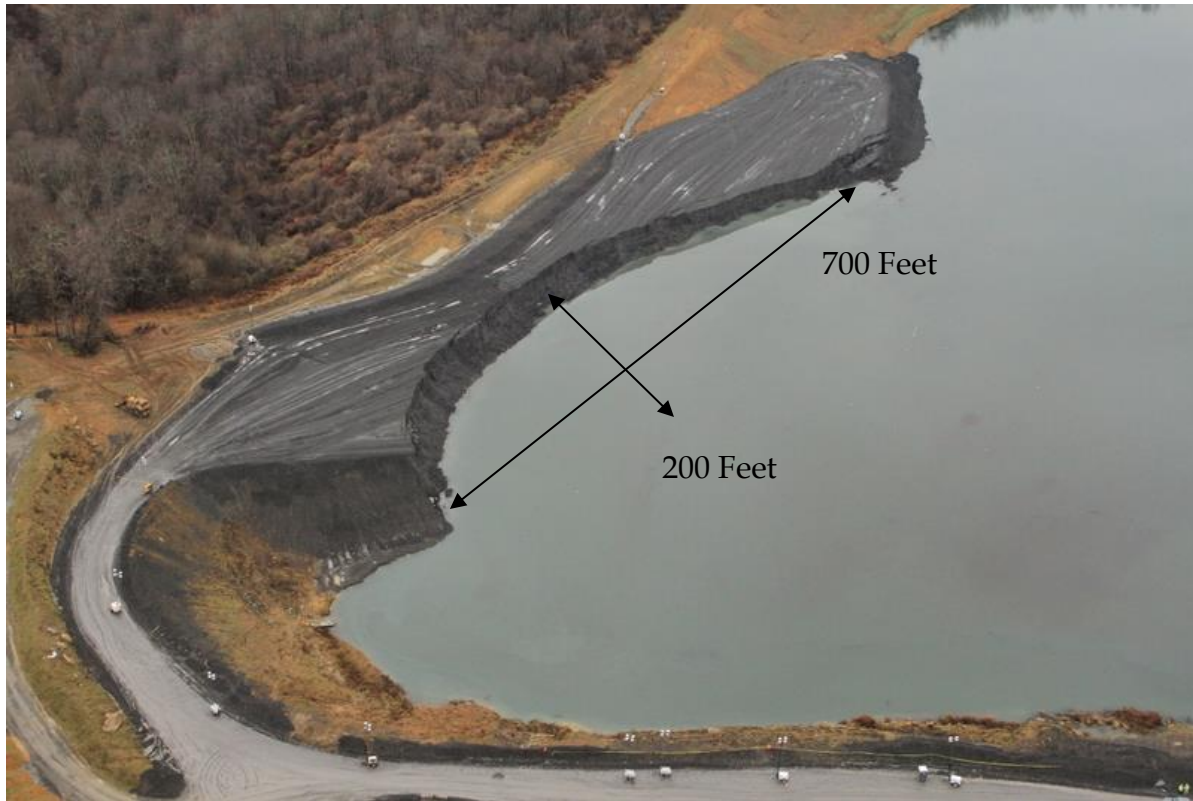
On Friday, November 30, 2012, at approximately 12:15 p.m., a massive upstream slope failure occurred on the Western Saddle Dike (dam) of the Nolan Run Slurry Impoundment, (see Figure 1 and Photographs 1 and 2) resulting in the death of one miner. The victim was a 58-year-old Mobile Equipment Operator, Markel J. Koon (see Appendix A), who was cutting the upstream slope (water side) to final grade. The bulldozer he was operating was carried into the pool area where it went underwater. Two other miners, P. Stuart Carter, Project Engineer, and Michael Friedline, Impoundment Construction Foreman, were also standing on the portion of the saddle dike that collapsed. Friedline was able to reach to natural ground safely. Carter was rescued from the pool by a local volunteer fire department rescue boat. The initial failure was 80 to 130 feet wide (measured east-to-west). Subsequent failures and toppling coarse coal refuse (CCR) further widened the affected area to approximately 200 feet wide. The length (north-to-south) of the failure was approximately 700 feet, or approximately 850 feet along the former perimeter of the upstream slope (See Photographs 1 through 3).

**Photograph 2: Western Saddle Dike after failure.**

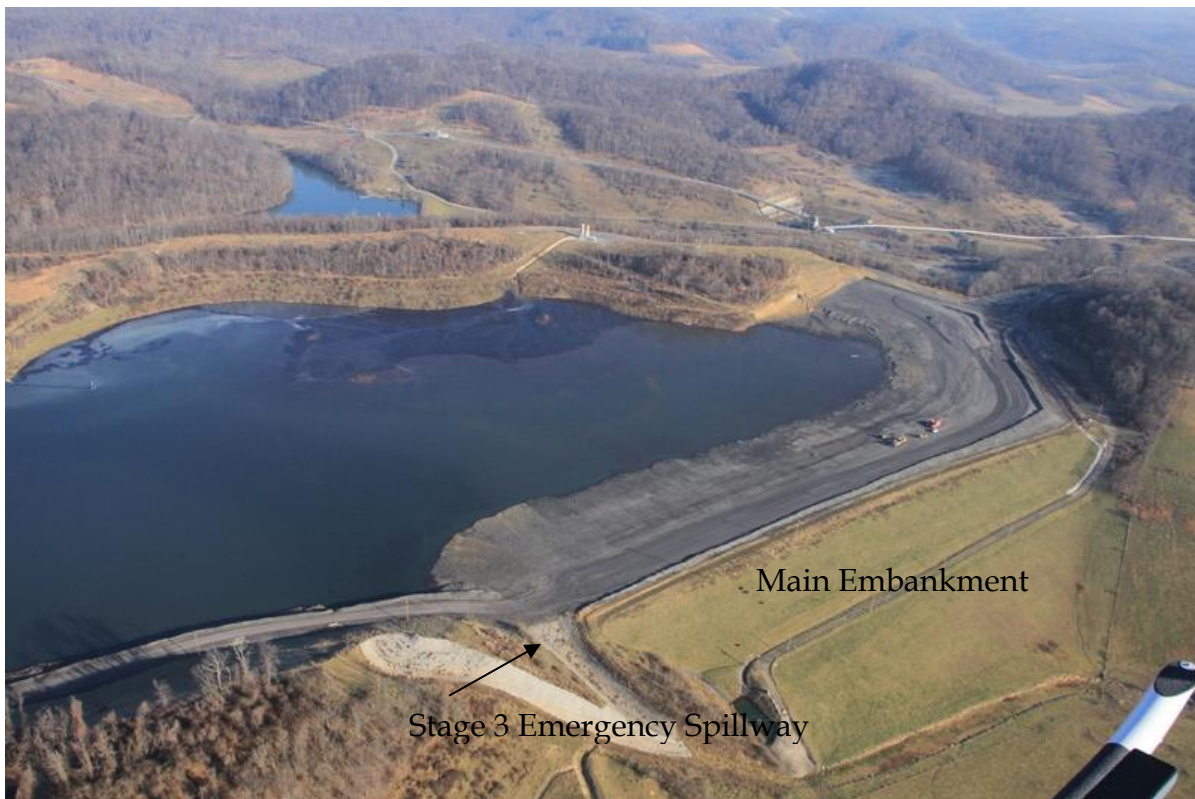
**Photograph 3: Nolan Run Impoundment main embankment**

Observations were also made on the main embankment of the impoundment where upstream construction was also completed. In numerous locations, bubbling was observed through the FCR. Based on visual observations and geochemistry of the gas, the bubbling observed in the impoundment pool appears to be originating from the CCR push-out for the saddle dike and the volume of CCR submerged in the pool as a result of the failure. Therefore, the bubbles observed in the pool do not appear to be a contributing factor to the accident. Additional technical information is provided in Appendix D.

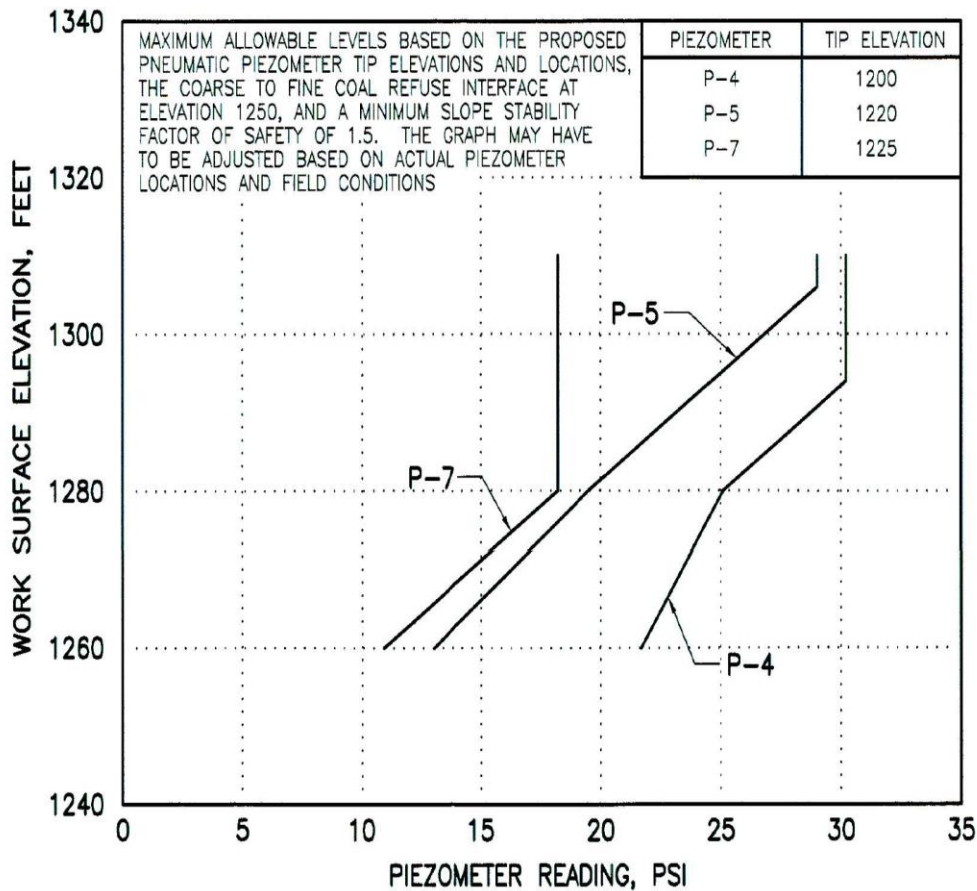
**Figure 8**  
**Maximum Allowable Pore Pressure Reading**  
**"Expansion Plan - Stage IV"**  
Drawing No. B05-022-E4

The first reading of Piezometer P-7 took place during the morning of November 23, 2012. Jeff Cox, Impoundment Inspector, contracted through Forquers Contracting, recorded a pressure of 15 psi. Since the reading was greater than the hydrostatic pressure acting alone on the instrument, it indicated that excess pore water pressures had developed. Cox had been instructed to notify Consol if the piezometer reading

The excess pore pressure action levels were not derived from a consolidation analysis. The action levels were back-calculated based on the value of the pore pressure parameter determined from the slope stability analyses. The pore pressure parameter was varied until a factor of safety of 1.5 was obtained. A factor of safety of 1.5 means that the computed resistance of all the soils involved is 50 percent greater than what it needs to be to prevent the slope from failing. The corresponding pore pressure at the location of Piezometer P-7 was then computed from the resulting pore pressure parameter for various overburden conditions due increasing the height of the embankment. These pressures were then plotted on a chart versus the dike surface elevation. The analyses used the same material densities and strength parameters that had been used in the design of previous stages for the main embankment. The analyses were performed on the cross-section of the main embankment.

Corrective Action: The mine operator was required to develop an action plan to address "level of safety" below that specified in the approved impoundment plan. Specifically, the mine operator must stop construction if conditions indicate a "level of safety" lower than what is specified in the plan. Additionally, all surface foremen who oversee work at the Nolan Run Slurry Impoundment will be trained in the requirements of approved impoundment plan design plan, revisions, and modifications. MSHA will verify that the training has been completed.
