REPORT OF INVESTIGATION

Fatal Machinery Accident  
November 23, 2013

Century Mine  
American Energy Corporation  
Beallsville, Belmont County, Ohio  
I.D. No. 33-01070

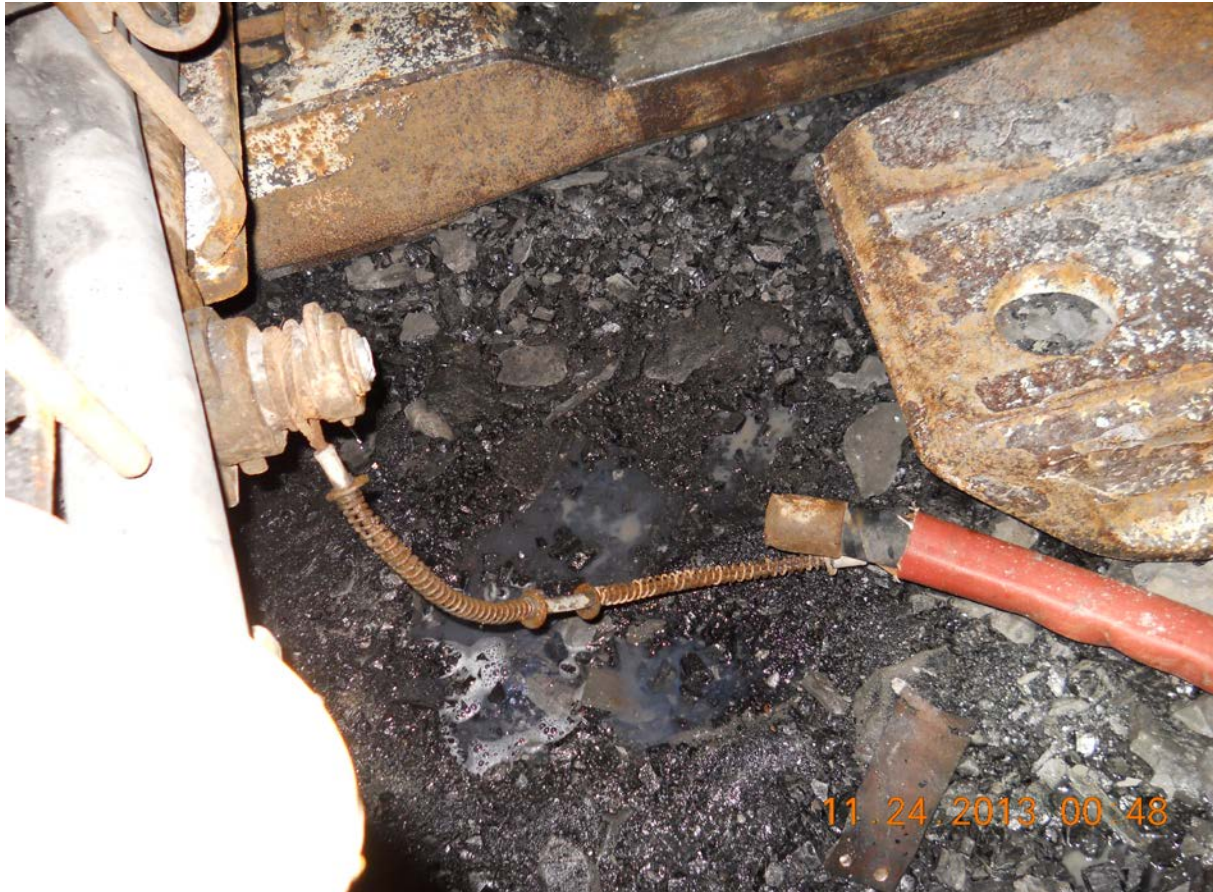
## PHOTOGRAPH of Broken Tee Connector and High Pressure Hose (LADDER LINE)

On Saturday, November 23, 2013, at approximately 4:00 p.m., Ryan Lashley (victim), a 32-year-old longwall shieldman, was struck by hydraulic fluid resulting in fatal injuries. Lashley was executing a “push” of the panline toward the face as he followed the shearer towards the headgate. Lashley activated the panline push in by the No. 144 shield. A high pressure hydraulic hose that connects the shield hydraulic circuit to the ring main circuit (ladder line) was in the walkway in front of the shield pontoon. The No. 144 shield tailgate pontoon advanced on top of the ladder line and pressurized against the roof, pinching the hose between the pontoon and mine floor. As Lashley passed the No. 144 shield, the pinched hose ruptured. Fluid from the hose struck the victim, resulting in fatal injuries.

The primary cause of the accident was the mine operator’s failure to adequately secure the high pressure hose to prevent damage by moving machine components.

The mine operator failed to assure ladder lines were installed and maintained in a manner to prevent contact with longwall shields.

The accident was caused by the failure to assure the ladder line located at No. 144 shield was installed and maintained in a manner to prevent contact by the longwall shield or its components.

The mine operator removed the ladder lines along the face which were previously located between the headgate and tailgate. If the operator determines ladder lines are necessary to maintain adequate hydraulic pressure, the company has developed a means to assure the ladder lines will not be struck by the shield pontoons. Ladder lines will be suspended from longwall shields with a wire rope, chain, or other suitable means to prevent contact with shield pontoons.

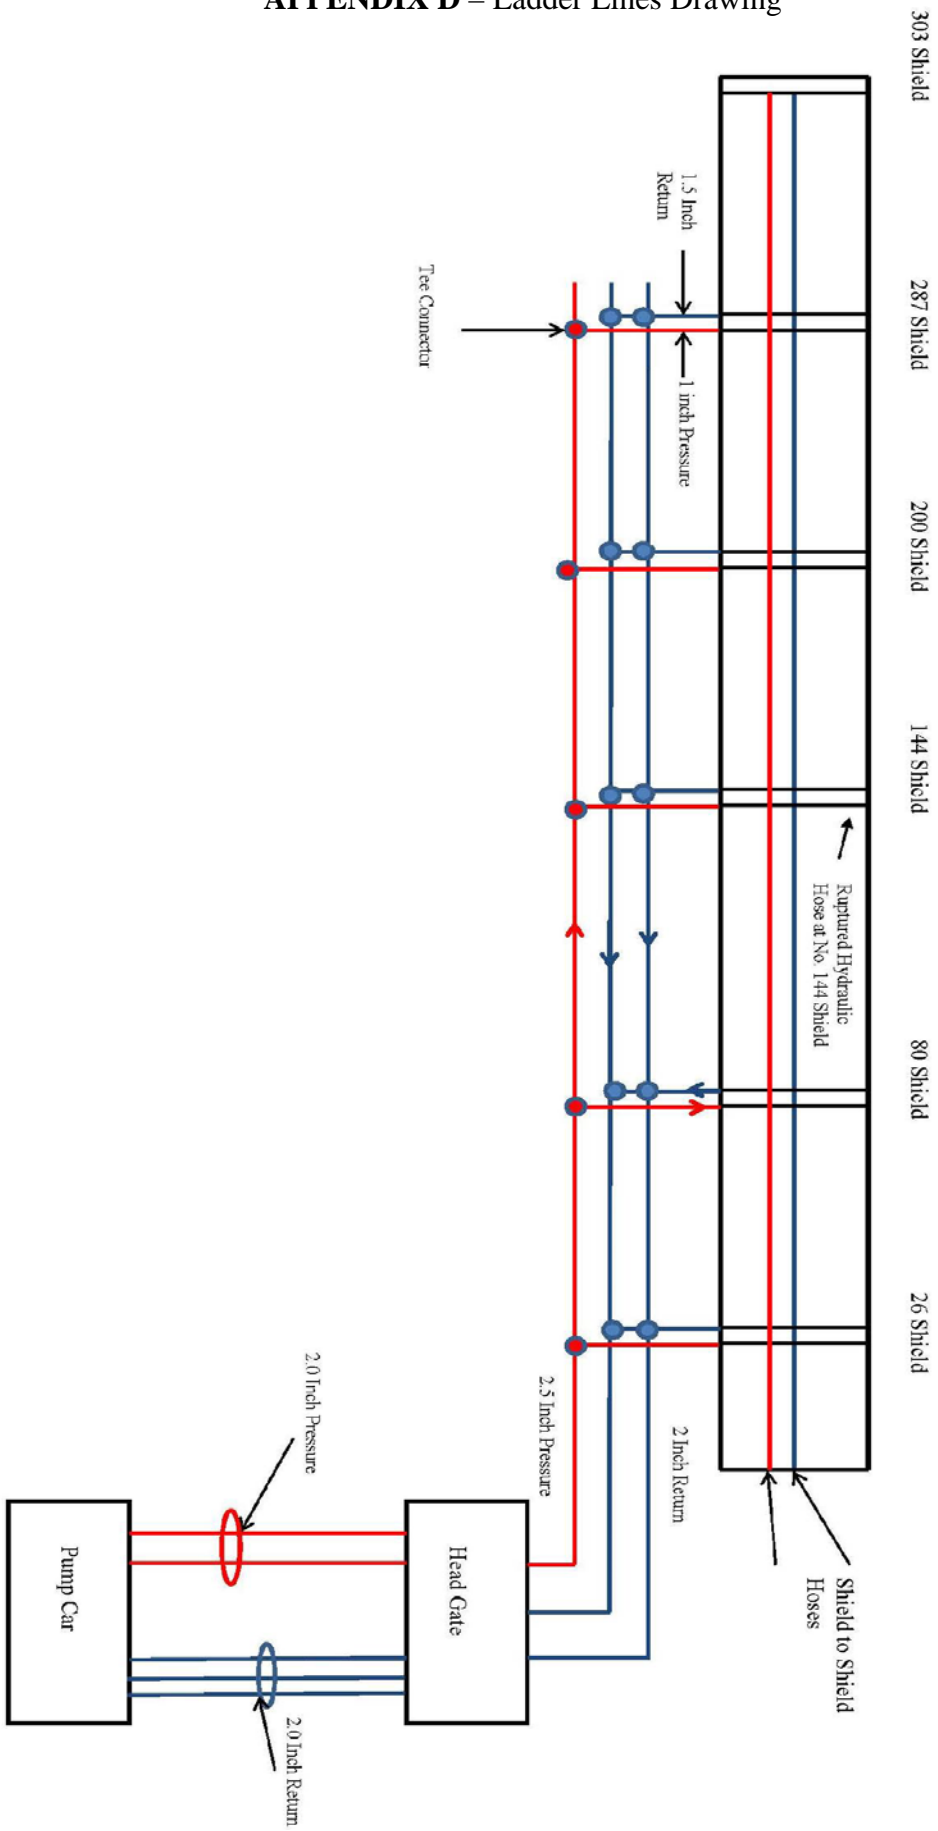
# APPENDIX D – Ladder Lines Drawing

The hydraulic system for the longwall was a closed system consisting of two 2-inch diameter high pressure hoses supplying emulsion fluid to the headgate and three 2-inch

diameter return hoses that routed the emulsion back to the pumps (see Appendix D). The emulsion was fed to the longwall face from the headgate end of the longwall through a 2.5-inch high-pressure hose to the No. 285 shield. Two 2-inch return hoses routed the hydraulic fluid from the No. 288 shield back to the headgate. These hoses were installed in the panline under the cable tray.

The hydraulic circuit was completed through shield-to-shield pressure and return hoses which were connected from the manifolds mounted on the shields. A manifold mounted on each shield distributed pressure to the shield. Normal system pressure was 3,750 pounds per square inch (psi).

The typical hydraulic systems in the District 3 area (those used in face lengths of 1,200 feet or less) use a set of ladder lines near the headgate and another set at the tailgate to more evenly distribute hydraulic pressure. However, larger longwall faces, 1,200 feet or greater, require a larger volume of hydraulic fluid to operate the additional shields. Therefore, Century Mine strategically placed additional ladder lines along the longwall face to maintain consistent operating pressures between the headgate and tailgate. At five locations along the longwall face, 1-inch hoses extended from a tee connection to the shield-to-shield lines (See Appendix D). This was done for both the pressure and the return lines. An examination of the ladder line installations along the longwall face revealed the ladder lines were supported by nylon rope. It appeared the shield pontoons had contacted ladder lines installed in the other locations along the face. This was verified during interviews.
