REPORT OF INVESTIGATION

Fatal Slip/Fall of Person Accident
May 15, 2012

Frontier-Kemper Constructors Inc. (A01)
Evansville, IN
at
Gibson South
Gibson County Coal, LLC
Owensville, Gibson County, Indiana
I.D. No. 12-02388

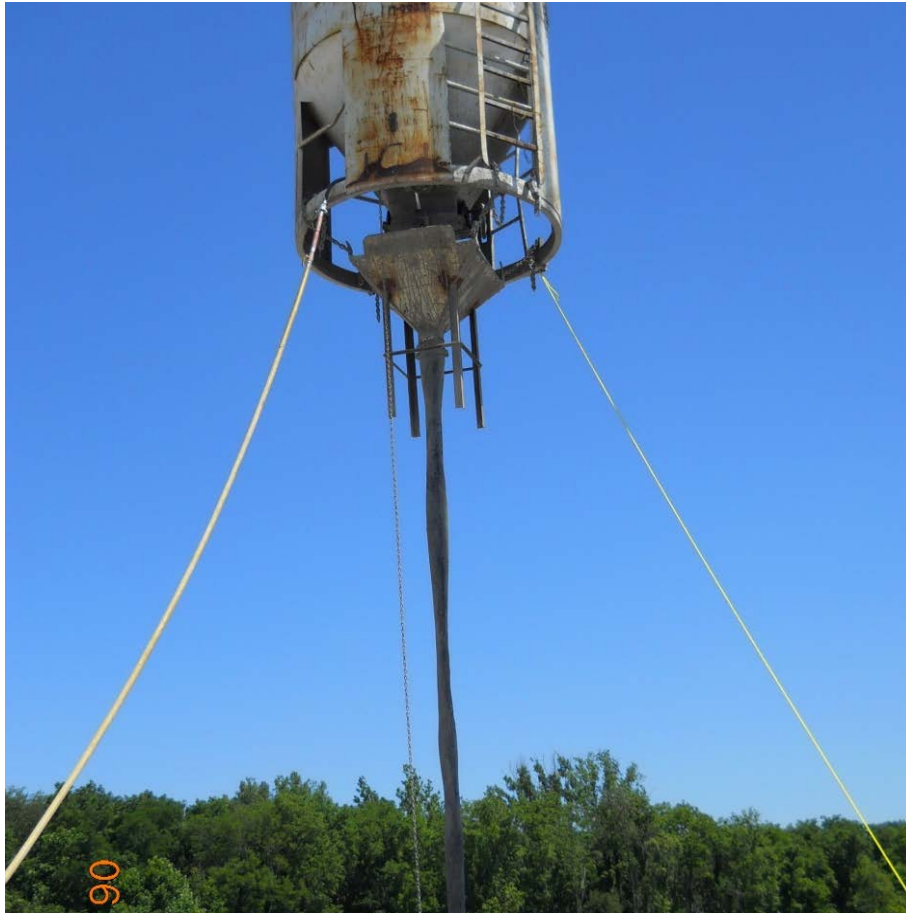
Photograph showing the concrete bucket, hopper, and 8" flexible hose

At the time of the accident, the clamshell gate on the concrete bucket was being operated remotely. A small chain was attached to the pneumatic valve and hung down from the concrete bucket to the work deck. An employee standing on the work deck operated the valve by pulling the chain. This in turn, caused the clamshell gate to open and close. Interviews with several employees indicated that this was not the preferred method of operating the gate. The flow of concrete from the bucket into the hopper was difficult to control because the person operating the valve could not see how much concrete was being released into the hopper. In addition, the pneumatic cylinder did not always completely close the clamshell gate. This often allowed an excessive amount of concrete to be released from the bucket into the hopper. The uneven flow of concrete through the flexible hose caused it to surge, which made controlling the hose difficult.

The accident occurred during a concrete pour, when the concrete hose surged with excessive concrete while Palmer was holding the hose, causing him to fall onto the work deck. The contractor's lack of effective procedures to prevent the concrete hose from surging contributed to the accident. The victim's death was charged to the mining industry because his death was attributed to a work-related injury.

Corrective Action: The contractor submitted an addendum to MSHA for their approved shaft sinking plan, which was approved by the District Manager. The addendum details the method to be used in future concrete pours, which would minimize employee exposure by changing the employee's location during concrete pours and by reducing the possibility of the concrete hose surging. The contractor's employees were trained in the plan's revised method for positioning of the employees and for the pouring of concrete.
