REPORT OF INVESTIGATION

Fatal Hoisting Accident  
February 7, 2013

Affinity Coal Company, LLC  
Affinity Mine  
Sophia, Raleigh County, WV  
I.D. No. 46-08878

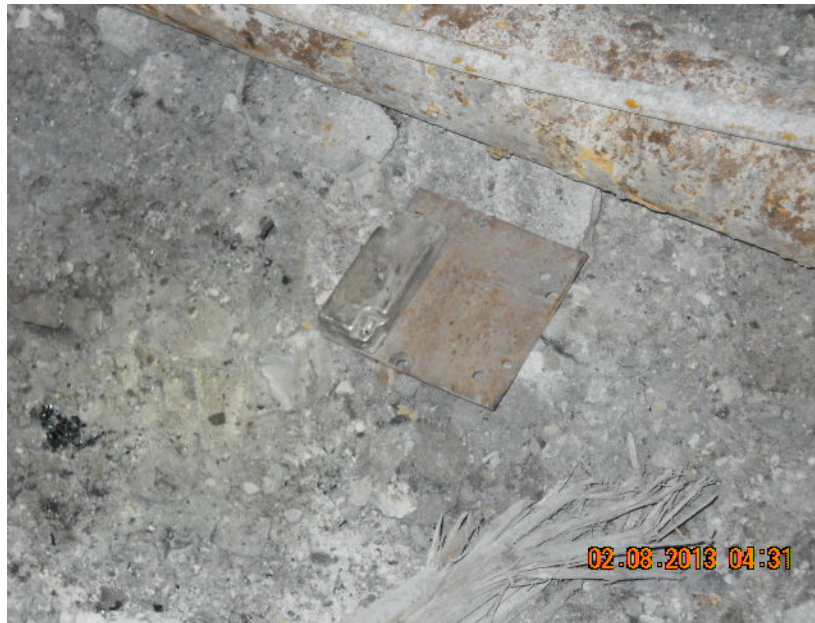
It was apparent during the investigation that the magnetic actuator of the safety switch, which should have been mounted on the west side gate, was not properly installed on the gate in order to maintain the safe operation of the hoist because it was found lying on the mine floor. The two-part safety switch consists of a magnetic actuator that is mounted on the safety gate, and a sensor switch that is installed on the gate post. When properly installed, the gate switches send an electrical signal to the Program Logic Control (PLC) that indicates that the gate is either open or closed. When a signal is received by the PLC indicating that the gate is closed, the hoist can be safely operated, and inversely, when a signal is received that the gate is open, the hoist will not function. Both, the magnetic actuator and the sensor switch must be installed and properly adjusted for the hoist to operate safely. When properly installed and operating, the safety switch protects persons traveling on or off of the hoist platform from hazards related to the movement of the hoist (raising or lowering).

The gate safety switches were not maintained in a manner to assure the safe operation of the service hoist. The magnetic actuator of the safety switch had been unbolted from its proper location on the gate and was installed (taped) to the gate sensor switch, which defeated (by-passed) the intended purpose of the safety features and allowed the hoist to operate with the landing gate open. Taping the two parts of the switch together sends an electrical signal to the PLC that falsely indicated the gates were closed and the hoist was ready to operate safely.

The magnetic actuator of the safety switch for the west side gate and black electrical tape were found lying on the mine floor near the gate post. The West gate was opened and it was physically located approximately 16 feet from where the magnetic actuator was found lying on the mine floor.

When the accident occurred, the magnetic actuator had been taped to the gate sensor switch. The magnetic actuator of the safety switch was untaped and found on the mine floor during the accident investigation (see top photo, Appendix D). Interviews indicated the component was untaped after the accident by maintenance foreman Glenn Paugh, a violation of 30 CFR § 50.12. The MSHA District Manager did not grant an exception to alter the accident scene. Accordingly, a non-contributory citation was issued to the operator for altering the accident scene.

Safety Switch Actuator on the Ground During Accident Investigation

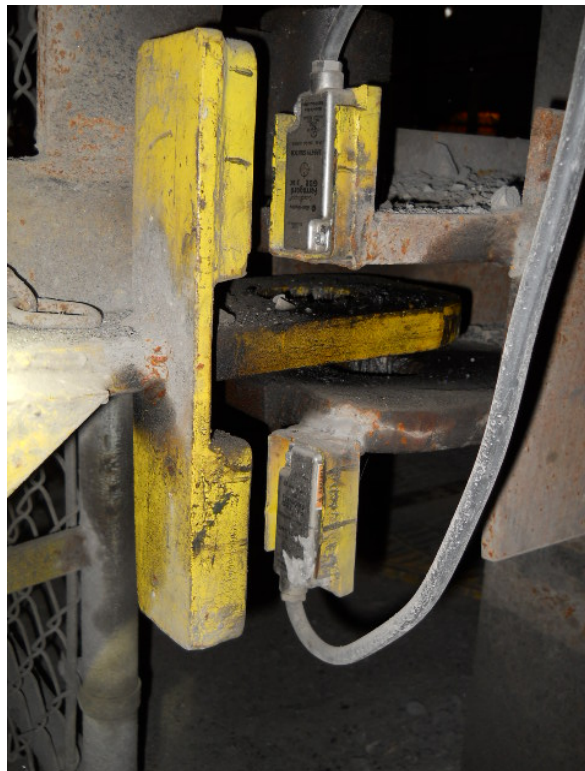
New Safety Switch Actuators Required by MSHA (post accident)  
Installed with Tamper Proof Bolts

Safeguard Number: 7224752 requires that all gate safety switches on all hoists at this mine to be installed using tamper resistant mounting fasteners.

Each of the four hoist landing gates, two on the surface and two at mine level, were equipped with two separate gate safety switches installed with tamper resistant hardware. Each gate switch was equipped with a “normally open” and a “normally closed” contact. The switch contacts are monitored by independent safety circuits to improve the safety integrity of the hoist gate electrical system. The gate switches and magnetic actuators were secured in place with tamper resistant mounting hardware, which requires a special tool for removal .
