COAL MINE SAFETY AND HEALTH
REPORT OF INVESTIGATION

Underground Coal Mine
Fatal Machinery Accident
February 13, 2013

Prairie Eagle South Underground Mine
Knight Hawk Coal LLC
Cutler, Perry County, Illinois
I.D. No. 11-03205

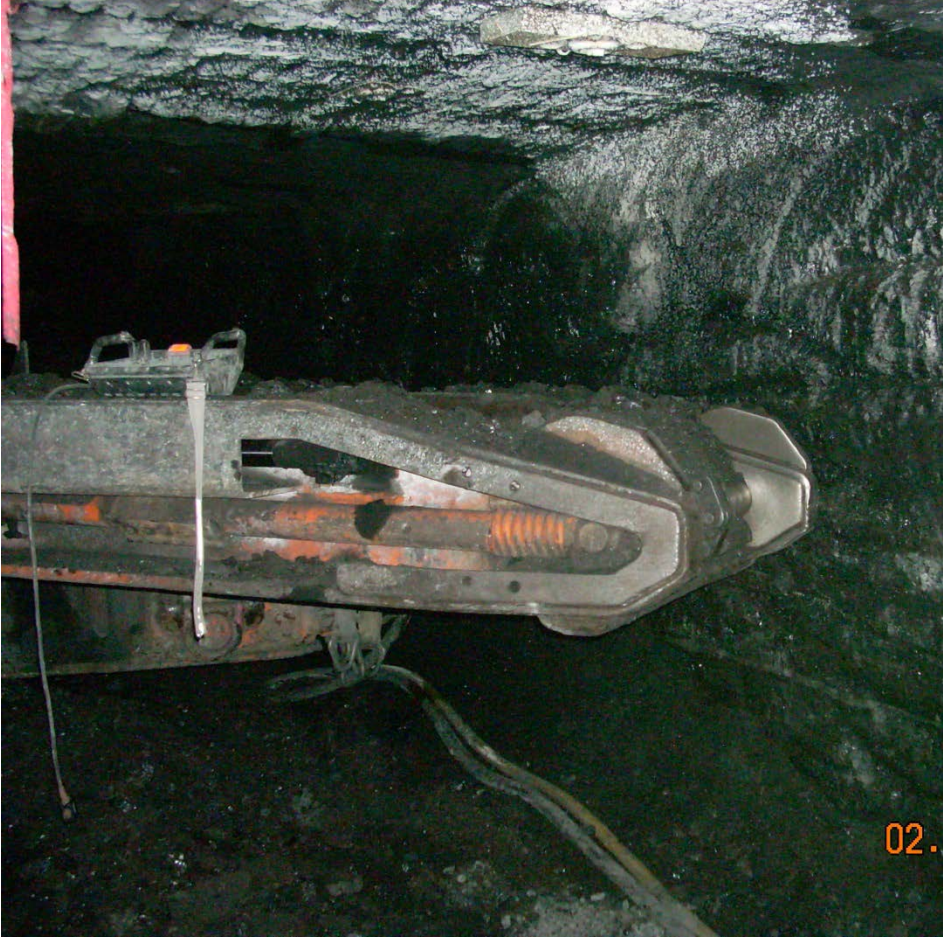
Photograph of Accident Scene Showing Continuous Mining Machine and Coal Rib

On Wednesday, February 13, 2013, Timothy Chamness (victim), a 28-year-old continuous mining machine operator, was fatally injured when he was pinned between the tail of the remote controlled continuous mining machine and the coal rib on MMU 001-0, located on the 3rd North section of the Main West entries. While repositioning the continuous mining machine to mine the final cut on the left side of the entry, the victim was pinned between the conveyor boom of the machine and the coal rib on the right side of the entry (See Appendix B).

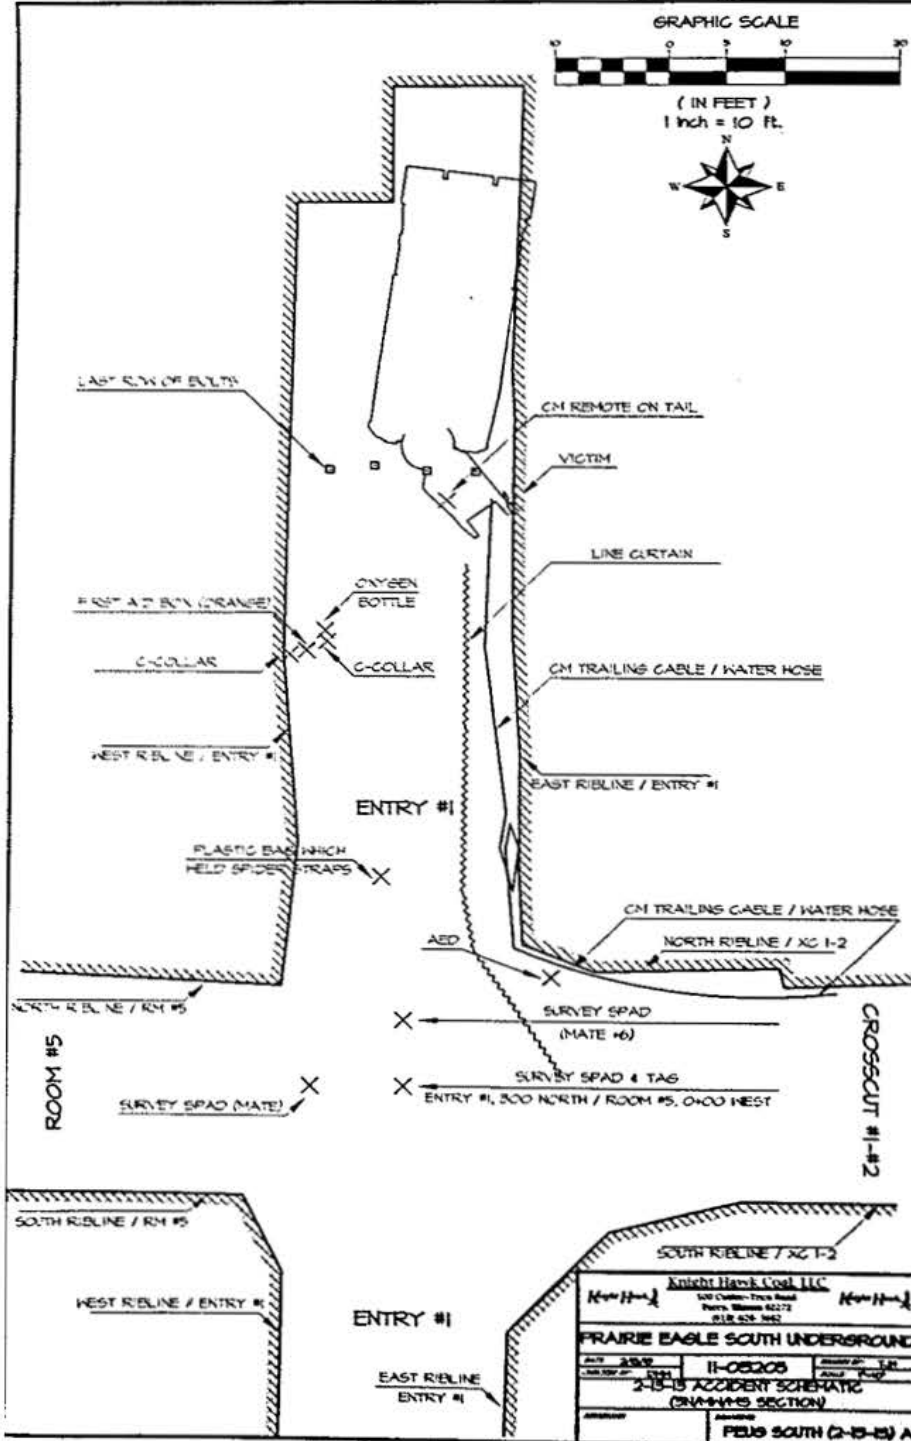
Accident Scene

The accident occurred in the face area of the No.1 entry approximately 50 feet in by the last open crosscut on the left side of the 3rd North entries off the Main West, No. 1 Unit (MMU 001-0). The last open crosscut was located at Survey Station (Spad) +300 N for the 3rd North entries off the Main west. The right side of the entry had been advanced 38 feet beyond the last row of permanent support. The left side of the entry had been advanced 19 feet beyond the last row of permanent support. The mine had approval for cut depths up to 40 feet. The coal seam height at the last open crosscut measured 88 inches and the entry measured 20 feet in width. Coal was being mined from the right side of the entry prior to the accident. Chamness was found in the No. 1 entry, against the right rib at the second row of permanent roof support. The cutting head of the continuous mining machine was approximately ten feet from the face on the right side of the entry. Chamness was faced against the coal rib and the outby end of the continuous mining machine conveyor boom was against the middle of his back. The pump motor on the continuous mining machine was not running. This indicates that the remote control emergency stop (e-stop) or the pump "off" switch had been activated, or there was a loss of battery power to the remote control unit station. Illumination in the area was not a factor. When the continuous mining machine was energized for the investigation team, all of the lights were operative.
