REPORT OF INVESTIGATION

Fatal Powered Haulage Accident
February 12, 2013

Loveridge #22
Consolidation Coal Company
I.D. No. 46-01433

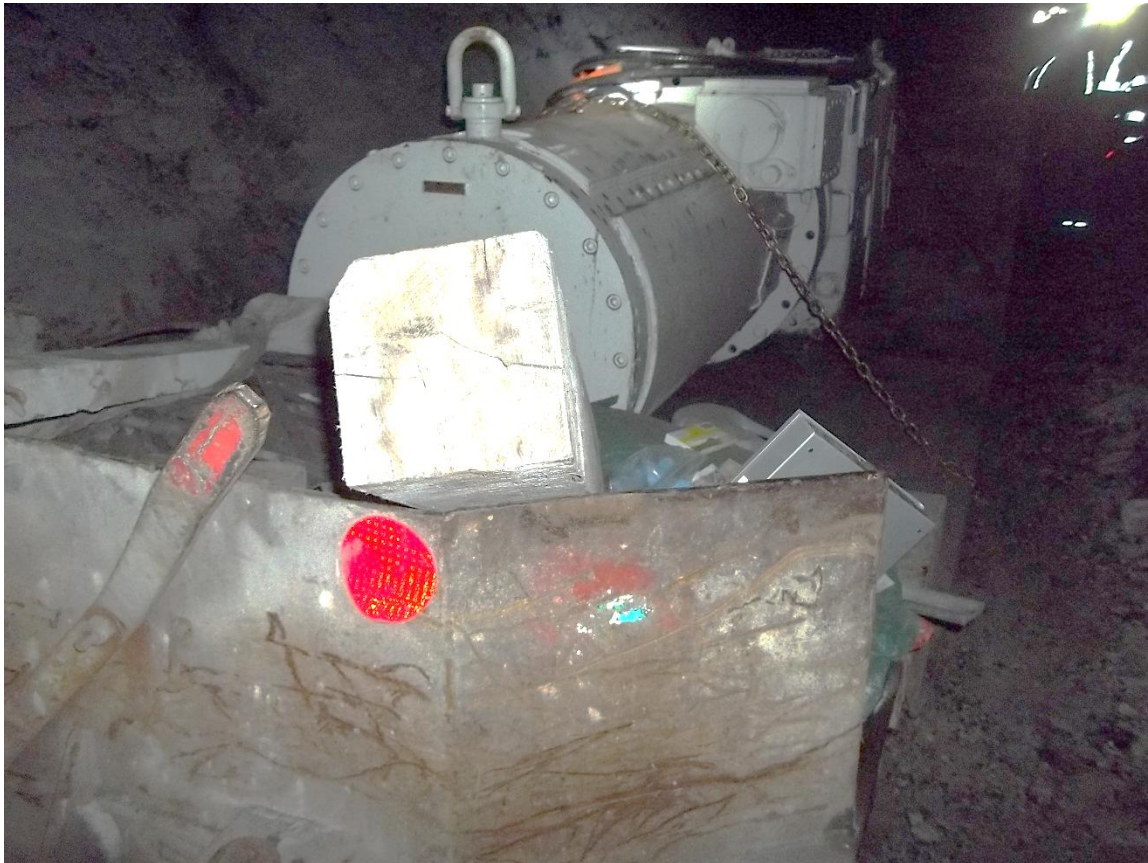
PHOTO OF ACCIDENT SCENE

On February 12, 2013, at approximately 9:35 p.m., Glen Clutter (victim), a 51-year-old general inside laborer and acting motorman, with 31 years of mining experience sustained fatal injuries. A slate bar struck the victim as he attempted to re-rail a supply car. Clutter and Scott Shay, General Inside Laborer, were attempting to re-rail the first of four cars that had de-railed. The car shifted and the slate bar struck Clutter on the right side of his face and on the forehead.

The supply trip derailed between the No. 124 and No. 126 blocks of the Main West track haulage, developed in March 1973. The accident investigation revealed the track rail rolled out for a distance of approximately 120 feet on the wire side. Rock dust, dirt, dried mud and other loose material covered most of the track ties and rail spikes in the area where the accident occurred. The rail (85 pound) had deteriorated from years of exposure to the elements. The bottom flange of the rail had rusted and weakened. A citation that did not contribute to the accident was issued to the mine operator for failure to maintain the track.

but this does not increase lifting capacity. The manufacturer recommends that on each side of the air bag foundation, additional safety supports, such as cribbing, matting or blocking, (or combination of all) should be used, progressively during lifting. This prevents load-shift failure or lift bag failure. This also reduces the height, from which the load would fall in case of air bag or inflation system malfunction or failure. This recommendation was not followed in that the load was not blocked as it was raised. The condition of the track did not increase the hazards of the re-railing process.

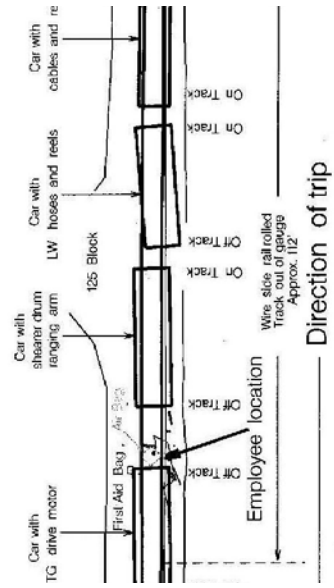
Accident 2-12-13
Main West Haulage
trip from 124 to 126 bloc

The mine operator did not maintain the track to prevent a derailment between the No. 124 and No. 126 blocks of the Main West Haulage. The wire-side rail rolled out for a distance of approximately 112 feet and there were no steel ties. The track was spiked to wooden track ties and the rail was rusted and deteriorated.

The operator did not perform an adequate pre-shift examination of the track. This could have prevented the derailment because the track deficiencies would have been repaired. The Main West haulage between the No. 124 and the No. 126 block had missing track ties. When a supply crew traveled across this area, 112 feet of rail rolled out on the wire side of the track.
