REPORT OF INVESTIGATION

Fatal Powered Haulage Accident
February 19, 2013

Affinity Coal Company, LLC
Affinity Mine
Sophia, Raleigh County, WV
I.D. No. 46-08878

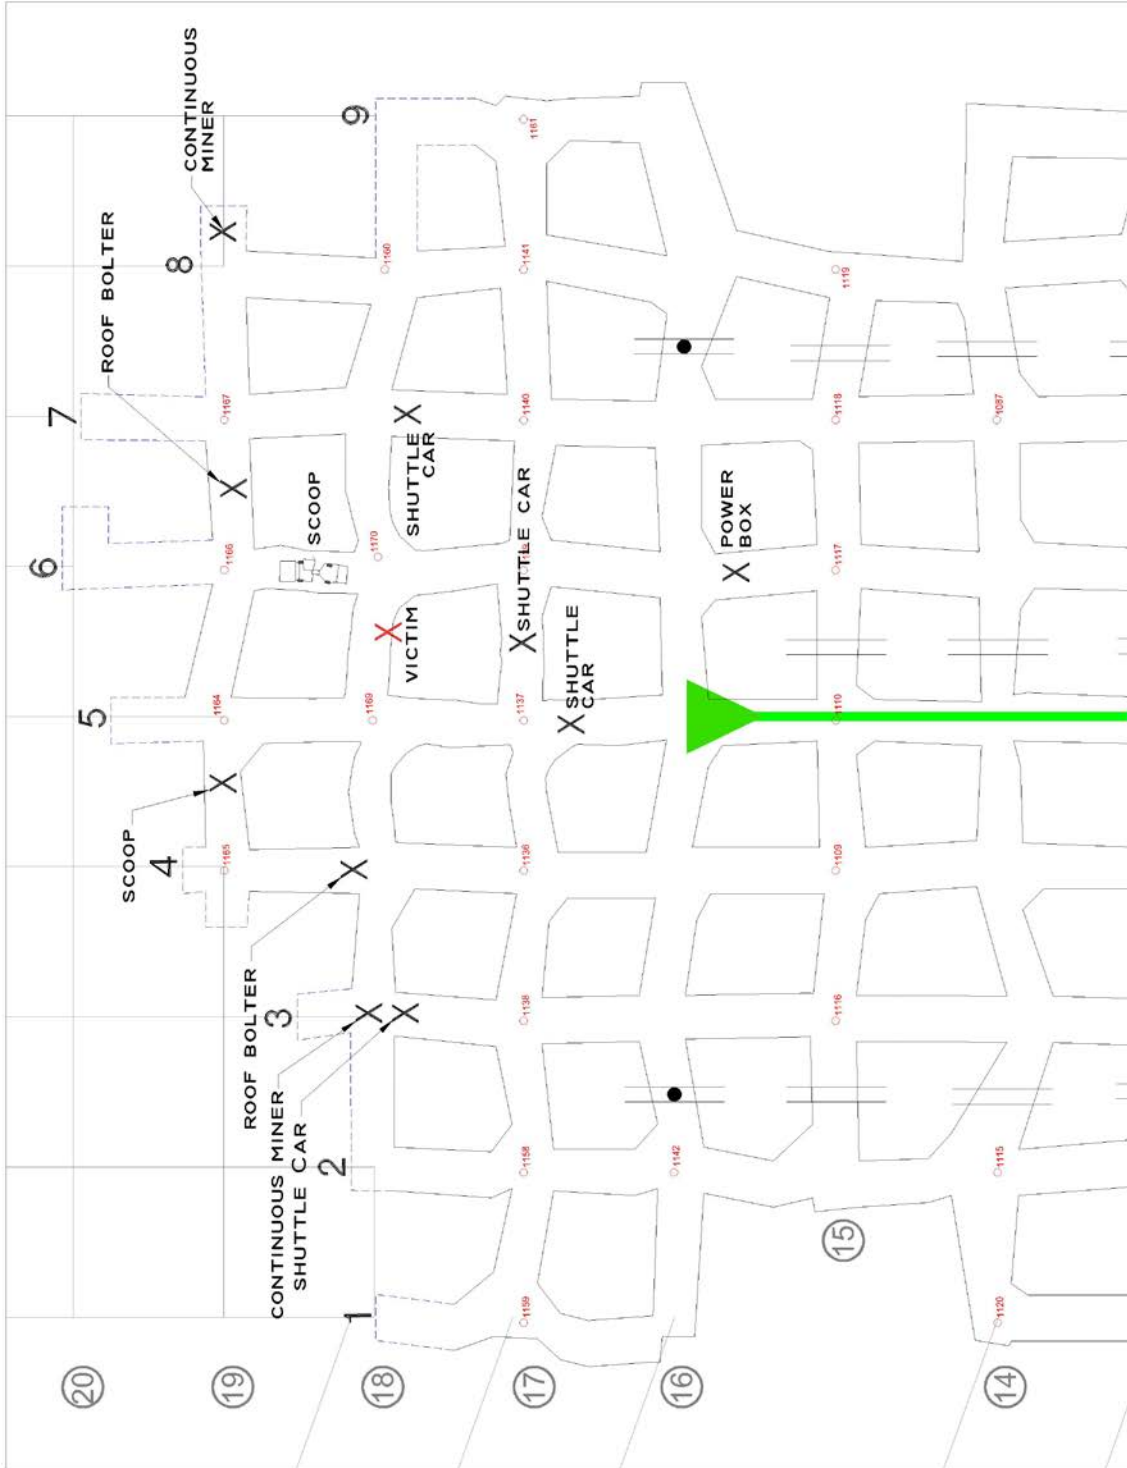
Appendix C Sketch of Accident Scene

John Myles normally operated the Number 12 shuttle car on the Number 3 Section. The Number 12 shuttle car was inoperative due to a broken hydraulic pump motor. Myles was directed by Laramee, Assistant Mine Foreman, to help Justin Ward perform clean-up work on the section by shoveling loose coal along the ribs in areas outby the working faces. Myles was working in the Number 18 crosscut, connecting the Number 5 and Number 6 entries, near survey station #1170, when the accident occurred.

Ward was operating the Fairchild battery-powered scoop. During his interview, Ward stated that just prior to the accident he had observed Myles shoveling the ribs in the Number 18 crosscut, connecting the Number 6 and 7 entries. At approximately 7:15 p.m., after pushing loose coal into the Number 6 entry face, Ward backed his scoop into the No.18 crosscut, connecting the Number 5 and Number 6 entries, and struck Myles with the battery end of the machine, causing Myles to suffer fatal injuries.
