UNITED STATES
DEPARTMENT OF LABOR
MINE SAFETY AND HEALTH ADMINISTRATION

REPORT OF INVESTIGATION

Fatal Roof Fall Accident
March 13, 2013

Newtown Energy, Inc.
Peerless Rachel Mine
Comfort, Boone County, WV
I.D. Number 46-09258

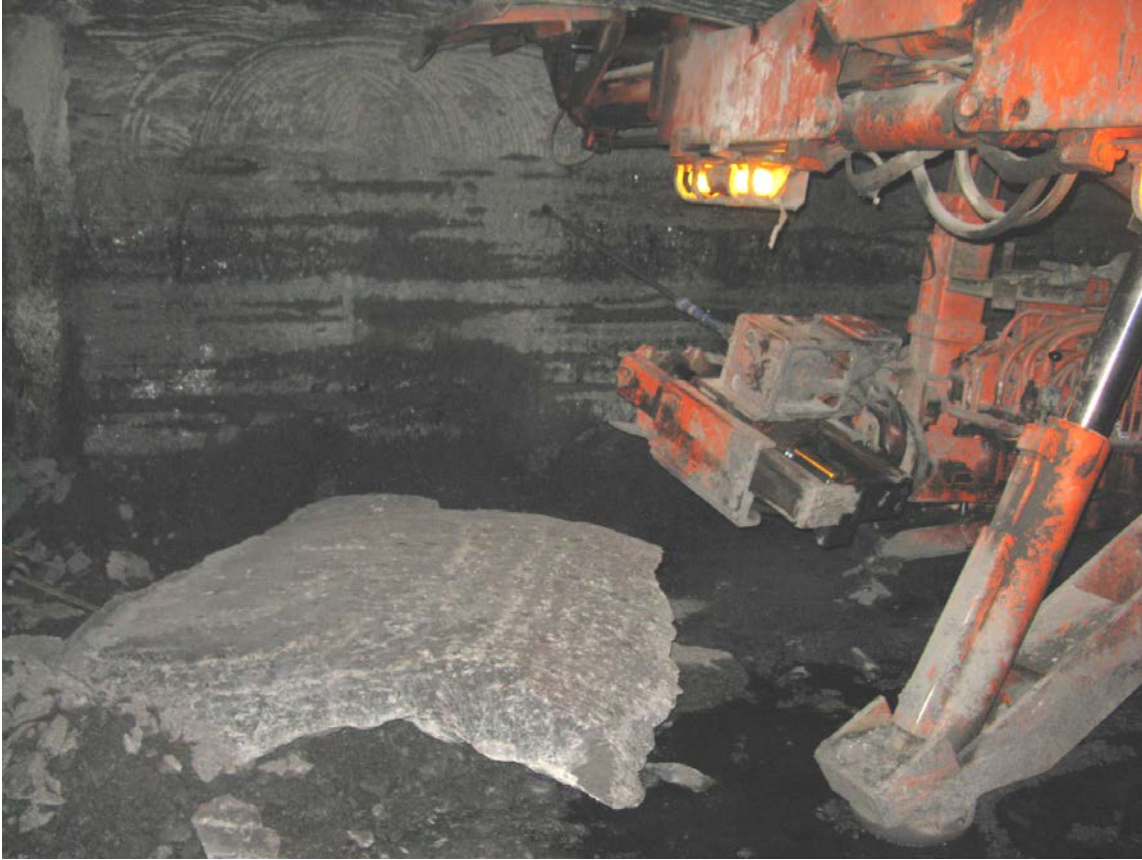
Photo of the accident scene reenactment

The roof rock that struck Fitzpatrick fell in such a manner that the portion of rock closest to Fitzpatrick pinned and crushed him in a semi-upright position against the inby edge of the drill mast. This placed Fitzpatrick at the inby edge of the drill mast with only 12 inches of clearance to the front of the ATRS. At least a portion of his body was under unsupported roof when the rock fell. Based on the evidence at the accident scene, Fitzpatrick apparently positioned himself in this manner in order to insert the resin glue and the rib bolt into the hole.

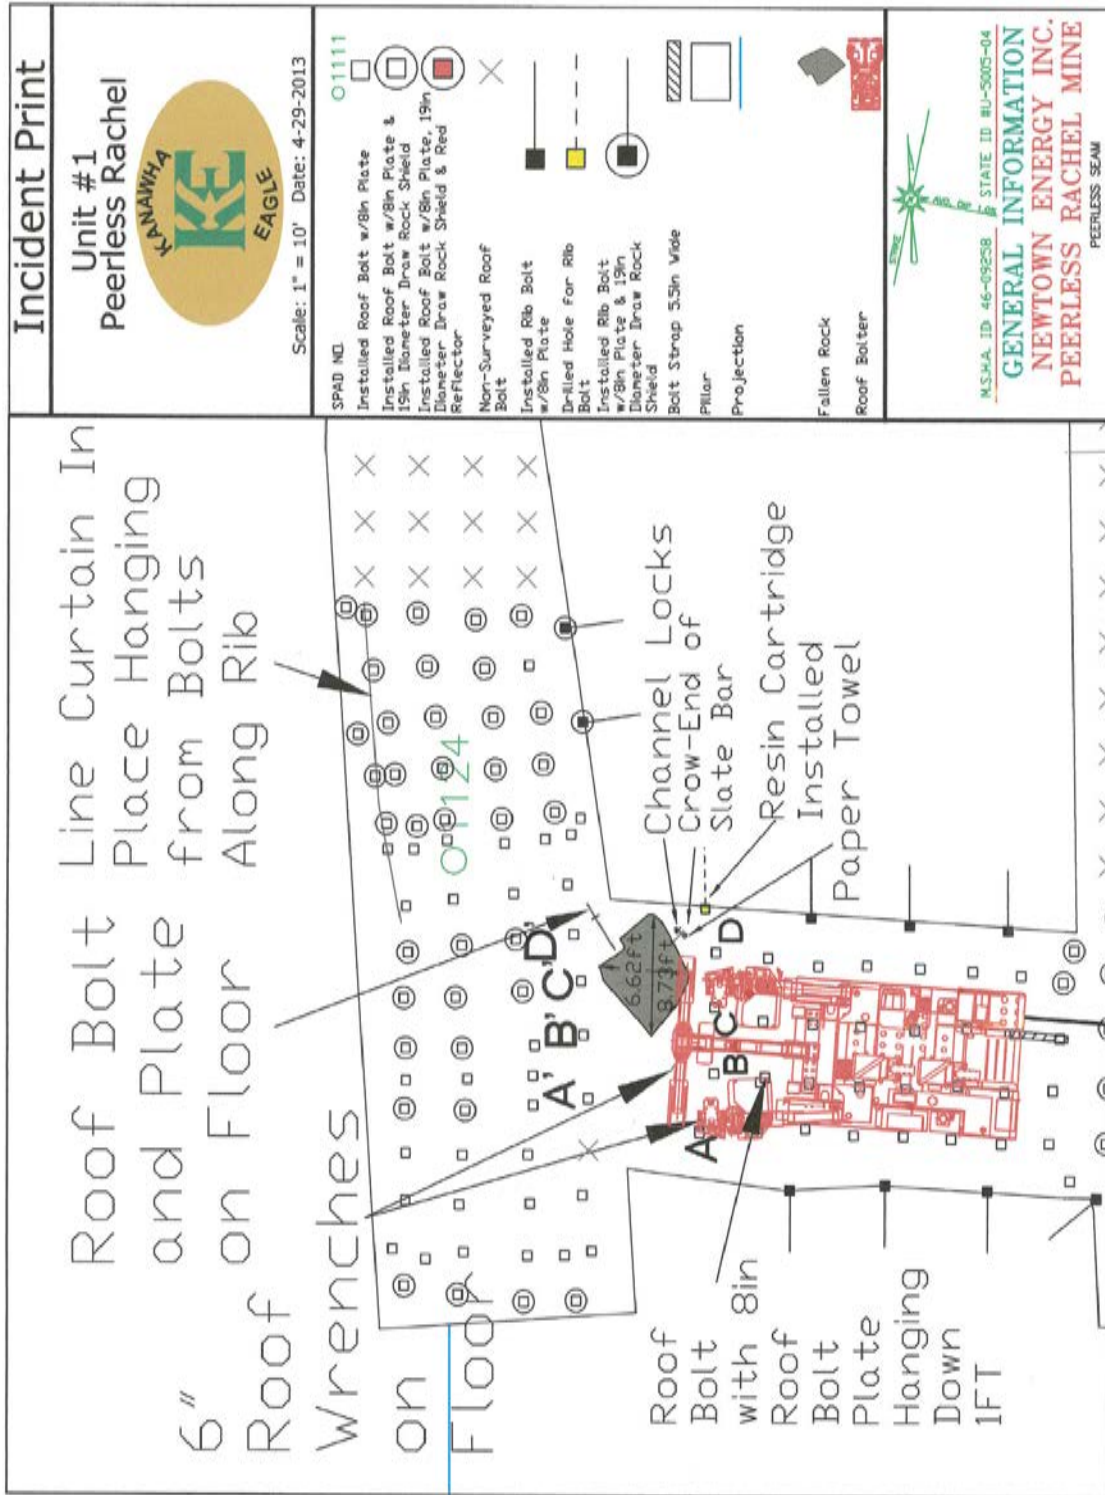
APPENDIX C
Sketch of the Accident

The rock that struck Fitzpatrick was found on the mine floor with the leading edge approximately 5 inches outby the front edge of the ATRS. The rock measured 6 feet by 5.5 feet and averaged 5 inches in thickness. The rock weighed approximately 2,200 pounds. The rock shape was semi-elliptical in profile and had a shallow dome shape, which ranged in thickness from 0 to 9 inches, (5-inch average thickness). The rock had measurements of 100 inches and 80 inches, measured diagonally. There was approximately 12 inches of clearance under the rock after it came to rest on the mine floor.

The roof bolting machine had not been moved, however the right side drill mast of the machine had been moved from its original position to allow first aid to be performed on the victim. The rib bolt drill hole was present in the right rib with four feet of resin glue still in the hole. When the drill mast was realigned with the rib bolt drill hole, and with the 4-foot section of drill steel, there was only 12 inches of clearance from the inby edge of the drill mast to the inby edge of the ATRS. At this location, it would not be possible to install the bolt resin glue from the opposite side of the drill mast without the use of a glue insertion device.

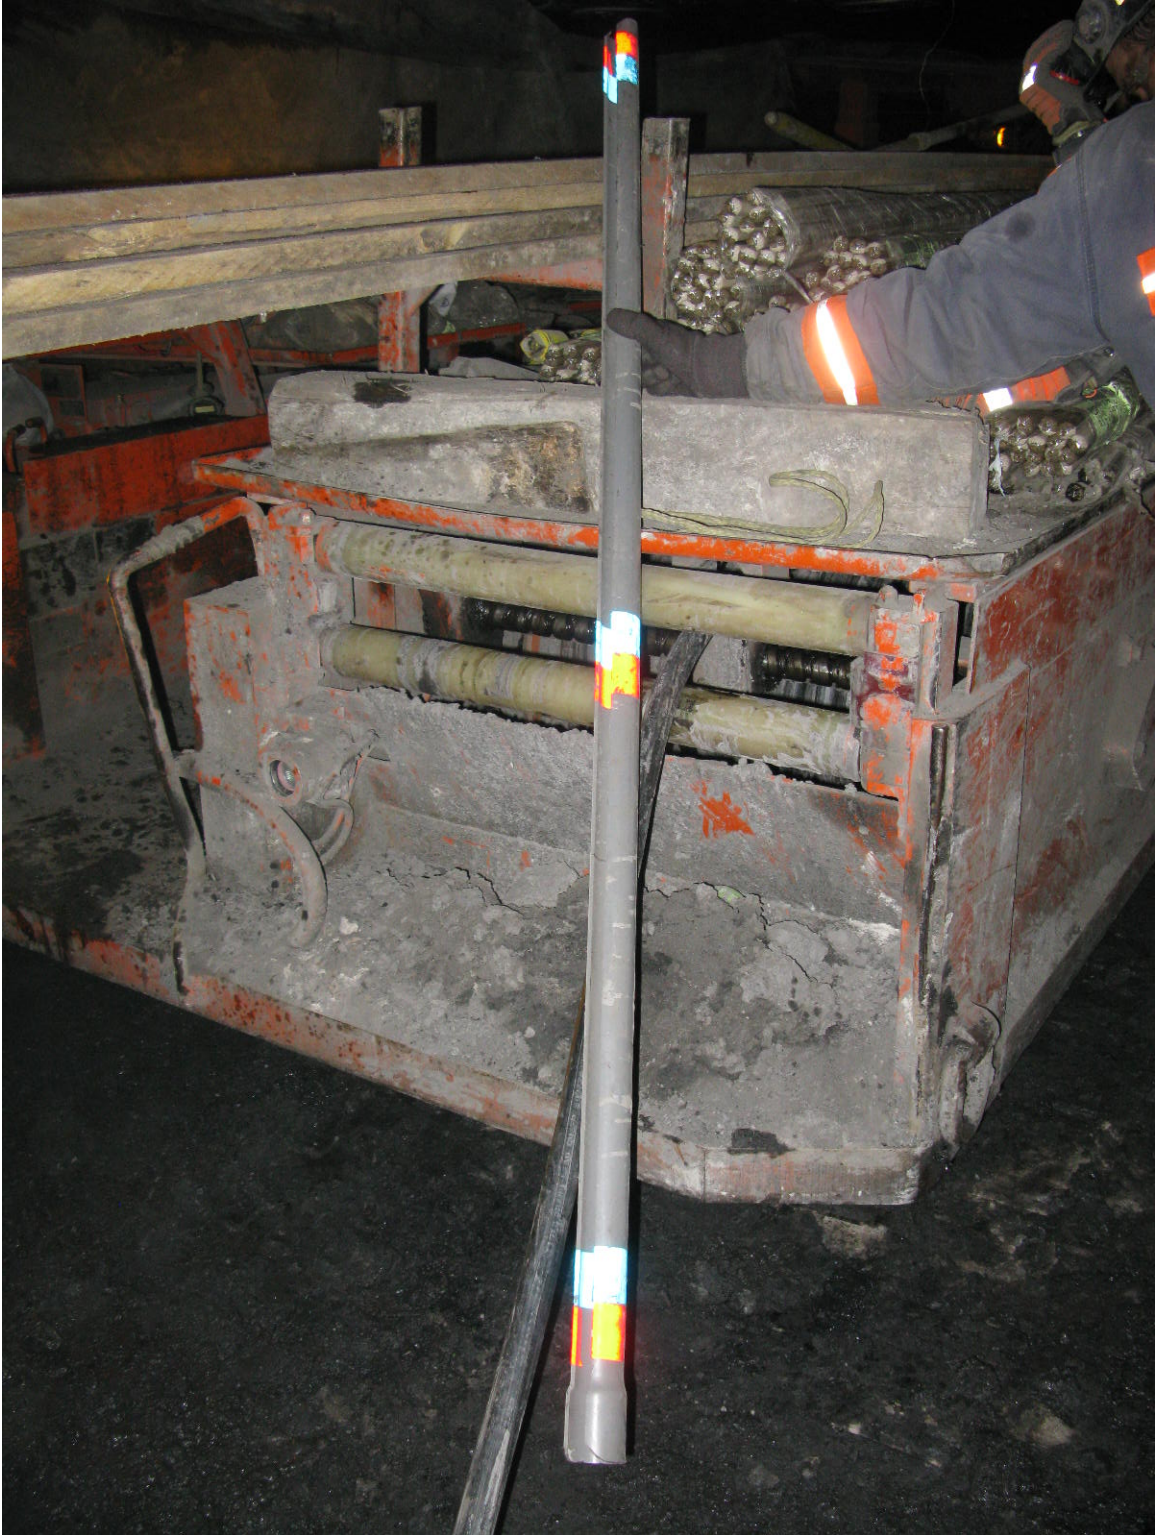
Photo of Resin Insertion Device

A resin inserter device and proper training in its use, would have provided the victim to means to install rib bolts while remaining at the drill station, beneath a canopy, and behind the protection of the ATRS. Mine management was aware that roof bolting machines were not adequately equipped and that proper training to safely install rib bolts had not been provided.

The mine operator was required by MSHA to reinstall the hydraulic drill guides and make resin insertion tools available on each roof bolting machine. Finally, the mine operator was required to provide additional task training to the affected roof bolting machine operators, which included specific training on the use of hydraulic drill guides and the resin insertion tools.
