REPORT OF INVESTIGATION

Fatal Fall of Roof Accident  
March 22, 2013

Castle Valley  
#4 Mine

Huntington, Utah  
I.D. No. 42-02335

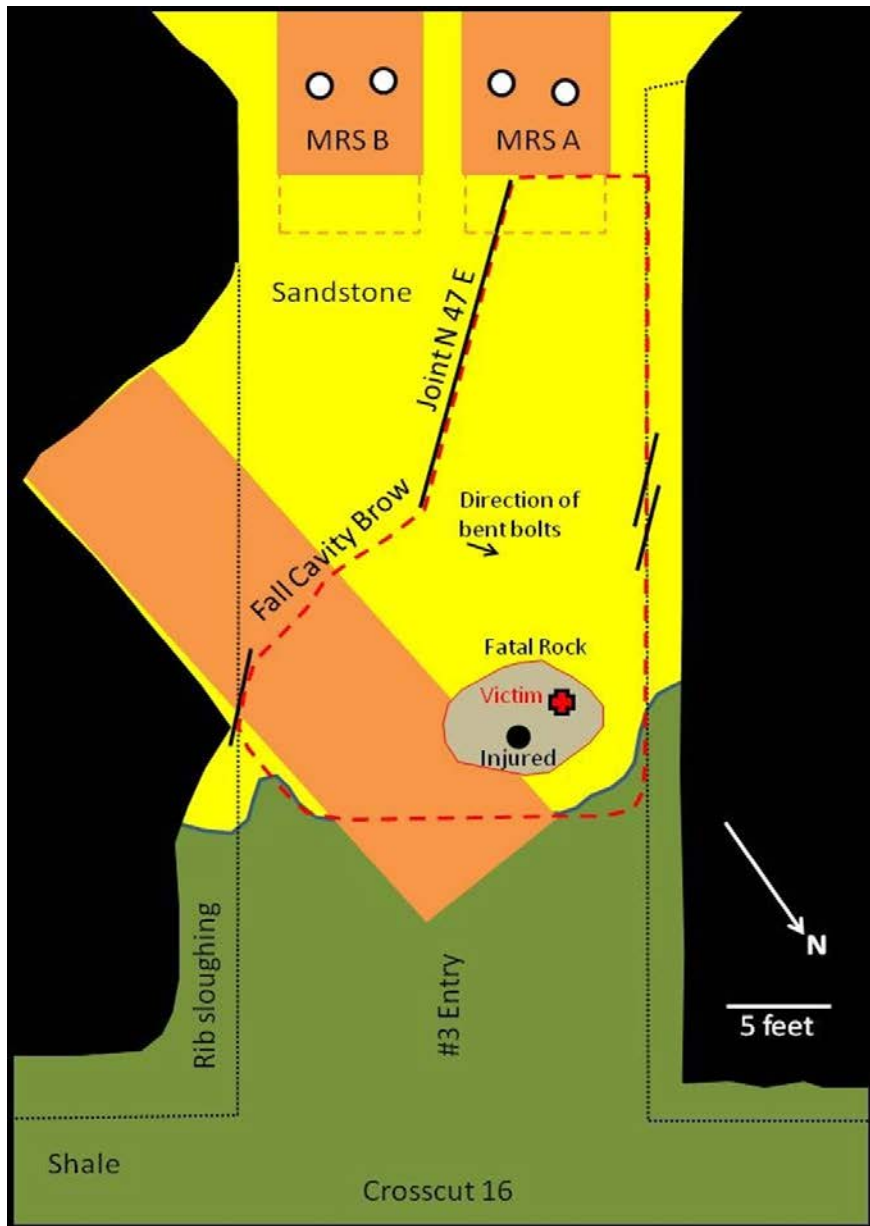
Sketch No. 1 after the Accident

MRS units are moved into position in pairs, located side by side to each other during retreat mining. At the location of the accident, it was found that the two inby MRS units in the No. 3 entry were located 24-feet inby the rib line at the beginning of the cut (See appendix C). The measurement was taken where the cut began which was where

the outby bit-ring of the continuous mining machine contacted the rib line, to the location of the MRS units. This placed the units approximately four-feet inby the required location. This condition created a large span (distance) from the MRS units to where the cut began.

At the accident site, rib sloughage had increased the actual entry width to 23 feet, for a distance extending from the back of the continuous mining machine to the pillar corner at crosscut No. 16. The distance of this excessive width condition was at least 10 feet. During the investigation, it could not be determined if this condition existed prior to the accident.

*Corrective Action*- The revised Roof Control Plan will show more detail in the diagrams with closer tolerances for the placement and location of the MRS units in relation to the pillar-lifts.

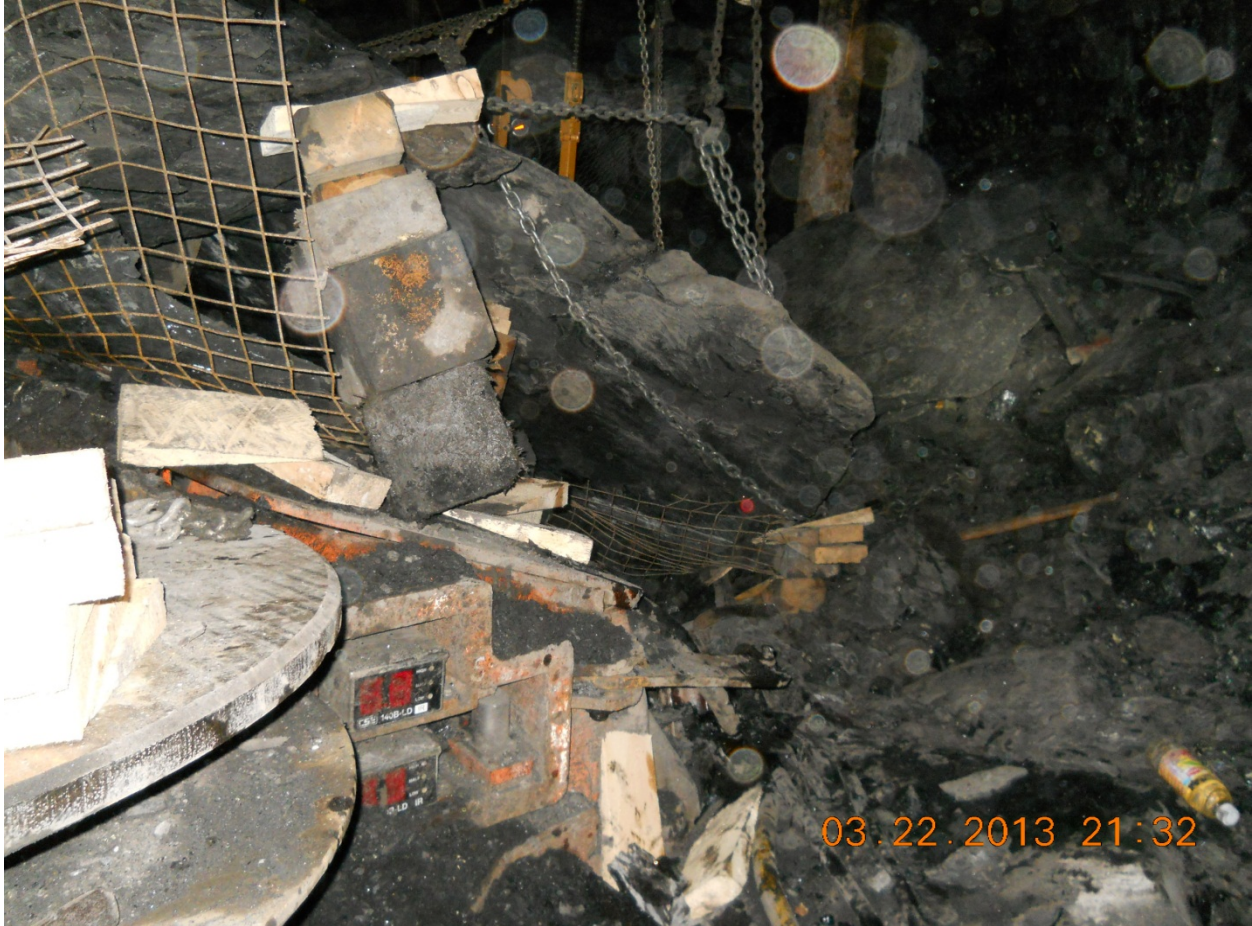
Appendix D  
Photograph of Accident Scene

The sandstone layer failed adjacent to the location of the left-hand cut, where the roof span was locally increased and where the N 47° E-striking joint dissected the sandstone beam. A series of prominent joints cut in to the hard sandstone but were not present in the shale. During the accident, several roof bolts were bent and sheared off by the falling roof. The bolts were bent in a direction perpendicular to the strike of the joints, indicating a cantilevering style of failure. It is possible that the increasing span of the entry resulting from mining the left lift may have allowed the sandstone roof to cantilever and break the roof bolts. If not for the levering effect of the hard sandstone, the strength of the bolts was such that they should have been able to support the dead weight of the fallen sandstone slab. The vertical tension fractures that developed in the brow above the unbolted cut may also be an indication that the resulting span was too great for the sandstone beam to bridge.

The sandstone layer broke into several smaller pieces as it fell, one of which was the fatal slab. As viewed inby, the same layer of sandstone that failed in relation to the fatality had separated from the roof along a very prominent bedding parting, showing a 3-inch gap that extended for several feet over the separated slab. This layer was suspended as a dead load by the existing roof bolts.

*Corrective Action* – The mine operator submitted a revision to the approved Roof Control Plan to narrow the maximum width of the entry to 18-feet instead of 20-feet; to install bolt rows on 4-feet centers and closer spacing between bolts in the row; and to reduce the pillar cut width from 20-feet to a maximum of 15-feet. MSHA approved this revision. The operator trained all miners in these changes. The proposed revision to the approved roof control plan also requires supplemental support installed on-cycle where rib sloughing is anticipated, to control excessive spans of roof.
