**REPORT OF INVESTIGATION**

**Fatal Powered Haulage Accident  
June 6, 2013**

**No.7 Mine  
Jim Walter Resources, Inc.  
Adger, Tuscaloosa County, Alabama  
I.D. No. 0101401**

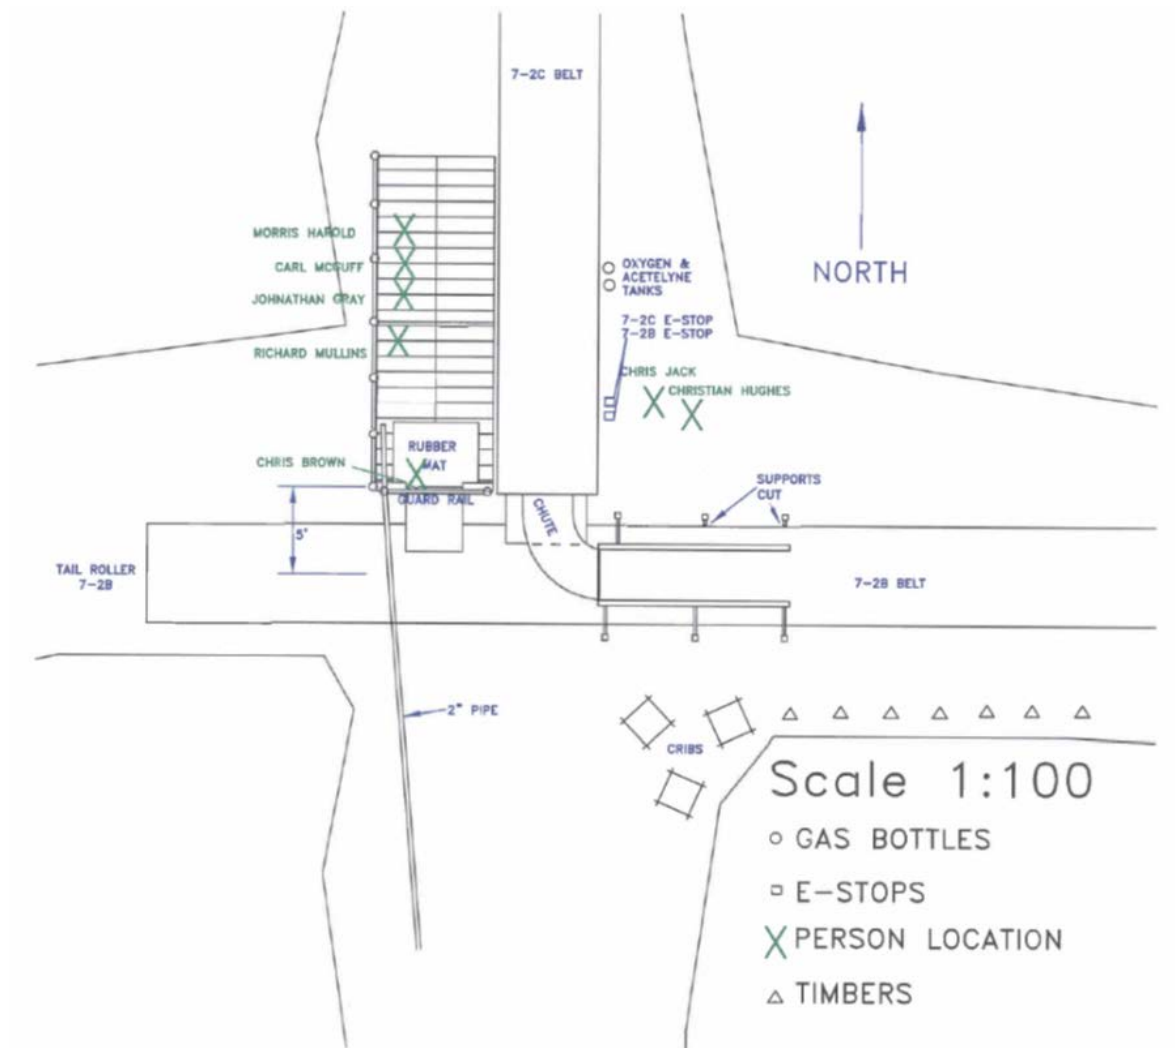
**Diagram #1 Depicting Location of Belt Crew and Victim Prior to Accident**

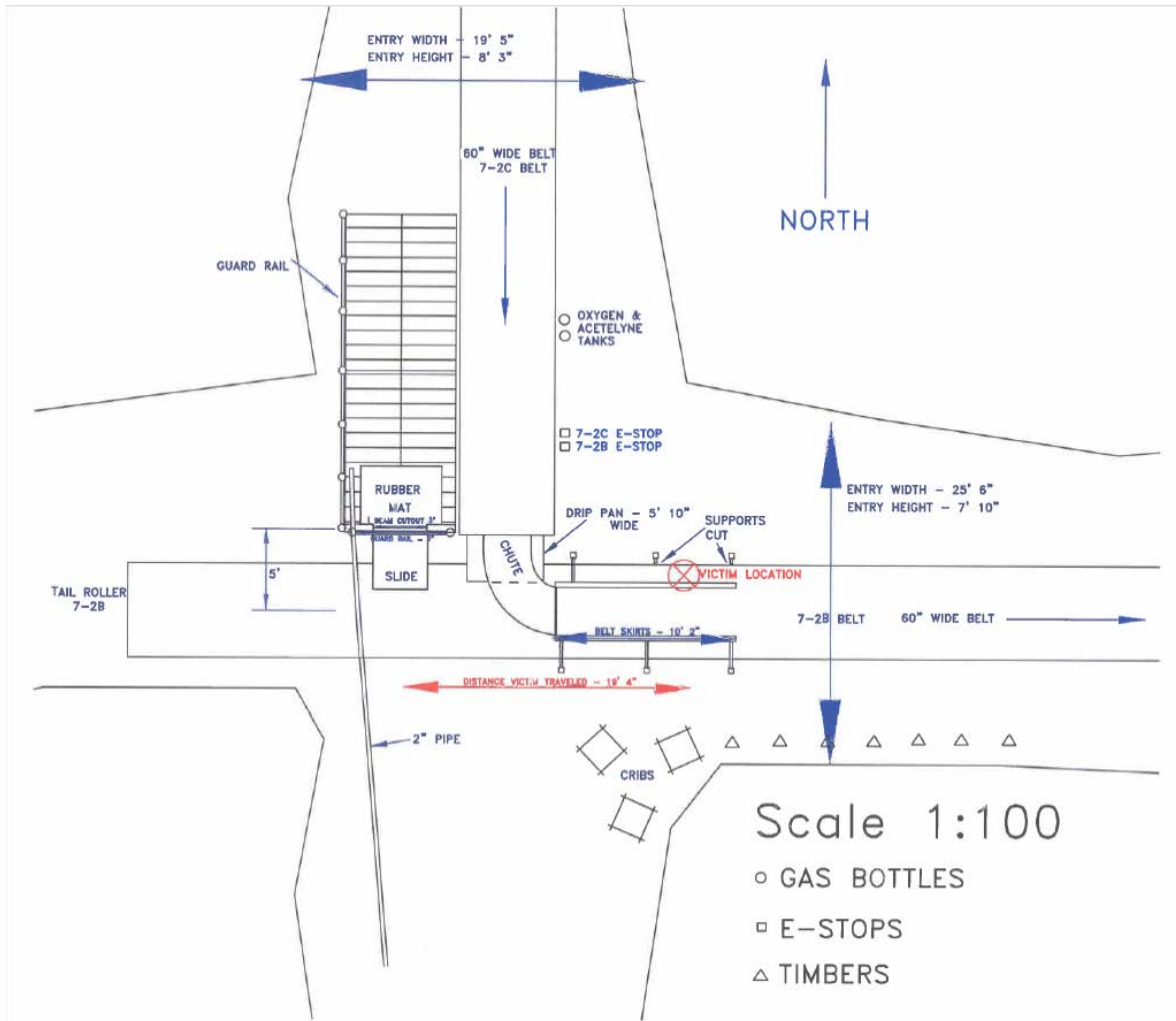
**Diagram #2 Depicting Victim Location after Accident**

Before the 7-2B belt stopped, it had pulled Brown into and behind the drip pan of the 7-2C conveyor belt discharge, and beneath the south side skirt structure of the 7-2B conveyor belt, a distance of 19 feet 4 inches from where he had fallen onto the moving conveyor.

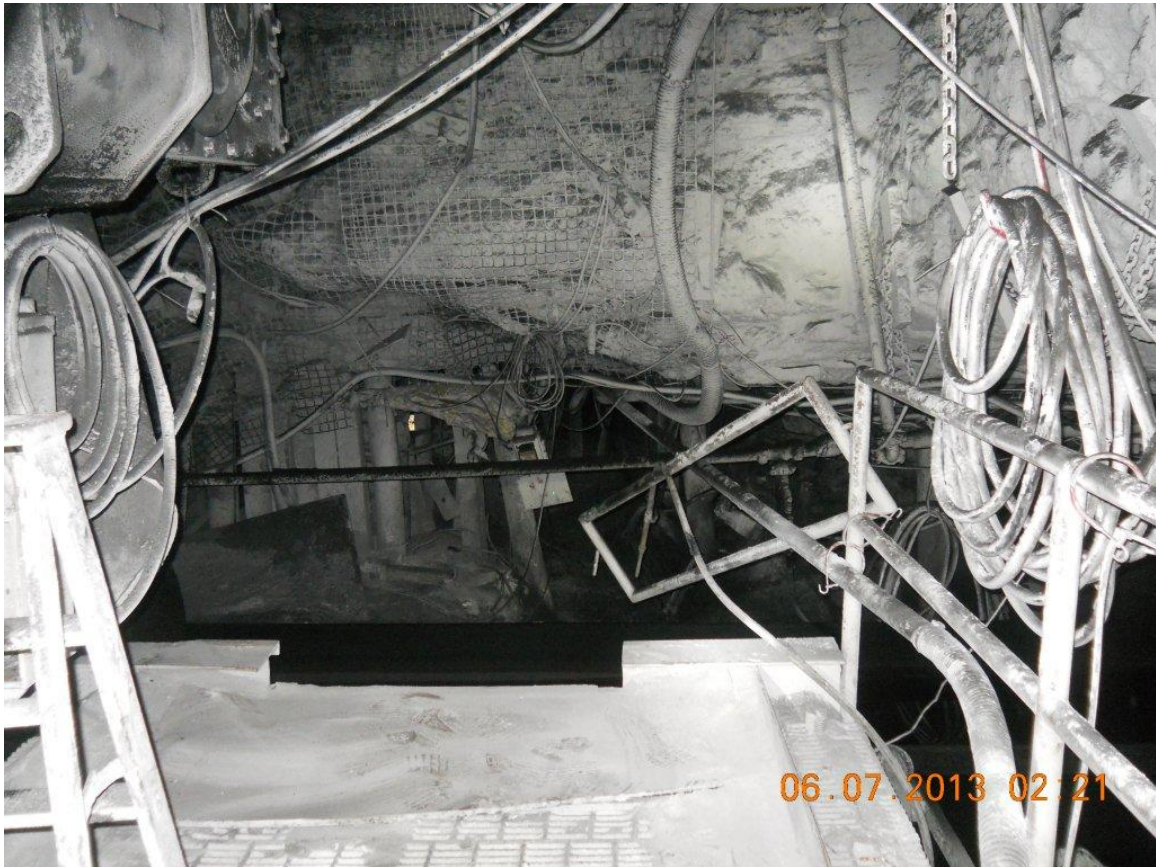
### Accident Investigation Photo Depicting Accident Scene

The investigation revealed that the post on the conveyor belt side of the walkway was missing. With the post missing, there was no longer a means to secure the removable guard rail. A horseshoe shaped wire hanger, normally used to suspend electrical cables from the mine roof, was being used to secure the guard rail to the frame of the belt drive head roller structure. The hanger had been damaged and would no longer lock closed as designed. The hanger was being used to hold the guard rail in a manner so that only a slight amount of pressure would cause it to give way and swing outward over the 7-2B conveyor operating below.

**Root Cause:** The guard rail installed at the end of the elevated ramp alongside the 7-2C belt discharge was not maintained and secured in a manner which would prevent persons from coming in contact with operating conveyor belts and conveyor belt components. The guard rail gave way when contacted by a belt foreman, allowing him to fall onto the 7-2B conveyor. The moving conveyor pulled the foreman between the small space separating the conveyor from the rigid belt skirting, resulting in fatal crushing injuries. The accident occurred because the guard rail was not properly secured. It was held in place by an unsecured, deformed, cable hanger.

**Corrective Action:** Mine management initiated an examination of all belt guarding installed at required locations throughout the mine. New guarding was built at the accident site, and installed in a manner that prevents persons from coming into contact with the operating conveyor belt.
