REPORT OF INVESTIGATION

Fatal Machinery Accident
July 2, 2013

Wildcat Hills Mine - Underground
Peabody Midwest Mining, LLC
Eldorado, Saline County, Illinois
I.D. No. 11-03156

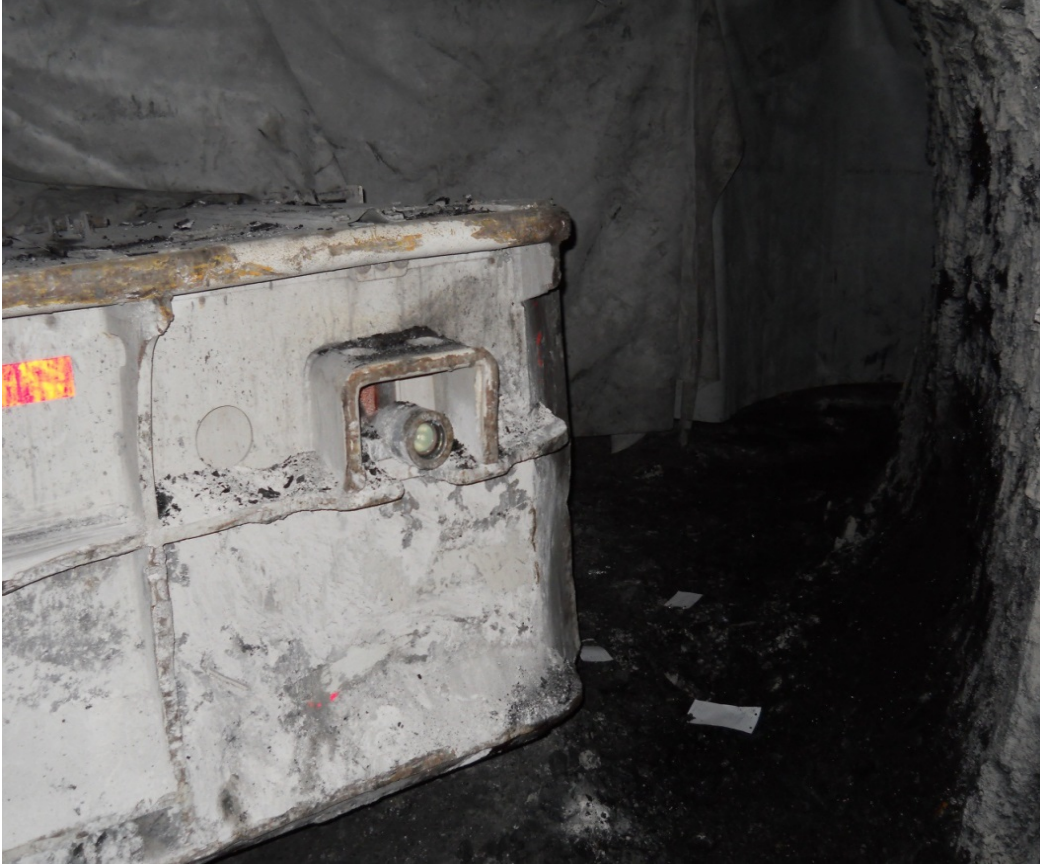
Photograph of Accident Scene Showing Battery-powered Coal Hauler and Coal Rib

When investigators arrived at the accident scene, the No. 308 coal hauler was located in the last open crosscut of the No. 4 entry, with the machine's left side battery end bumper positioned approximately 3 feet from the inby right rib corner. The outby end of the opaque ventilation line curtain was observed over the battery end of the No. 308 battery-powered coal hauler.

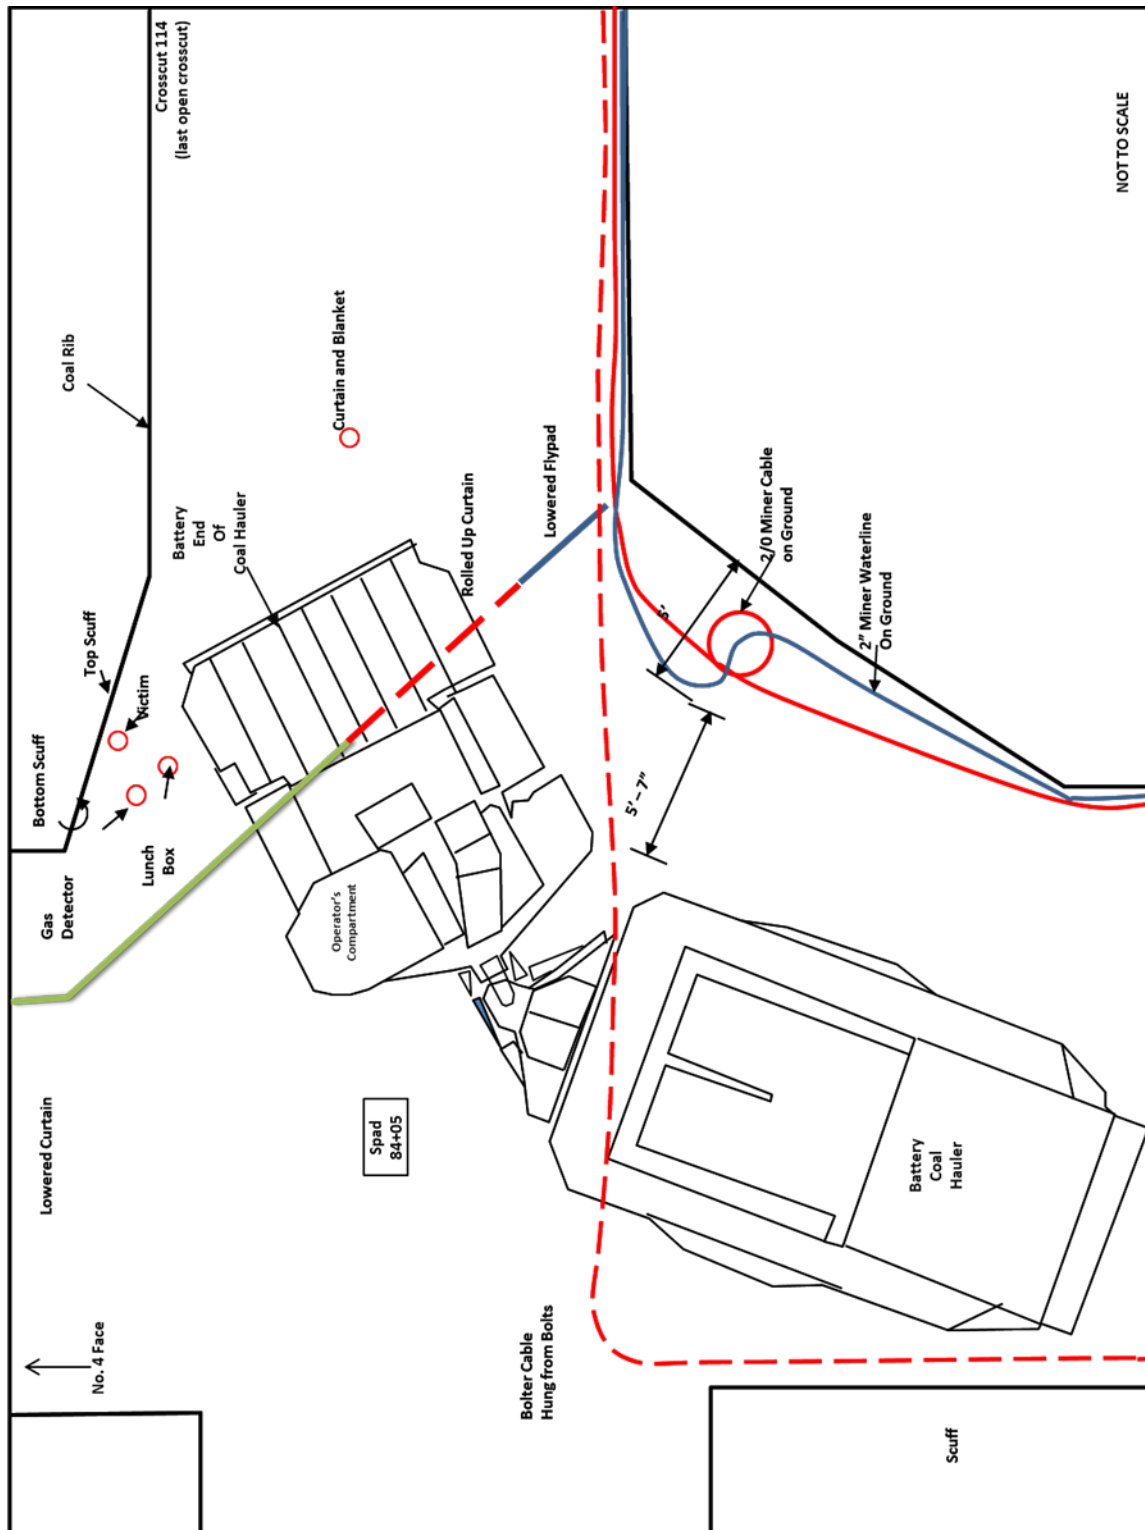
Appendix A - Sketch of the Accident Scene

The accident occurred on the left side of the No. 2 Unit (MMU 003-0) in the last open crosscut of the No. 4 entry, on the inby right rib corner at the entrance to the No. 4 entry face area, at Survey Station (spad) 84+05. No unusual mining conditions were noted by the investigation team.
