REPORT OF INVESTIGATION

Surface Coal Mine
Fatal Machinery Accident
July 31, 2013

Amerikohl Strips
Oneida Operation Pit 114
Amerikohl Mining Incorporated
Dubois, Jefferson County, Pennsylvania
MSHA ID 36-09654

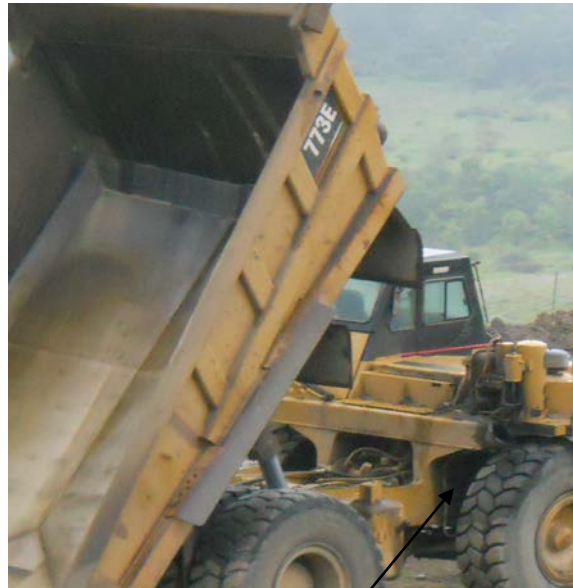
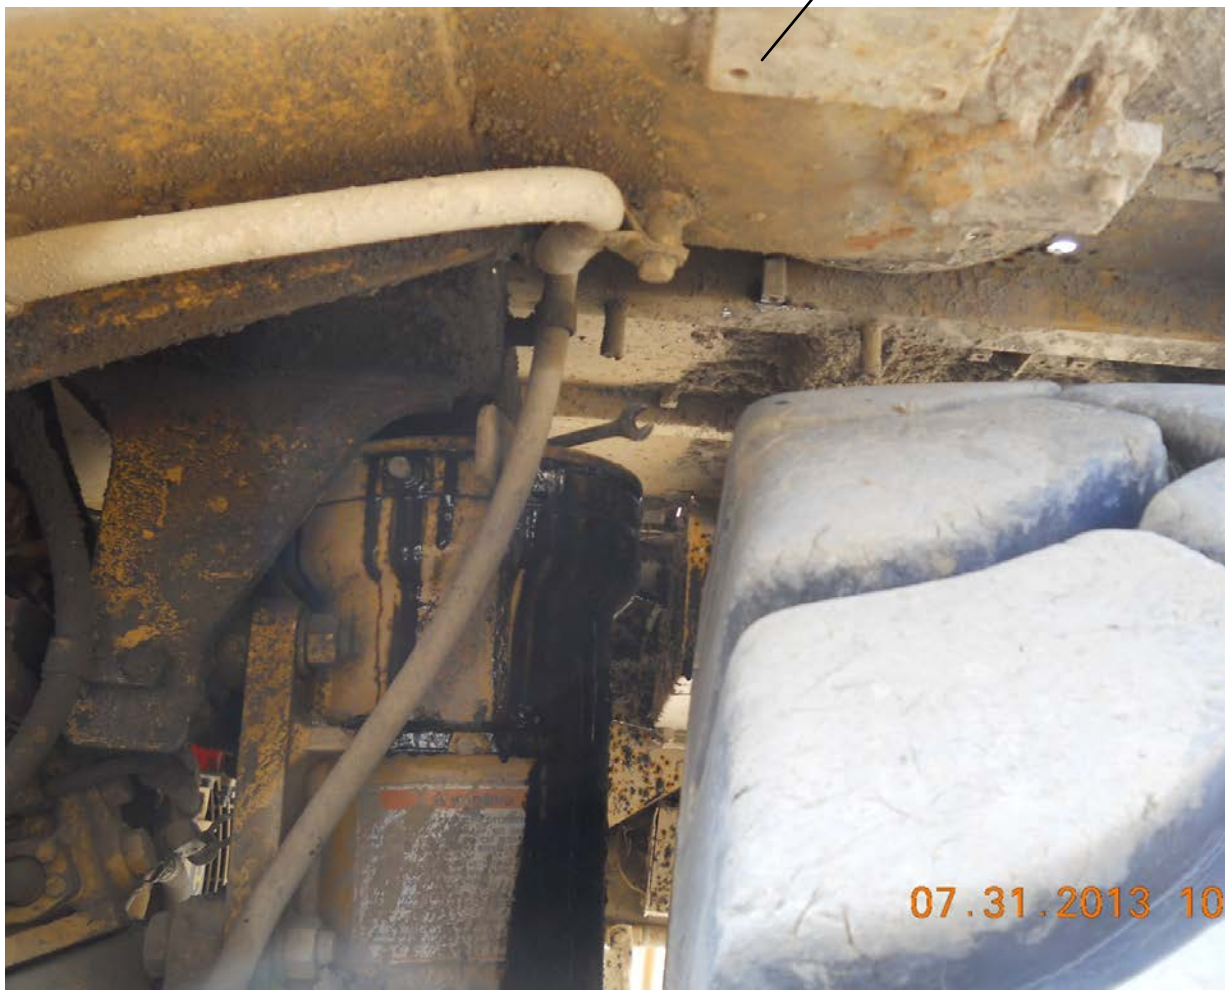
Appendix B - Accident Site

At about 7:00 a.m., Rosencrance and Gomola were discussing mine operations when they heard a "whooshing" noise and observed a cloud of dust surrounding the right front tire of the truck where Kanouff was working. Rosencrance saw that Kanouff was trapped between the top of the truck's right front tire and the bottom of the right front fender. The victim had been working between the top of the right front tire and the bottom of the right front fender without blocking the frame of the truck.

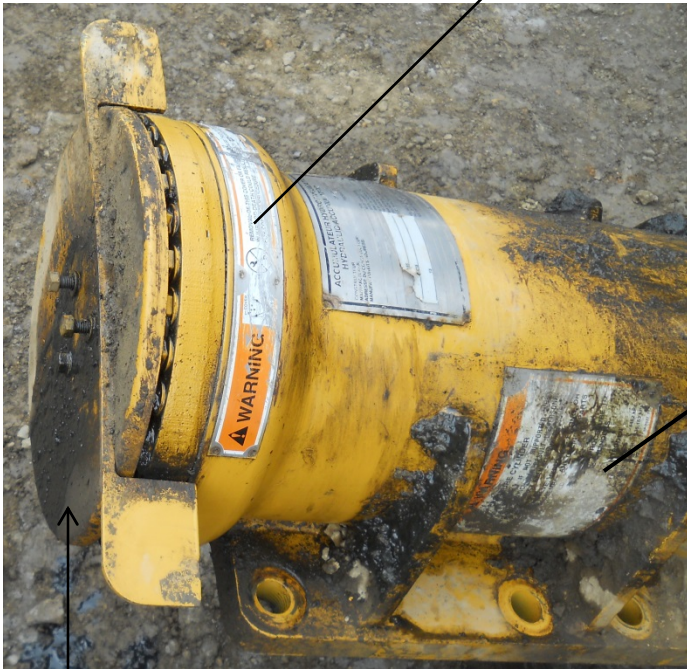
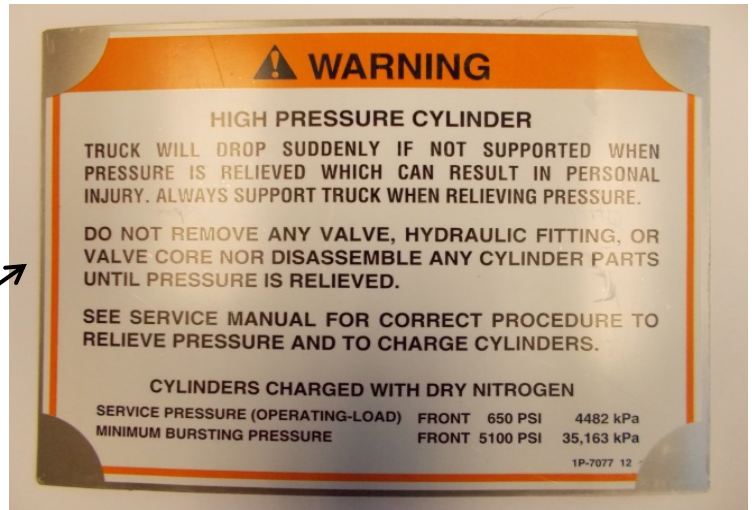
Appendix C - Photographs of Warning Label and Suspension Cylinder Cover Assembly

The suspension warning labels can be viewed in Appendix B. When viewed after the accident, the warnings on the truck's right side cylinder (accident cylinder) were covered with dirt and black oil. In addition, the warning directly below the cover assembly was scratched. The warning labels should have been readily visible.

The warnings and cover assembly can be viewed in Appendix B. The warnings in the manual and on the cylinder are specific to the hazard of the machine falling if pressure is released from the cylinder. The warning immediately below the cover assembly provides pictorials of the cover assembly, securing bolts, and a "no tool" sign. It also describes the hazard of a person being trapped between the tire and fender if the truck does fall, as occurred in this accident. The investigation revealed that two of the three bolts of the cover assembly were unthreaded and the last bolt was loosened.

The cover assembly has limited structural rigidity. The outer portion of the cover assembly consists of thin steel that can be manually deflected. It is also open at the outside edge above the bolts securing the cylinder head. The bolts can be seen and the cover assembly appears to be open above the cylinder to the center of the cover. The lack of structural rigidity and the open design of the cover could give the impression that it is a common guard (dust cover) over the cylinder.

CAT's Specifications Systems Operation Testing and Adjusting manual, RENR6514-01, October 2003, addresses the purpose of the cover assembly: "These protective plates cover some of the head bolts in order to prevent removal of the head while there is pressure in the suspension cylinder." Therefore, the cover assembly is an engineering control (safety device). While the cover assembly provides an engineering control to address a hazard to shop mechanics if they fail to follow proper procedure and relieve cylinder pressure before disassembly, no equally effective means is provided to prevent injury to field mechanics if they fail to follow proper maintenance procedures. While the cover assembly provides a safety feature to protect shop mechanics, it creates a hazard for field mechanics. The design of the cover assembly is intuitively counter to the message presented by the warning labels. This possible confusion, along with the different training and experience of field mechanics versus shop mechanics, greatly reduces the effectiveness of the warning labels in addressing the risk.

Corrective Action: All mechanics received task training on the hazards of the cover assembly.

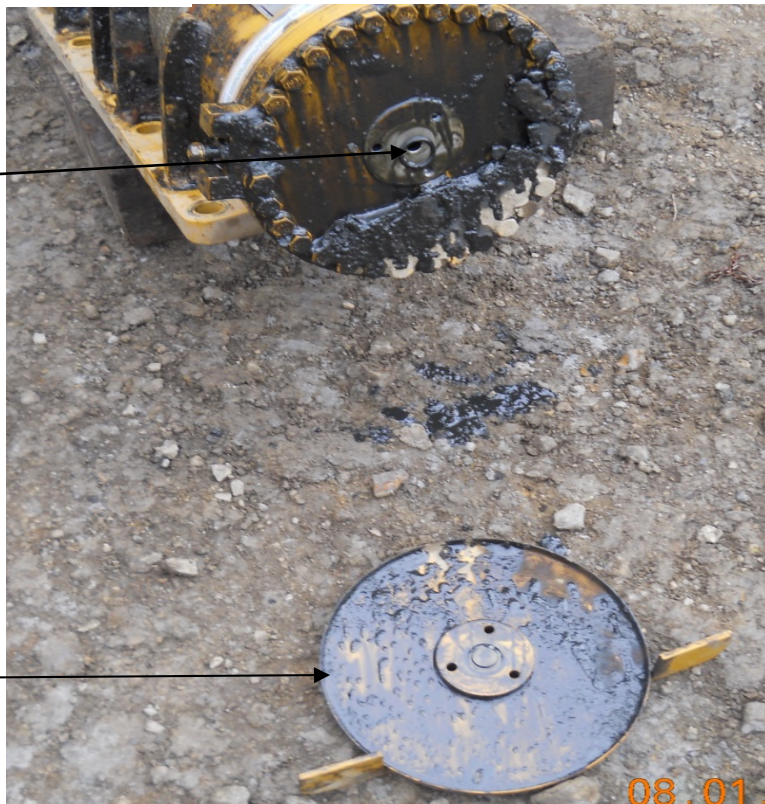
O-Ring Surrounding Pressure Port

Cover Assembly
