UNITED STATES
DEPARTMENT OF LABOR
MINE SAFETY AND HEALTH ADMINISTRATION

REPORT OF INVESTIGATION

Fatal Rib Rock Burst
August 6, 2013

Huff Creek No. 1
Lone Mountain Processing, Inc.
Holmes Mill, Harlan County, Kentucky
ID No. 15-17234

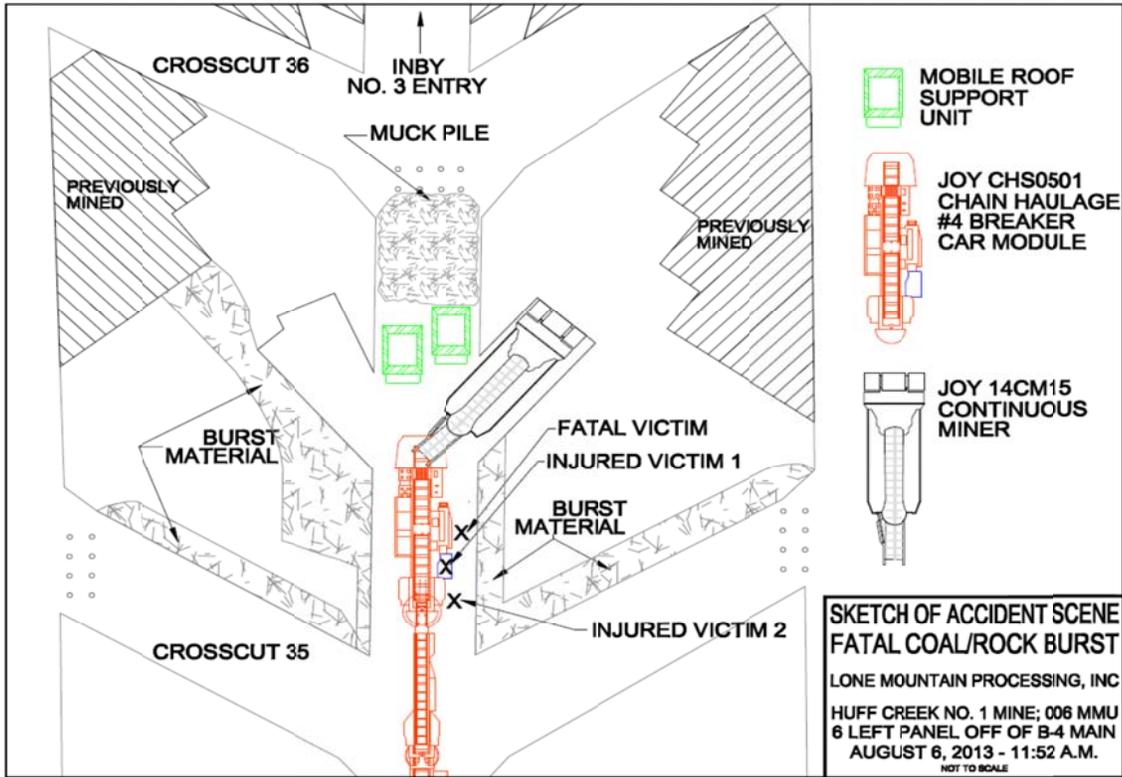
ACCIDENT SITE SKETCH

Breaker posts were set in the #4 intersection, and two Fletcher MRS units were moved to the #3 entry. Because mine floor debris (muck) had been pushed into the #3 entry, the MRS units had to be set several feet outby the installed breaker posts. Gilliam partially mined lifts #51A and #51B on the left side of the #3 entry after the MRS units were set. The MRS units were moved outby a short distance and the continuous mining machine was used to partially clean the #3 entry. Gilliam then began mining lift #52B on the right side of the #3 entry. After the continuous mining machine had cut approximately 15 to 20 feet, a coal and rock burst occurred.

Gilliam was operating the continuous mining machine by remote control from a position approximately 4½ feet inby the deck of the #4 MBC when the burst occurred. Gilliam was covered by coal and rock from the burst, which also covered Terry Scott in the deck of the #4 MBC. Johnny Nantz, MRS Operator, was located outby Gilliam and Scott. Nantz received minor injuries from the burst. When the accident occurred, Fox was conducting a preshift examination on the 006 MMU for the next shift, which started at 2:30 p.m. Fox was in the #2 entry at crosscut #31, approximately 4 crosscuts outby the location of the accident. Fox notified Donnie Feltner, Mine Superintendent, of the accident at approximately 11:55 a.m. Fox and other crew members began removing the coal and rock debris from around Gilliam and Scott. When Scott was freed from the debris, he and Nantz walked to a diesel mantrip awaiting them and were transported to the surface. Because Gilliam did not have a detectable pulse, Fox began Cardio-Pulmonary Resuscitation (CPR) as soon as a sufficient amount of debris was removed. An Automatic External Defibrillator (AED) was brought to the accident site, but was not used, as the AED read "No Shock Advised," when the leads were affixed to Gilliam. CPR was administered continually while the crew members removed the remainder of debris from around Gilliam. After Gilliam was freed from the debris, Dave Thomas and

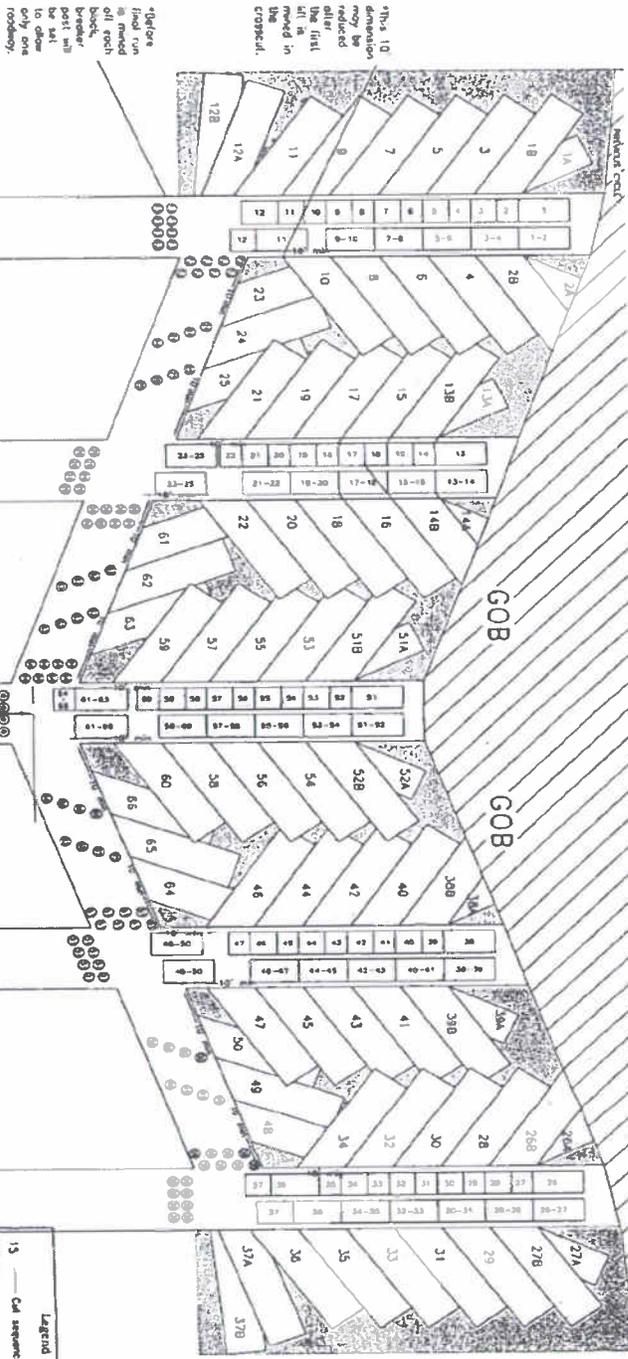
Pillar Recovery Plan Utilizing Two Movable Roof Supports

At approximately 6:45 a.m., the crew began retreat mining lift #44 in the #4 entry of crosscut #35 and proceeded to mine lifts #44 through #47 (See Pillar Recovery Plan Appendix A). While mining on the left side of the #4 entry, the cutter head on the Joy continuous mining machine stalled and the on-board electrical cutter-head breaker lost power due to pressure created by a coal/rock burst. Gilliam backed the continuous mining machine into the entry intersection at crosscut #35. Kenny Duff, Electrician, was called to restore power to the cutting head breaker. While the continuous mining machine's power was off a hydraulic fitting was repaired on the pan jack. After power was restored to the continuous mining machine, retreat mining resumed in the #4 entry with lift #48. Because of draw rock encountered, pillar lifts #49 and #50 were not mined.

For retreat mining, additional roof support was provided by two Fletcher MRS units in conjunction with wooden posts. The retreat mining sequence being used at the accident site was to mine the pillars in the 4 outside entries before mining and completing the row of pillars (closing out) in the middle entry of each pillar row. This retreat mining practice increased the amount of stress on the middle entry pillar where the accident occurred.

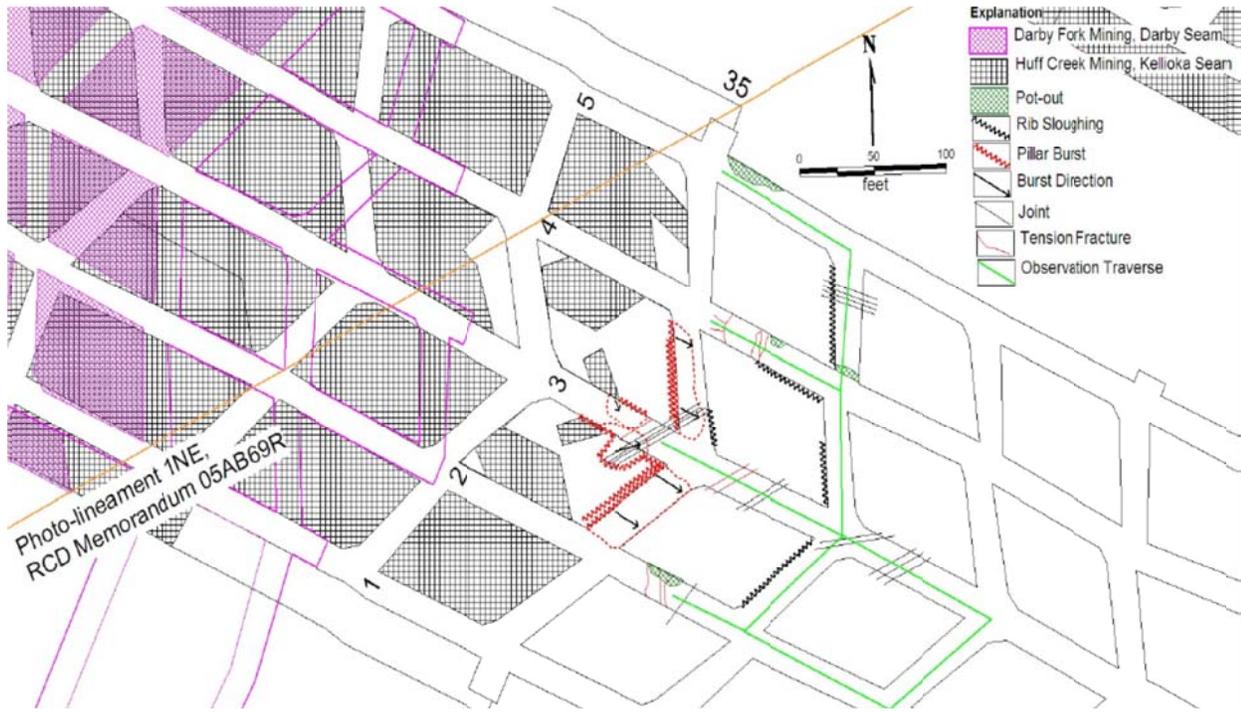
GEOLOGY MAP SKETCH

A prominent joint zone runs through the left-hand pillar and the outby left corner of the right-hand pillar involved in the burst (See the Geology Map Sketch in Appendix E). Blocks of rock and coal were ejected from the left-hand pillar to a depth of approximately 12 feet and 5 feet wide along this zone. However, the right-hand pillar involved only coal, creating a 7-foot-deep void into the right-hand pillar remnant, with fist-sized pieces of coal littering the floor of crosscut #35 between the #3 and #4 entries and extending 14 feet from the burst pillar. Although the effect of the joint zone cannot be determined, it may have dismembered the roof and allowed a weight shift onto the pillar remnants on the inby edge of the joint zone.
