REPORT OF INVESTIGATION

Fatal Machinery Accident
August 16, 2013

Black Thunder Mine
Thunder Basin Coal Company LLP
Wright, Campbell County, Wyoming
ID No. 48-00977

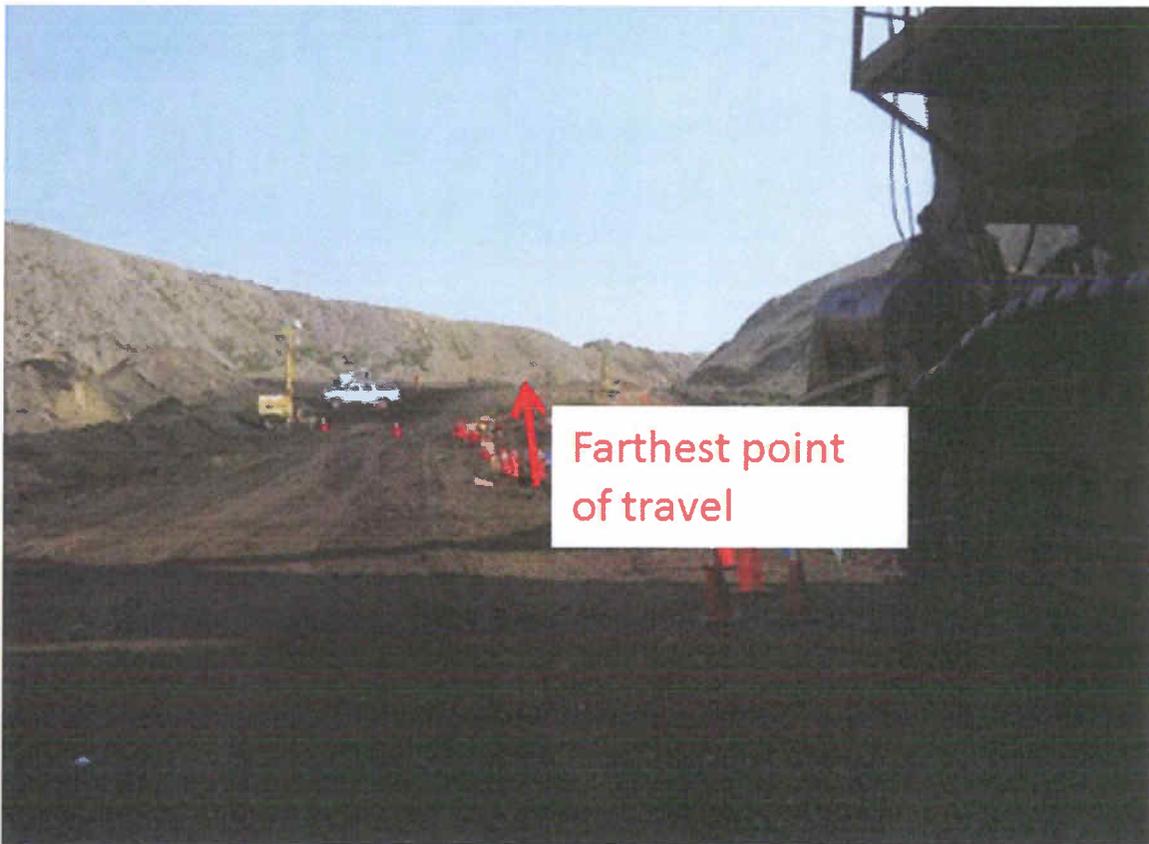
Photograph 1: View from shovel, up the 4 West Ramp to furthest point of travel

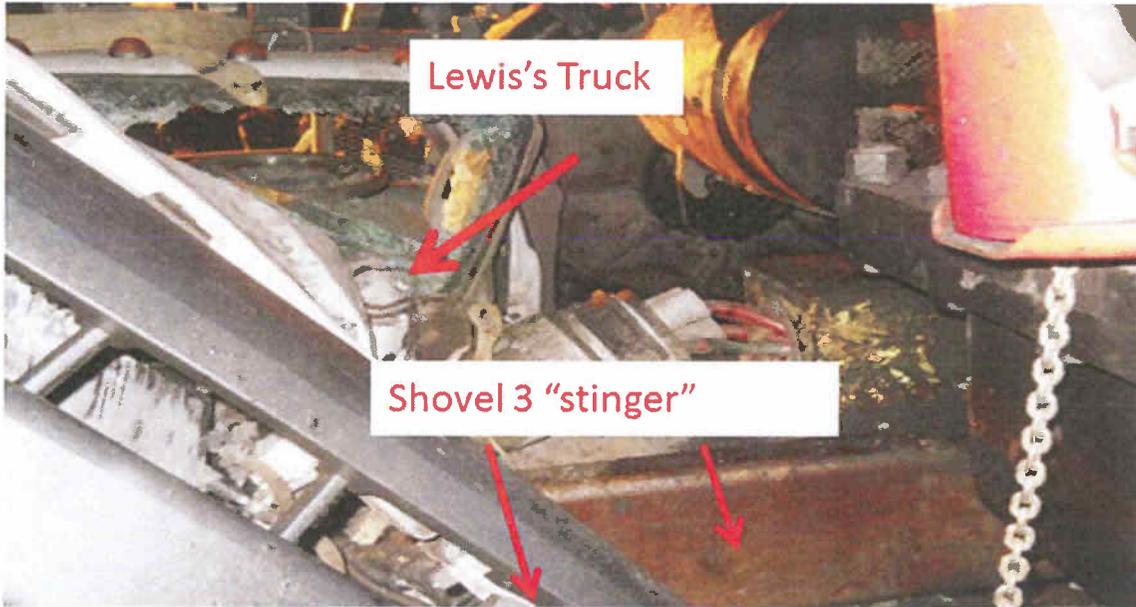
The shovel's right track contacted Dowdy's truck, crushing the truck. The shovel then contacted Lewis's truck impaling the truck on the "stinger," just behind the left front wheel of the truck (see Appendix A photograph 2). The stinger is a protective support where the trailing cable is attached to the shovel. Lewis was pinned inside his truck by the dash where he remained until he was extricated and taken to the local hospital. Dowdy received fatal injuries after the shovel crushed his truck.

Photograph 2, Lewis' Truck

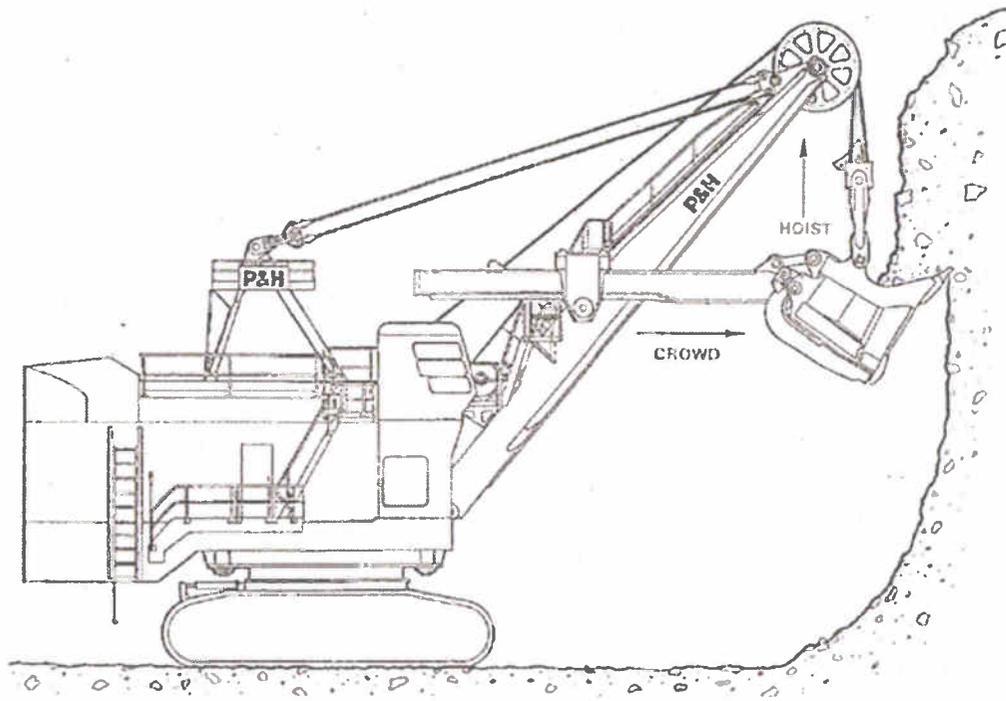
The machine involved in the accident was an electric P&H 2800 MKII shovel that weighed approximately 1.5 million pounds (750 tons). In the position shown in Appendix A, Figure A; the shovel is 55 feet high, 96 feet long and 34 feet wide. The maximum forward uphill safe operating grade limit, according to the manufacturer, is 15 percent.

Figure A, P&H 2800MKII Shovel

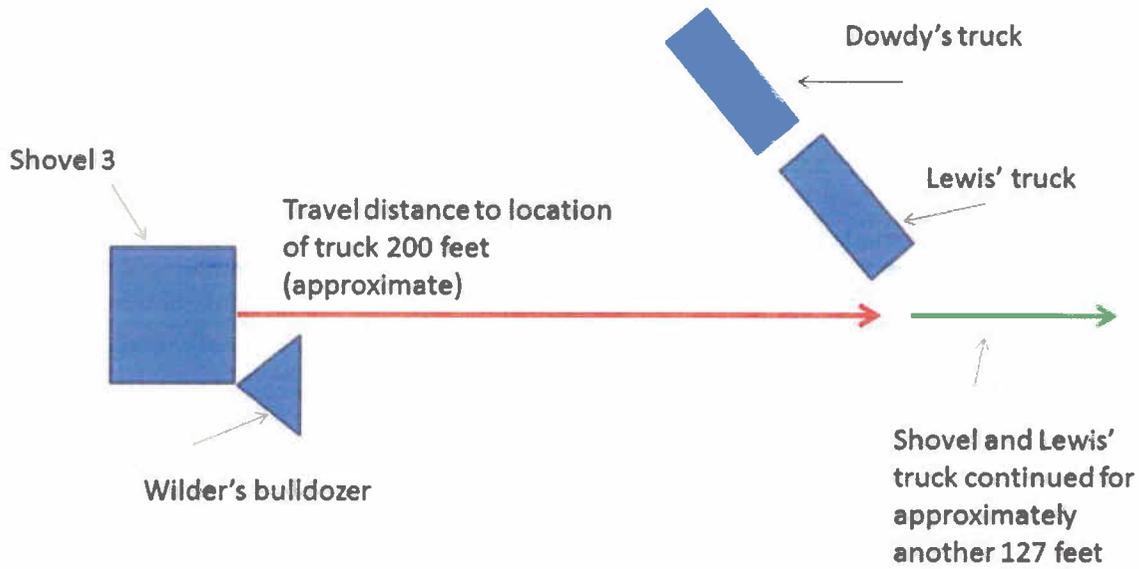
Figure B, Location of Equipment involved in Accident

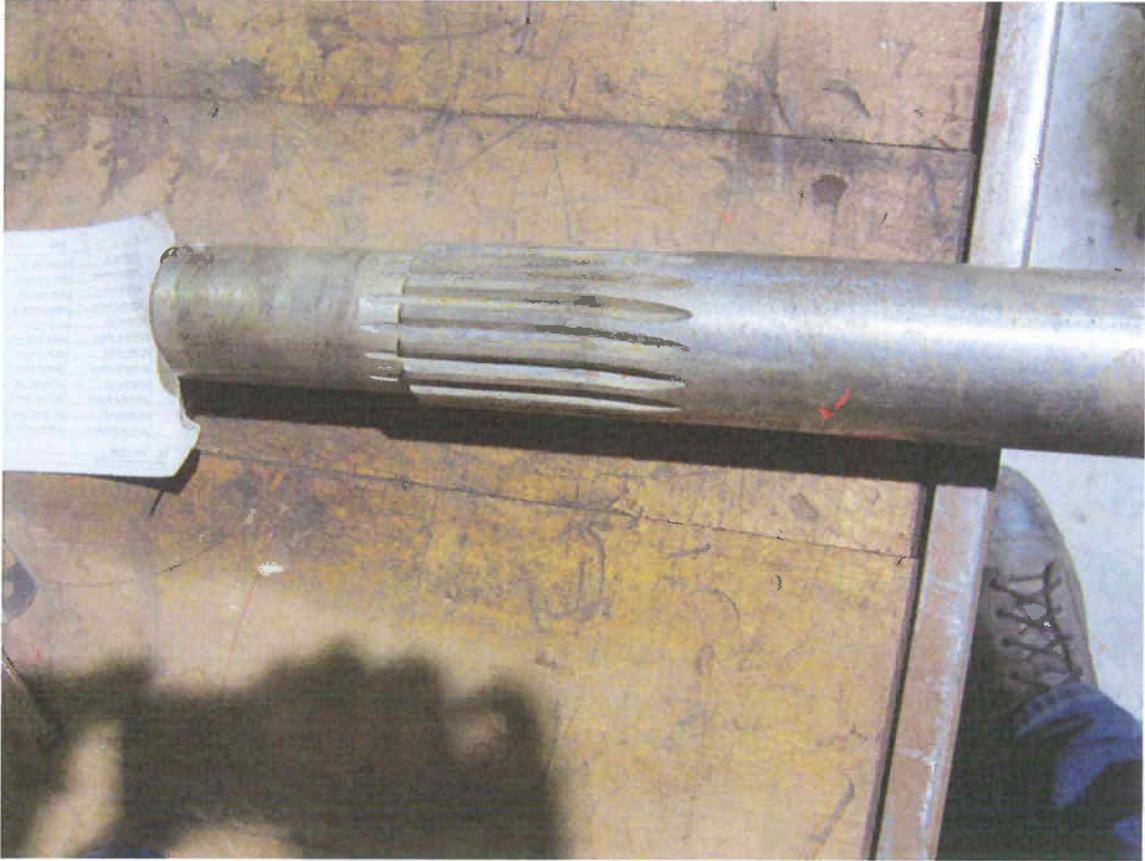
- a. The left side steering pin was visibly twisted (see Appendix A, Photograph 3). This twisting was not visible until the pin was removed from the machine. Prior to removing the steering pin for inspection, the linkage in this area appeared to be out of adjustment. Specifically, the left side air cylinder was found almost fully retracted, yet the left side steering jaw was found completely disengaged. The left side steering jaw should have been engaged instead of disengaged when the air cylinder is retracted. The right side steering pin was also inspected and no visible twisting was found.

A small amount of twisting in the 2¼ inch diameter steering pin caused a much larger displacement at the end of the shifter lever (17 5/8 inches) and interlock lever (27¼ inches) that operate the engagement and disengagement of the steering jaws.

Photograph 3, Twisted Left Side Steering Pin

Corrective Action: On the shovel involved in the accident, the mine operator replaced all components of the steering mechanism. Also, the propel brakes were replaced due to damage during the accident.

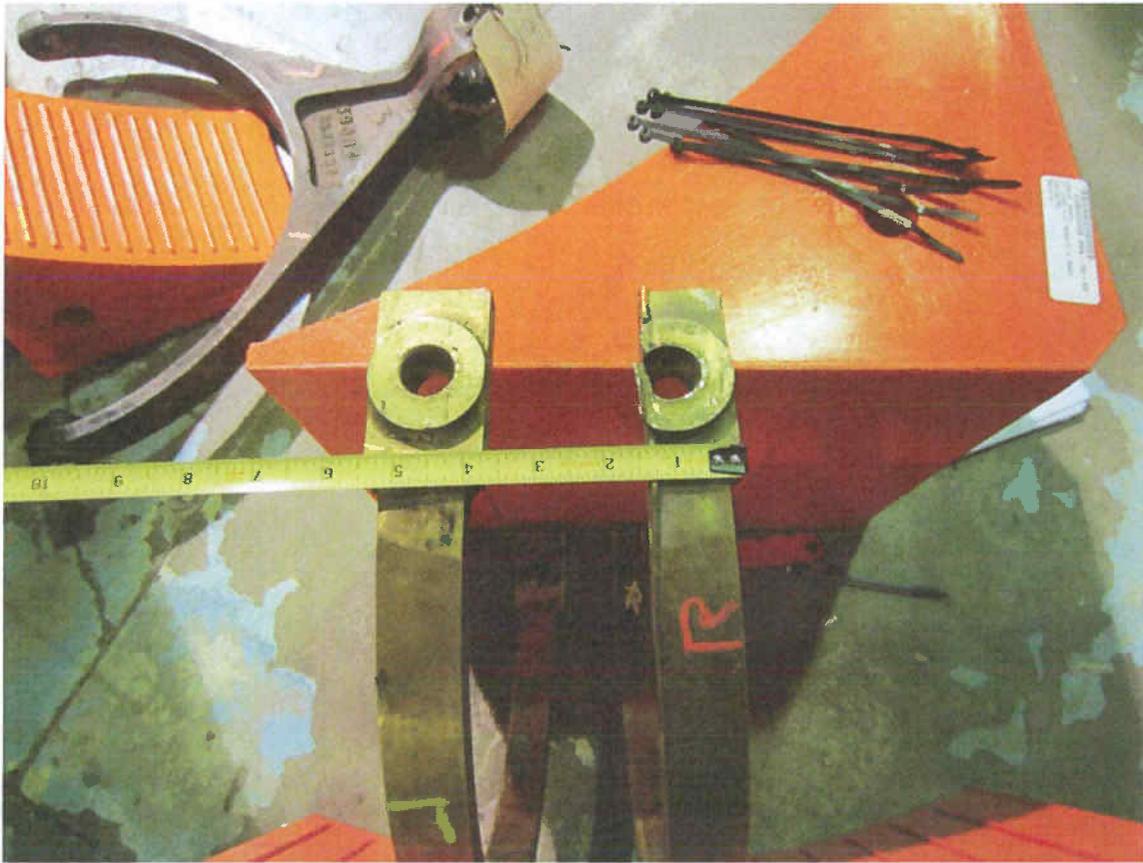
- b. The right side shifter lever and right side shifter yoke were worn (see Appendix A, Photograph 4). The left side shifter lever was worn and the yoke was relatively new and not worn.

Photograph 4, Comparison of Left (L) and Right (R) Side Shifter Yokes
