REPORT OF INVESTIGATION

Underground coal mine

Fatal Machinery Accident
October 04, 2013

McElroy Mine
McElroy Coal Company
Moundsville, Marshall County, WV
I.D. No. 46-01437

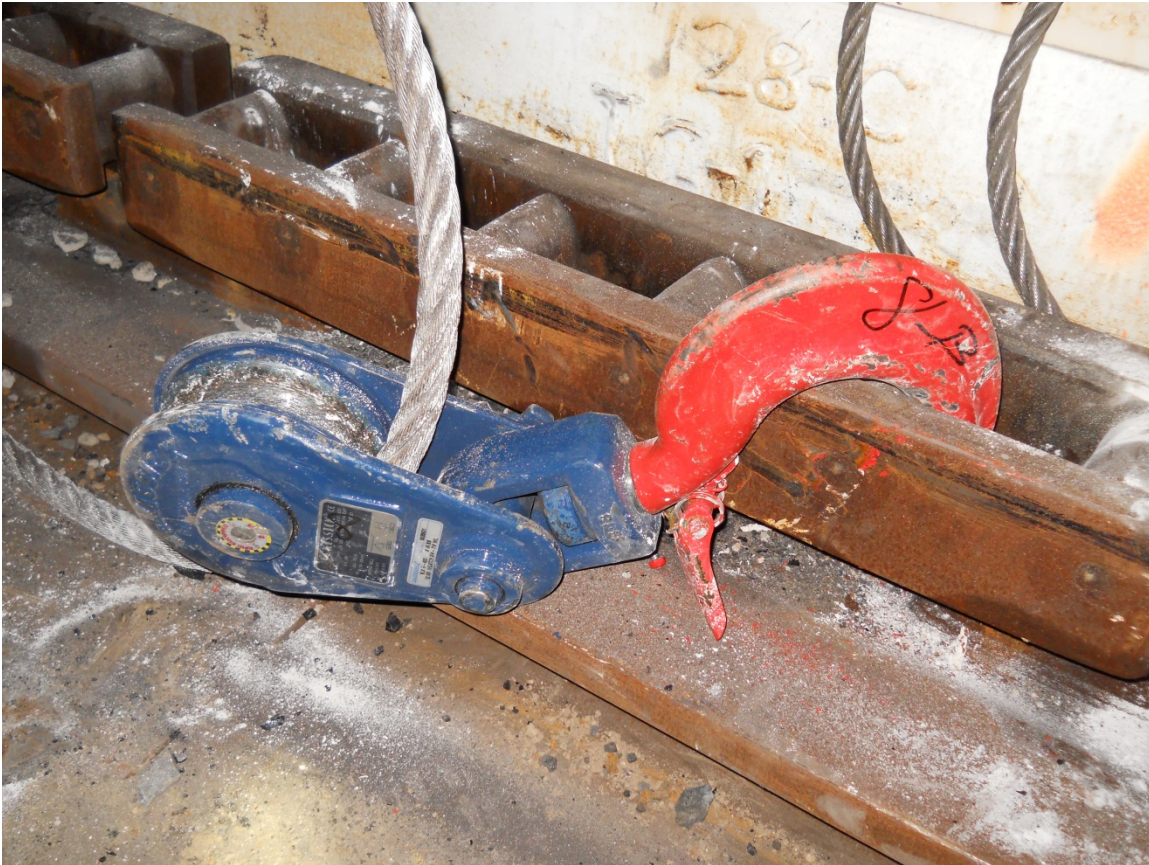
PHOTOGRAPH OF RACK BAR, SNATCH BLOCK, AND WIRE ROPE

The accident investigation revealed the snatch block was being used with a 1-inch diameter wire rope, which exceeded the manufacturers' recommendations. An informational label was on the unit showing the correct rope size to be used. The hook was elongated sideways and stretched open. When compared to a new unit, the opening had increased by 2.44 inches. The latch was also damaged from force being applied while pulling the chain in an odd alignment as the conveyor was fouled.

Longwall Associates, Inc. manufactured the panline. The extended longwall face required 245 sections of panline (5.75 feet each) to cover the length of the face. The panline sections have rack bars with openings measuring 2.7 inches wide and 3.6 inches deep mounted on the inside of the spill board. The rack bar, also known the Eiko track, located on the face side of the panline sections, is used as a track for the gears of the longwall shearer to run back and forth along the face. The hook of the snatch block was connected directly to one of these openings. A possible location where the chain may have been fouled was found at the connection of pans 230-231, where a possible incompatible joint section existed. These sections of pan are noticeably different in color, and the conveyor chain was found to be pulling sideways at this location. This difference could have been attributed to the connection point of the snatch block, since the rigging would not permit the chain to be pulled in a straight line.

Paint marks observed on the rack bar indicated the snatch block was directly attached to the panline structure. The size of the openings and the beveled edges of the rack bar, in conjunction with the large hook of the snatch block, did not permit the components to fit properly and created a system likely to fail. For safety protection, a normally accepted means of attachment is to use a hi-tensile rated chain through the opening of the rack bar and to connect the hook to the chain. There were no chains observed at the accident site.

Corrective Action: The mine operator developed a corrective action plan to address the adequacy of connection points. The action plan requires the anchor point to be near the centerline of the “pull” activity taking place and utilize a fully enclosed hook with a clevis. All affected miners were trained in the procedures.

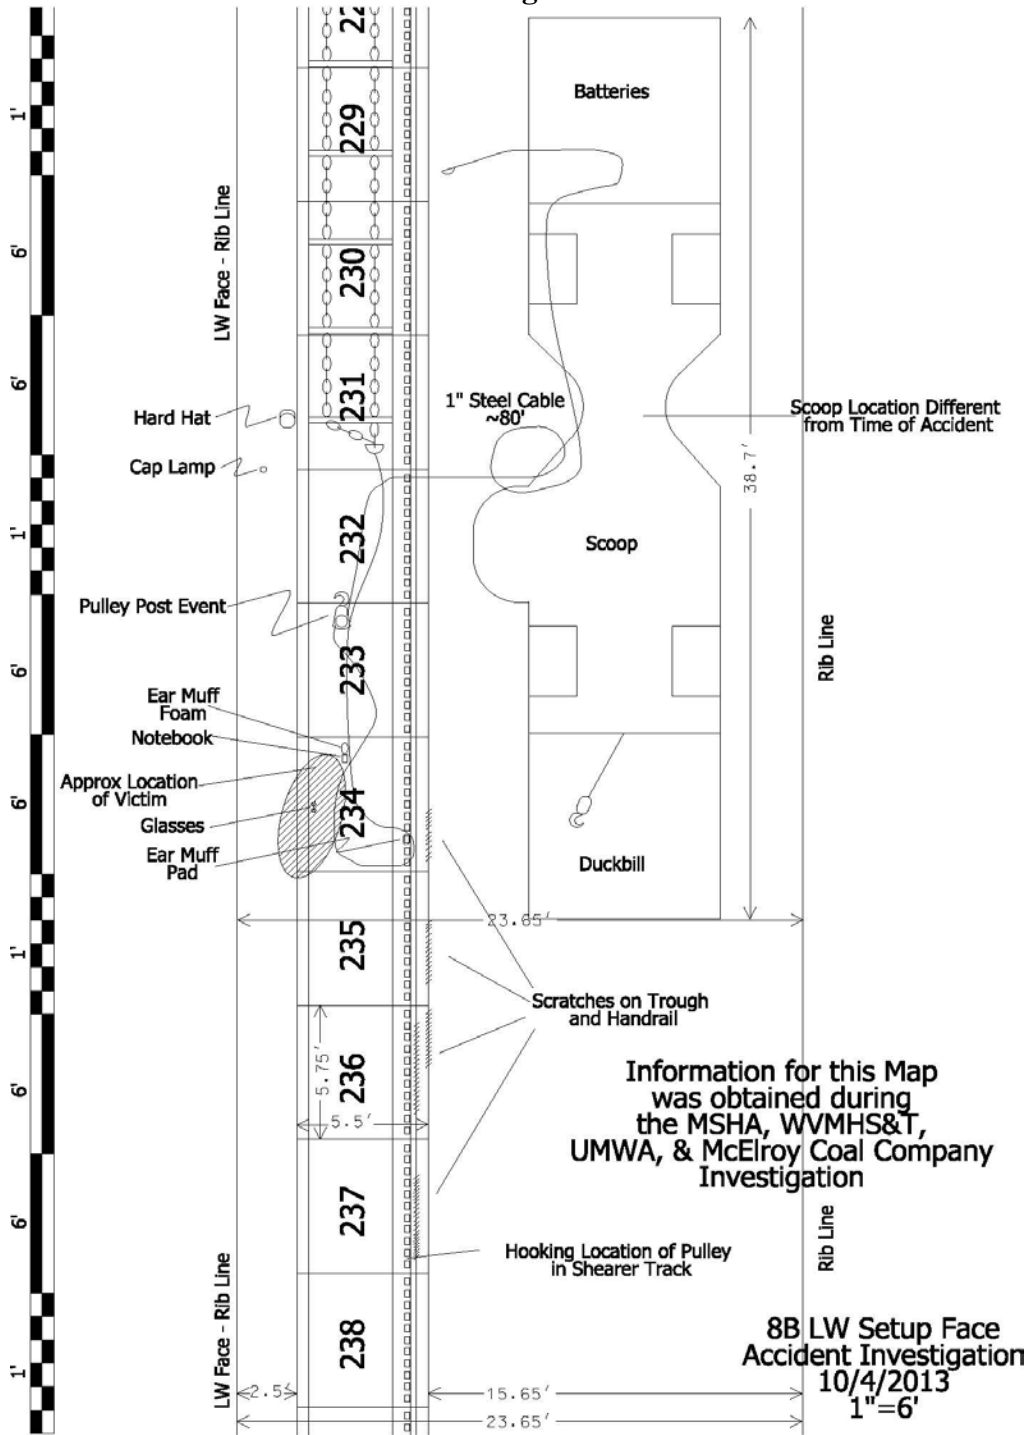
APPENDIX D - Drawing of the Accident Scene

The accident occurred at approximately 12:49 p.m. on the 8-B longwall setup face at pan 234, approximately 63 feet from the tailgate end of the face. Development of this section had been completed and the mine operator was in the process of installing longwall machine components for future mining. This panel, a right hand face, was to mine coal between the 8-B head gate section and the 8-A tailgate section. The panel has a width of 1,400 feet and is the first extended width panel in this area of the mine.

The panline was somewhat bowed out towards the longwall shields, but the bowing was not excessive. A dip in floor elevation was also found near the location of the accident. Both the alignment and change in elevation could have added some resistance in pulling the conveyor chain, but this was not established during the investigation or verified during the reenactment. Burn marks were present near the snatch block attachment location on one of the pans. The cable riding over the pan under tension while pulling the chain caused the burn marks.

Corrective Action: The mine operator revised its written policies and procedures to require all persons be located away from an object being pulled at least 1.5 times the distance of the working rope, chain, or sling as assurance to remain clear. The miners were trained regarding this requirement.
