REPORT OF INVESTIGATION

Fatal Powered Haulage Accident
October 11, 2013

Prosperity Mine
Five Star Mining Inc.
Petersburg, Pike County, Indiana
ID No. 12-02249

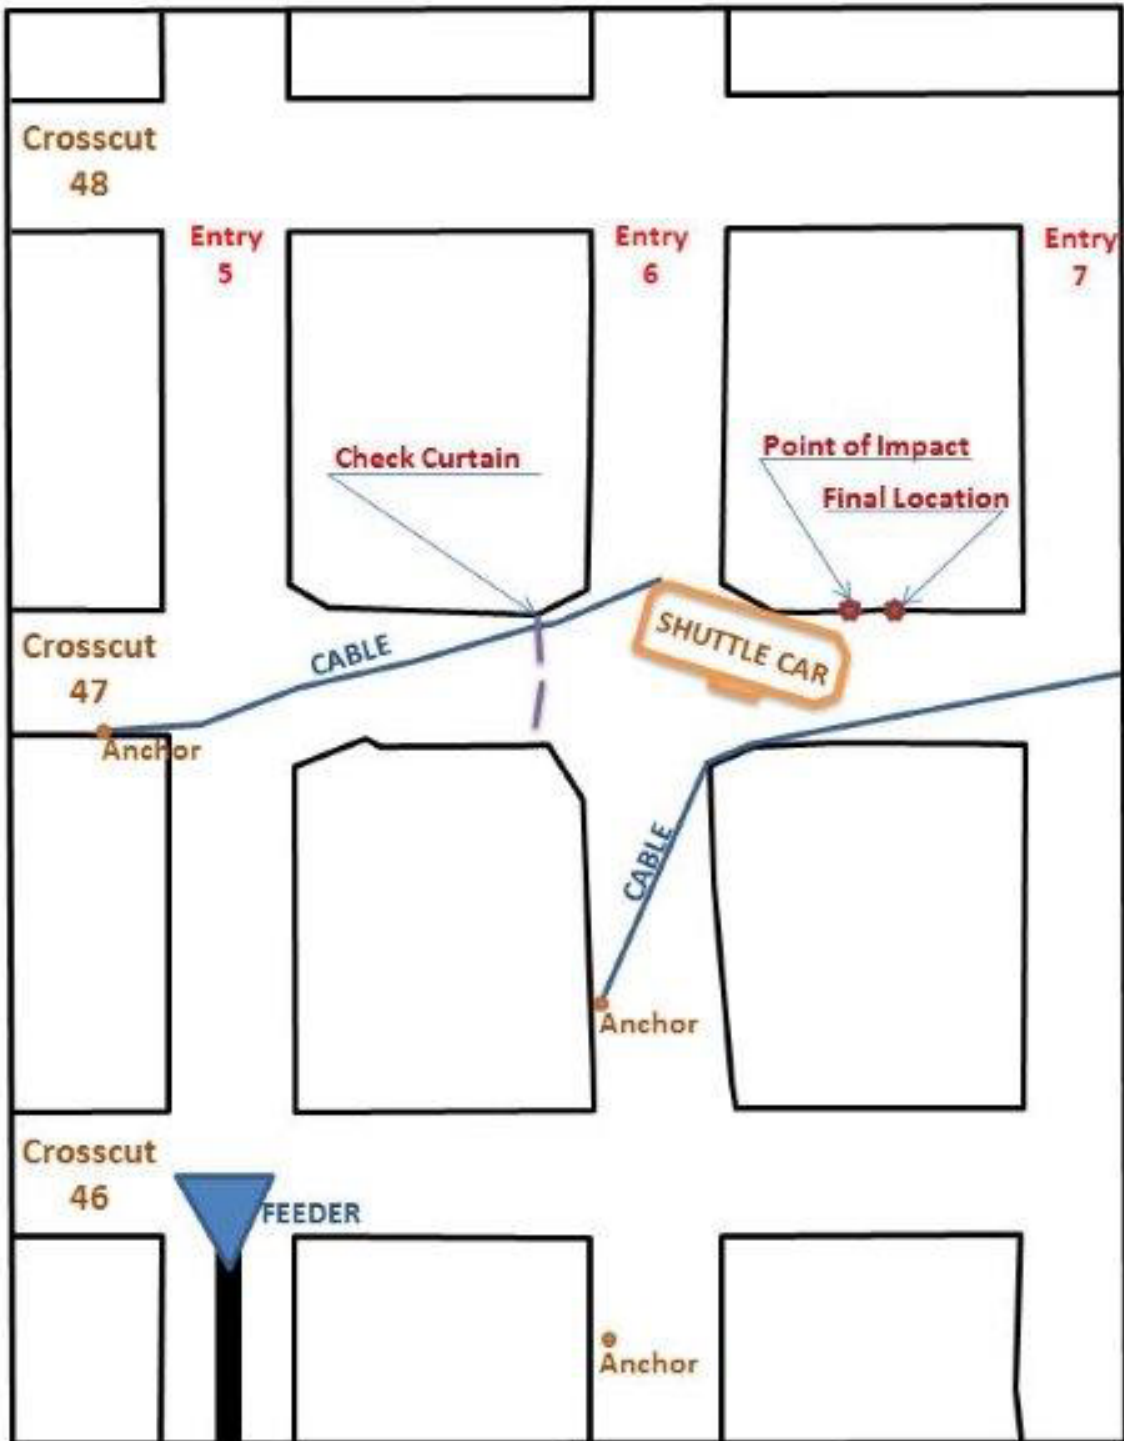
APPENDIX A - Map of Accident Scene

The accident site is located at crosscut 47, between entries 6 and 7, of the 5E panel off the Main West 2 entries.

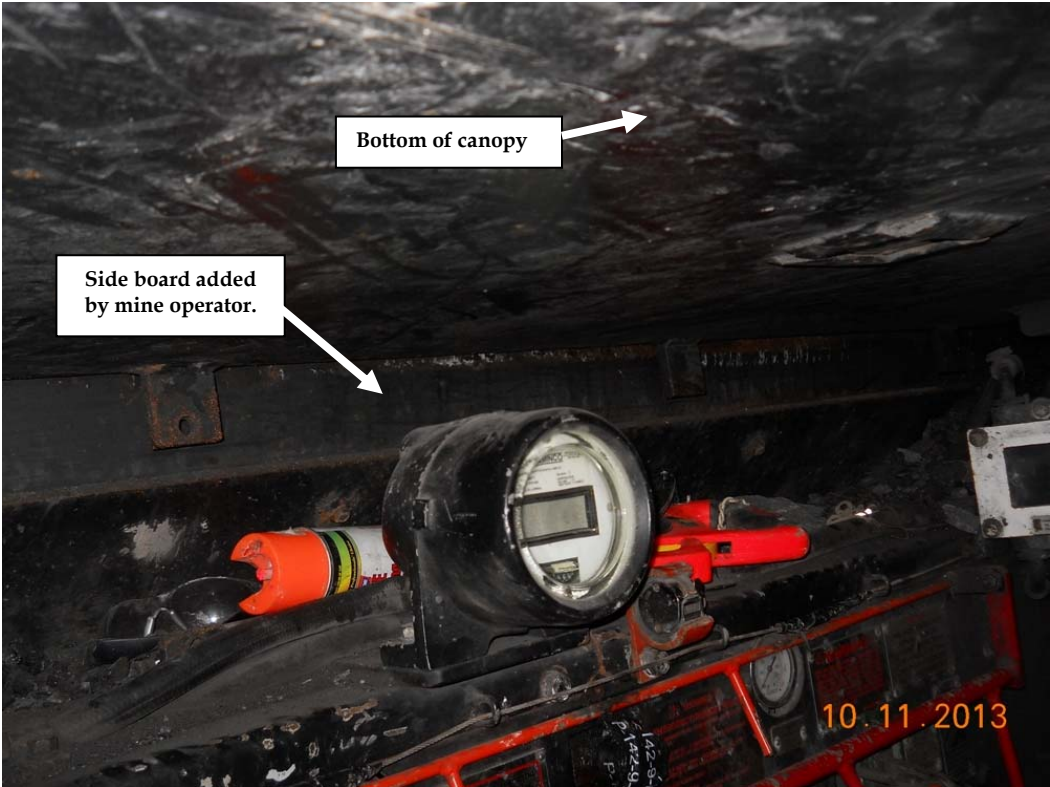
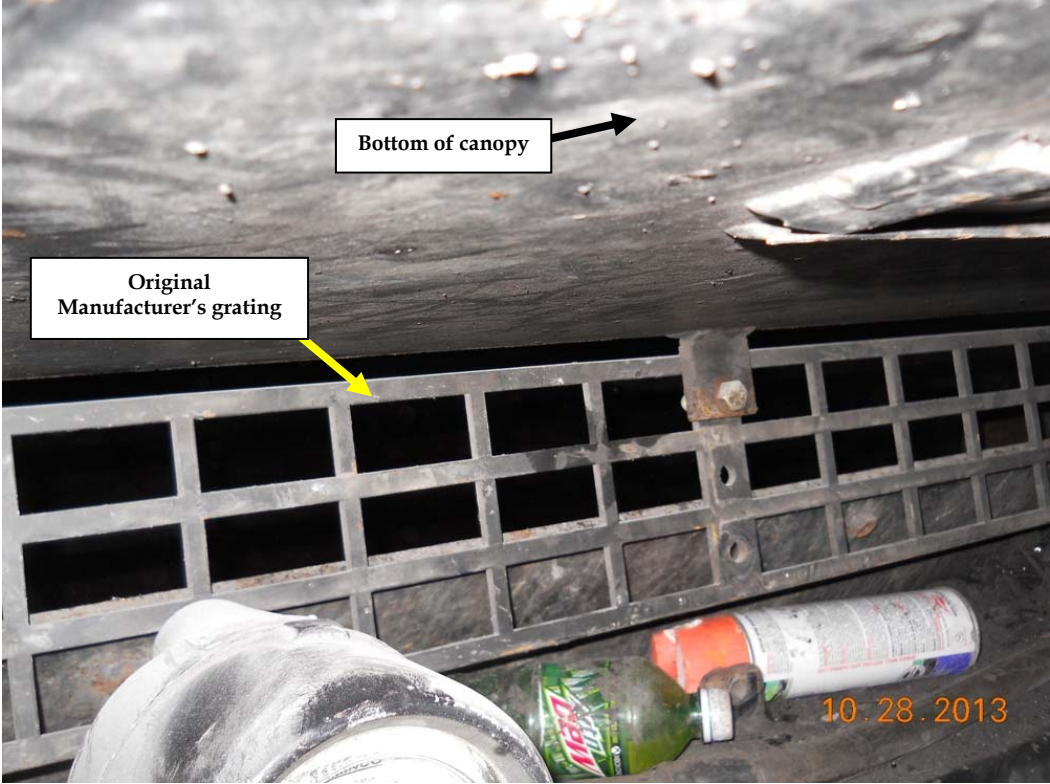
APPENDIX D - Photographs

The shuttle car is typically loaded with a load of coal to within 3 to 4 inches of the mine roof. The mining height is approximately 60 to 68 inches. The shuttle car was originally equipped with bar grating positioned in the sideboard at the operator's compartment, which allowed an approximately 3-inch by 75-inch window of visibility into the conveyor area and the offside of the shuttle car

(Appendix D). The operator's compartment had been altered in the following manner: The bar grating had been removed and replaced with solid metal sideboard extensions to prevent coal from spilling into the operator's compartment. This completely closed the 3-inch by 75-inch window. Accordingly, testing showed that a person standing at the load end of the empty shuttle car, where the victim was struck, was not visible to the operator.

Root cause: Mine management did not maintain shuttle cars to provide maximum visibility of the offside. Sideboards were added to the conveyor of the shuttle cars to increase production. This limited the visibility of shuttle car operators.

Corrective action: Safeguard No. 8448775 was issued to require all sideboard extensions to be removed and the original factory grating re-installed between the operator's cab and conveyor.
