REPORT OF INVESTIGATION

Underground Coal Mine

Fatal Powered Haulage Accident
January 16, 2014

Mountain View Mine
Mettiki Coal WV, LLC
Davis, Tucker County, West Virginia
I.D. No. 46-09028

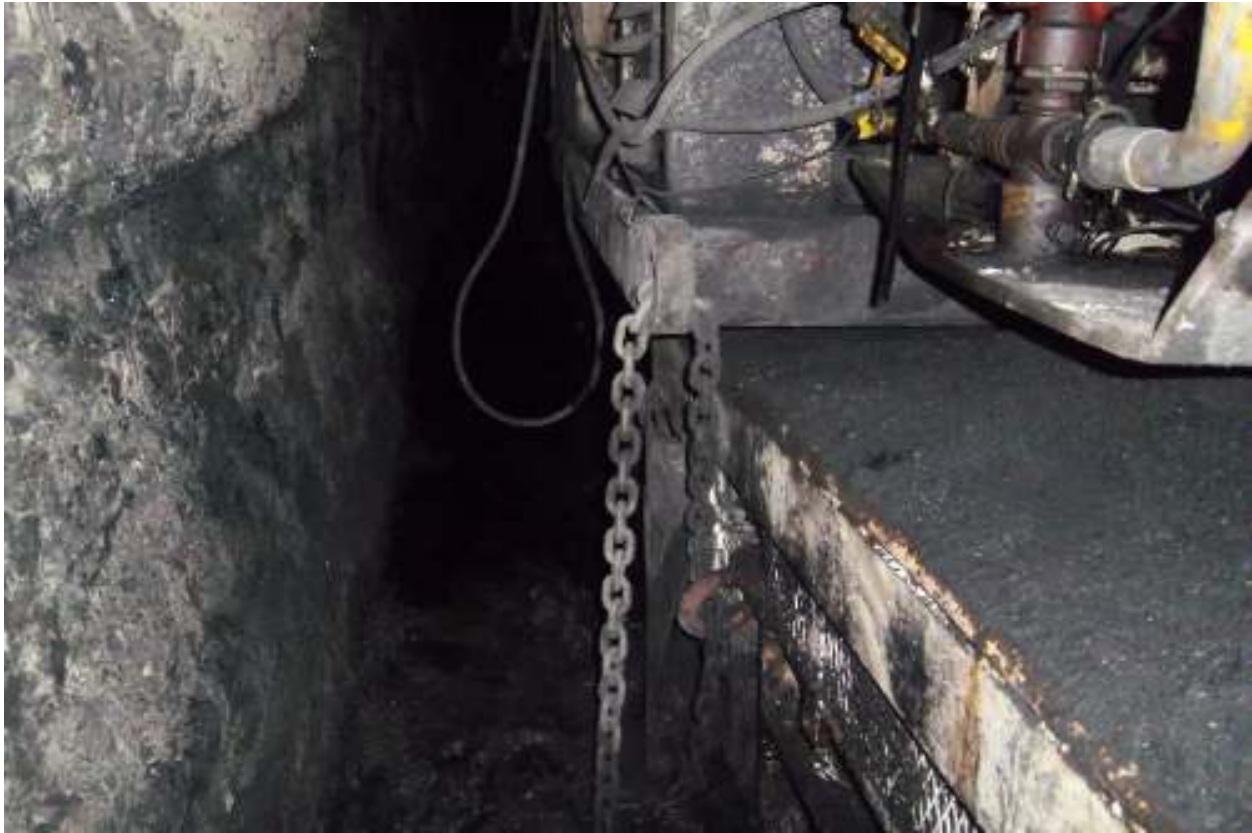
Photograph of Accident Scene

On Thursday, January 16, 2014, Daniel Lambka (victim), a 20-year-old general inside laborer, was struck by a coal feeder, resulting in fatal injuries. Lambka was on the off side of the belt conveyor, tightening a chain which connected the feeder to the section tailpiece. The tailpiece anchor, located between the rib and the tailpiece, came loose from the rib, allowing the tailpiece to shift, pinning Lambka between the frame of the feeder and the rib.

The mine operator uses five-inch by seven-inch wooden posts to anchor the tailpiece to the rib. Wooden posts are generally reused unless damaged. The physical inspection of the accident scene revealed the notch for the anchor post on the solid side rib was 5 to 6 inches deep by 10 inches high. The anchor post measured 73 inches in length and was secured to the rib with wooden cap wedges. Company procedures do not specify a minimum distance in which the anchor posts for the feeder must extend into the rib.
