REPORT OF INVESTIGATION

Fatal Machinery Accident
February 21, 2014

Mine No. 30
Dominion Coal Corporation
Jewell Ridge, Buchanan County, Virginia
ID No. 44-06748

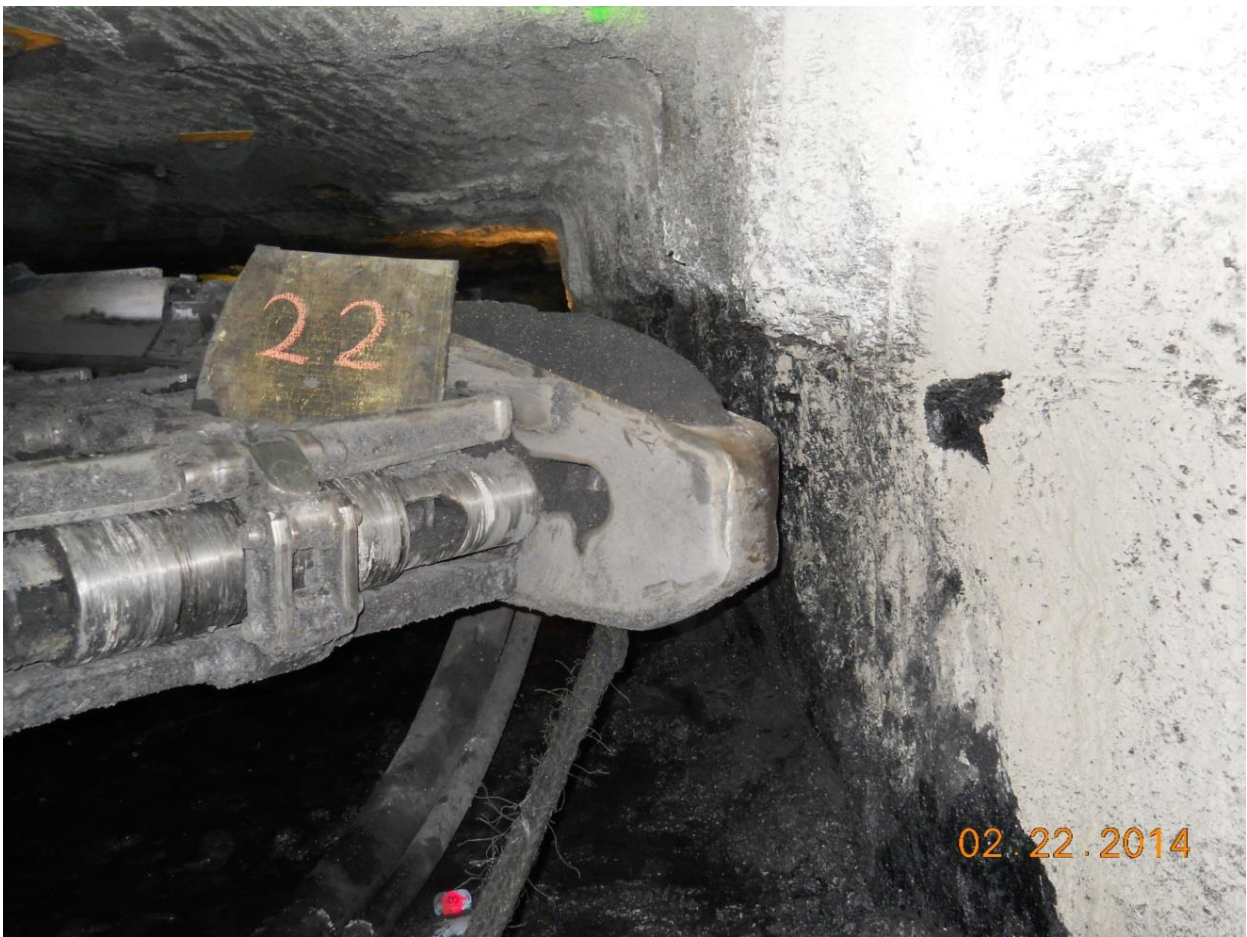
Photo No. 1 - Victim Location

At approximately 3:37 p.m., on Friday, February 21, 2014, Arthur D. Gelentser III, age 24, a continuous mining machine operator with 5.5 years of mining experience was fatally injured. The victim was pinned between the boom of a remotely controlled continuous mining machine and the coal rib.

The victim was located in a pinch point created by the machine and the coal rib while tramming the continuous mining machine. The root cause of the accident was a failure to comply with provisions of the approved roof control plan that prohibited anyone from being positioned between the continuous mining machine and the coal rib when tramming from place to place.

Keen went to the continuous mining machine and discovered Gelentser pinned between the back end of the boom of the machine and the inby coal rib of the crosscut. The boom was found in its far right position. The boom hit him mid-torso with his back to the rib. Gelentser was kneeling on his right knee; the left knee was caught by the boom and pushed to his chest. His arms were down; the left arm was against the front of his body. He was unresponsive and appeared purplish-black. The remote control unit was pinned between Gelentser's right knee and the bottom of the boom. The continuous mining machine was energized but the pump motor was not running.

Corrective Action: An Action Plan was submitted on March 7, 2014, to MSHA by the mine operator. The provisions of the plan are summarized as follows: Retraining on the topics of Red Zone, pinch points and entrapment awareness was conducted for underground employees. A proximity detection system was installed and operational on the continuous mining machine used on the H section (003 MMU) on March 15, 2014. By March 22, 2014, the continuous mining machine used on the A section also had a proximity detection system. Before the proximity detection systems were installed, the mine operator required a spotter be present to assist with the tramming of the continuous mining machine.

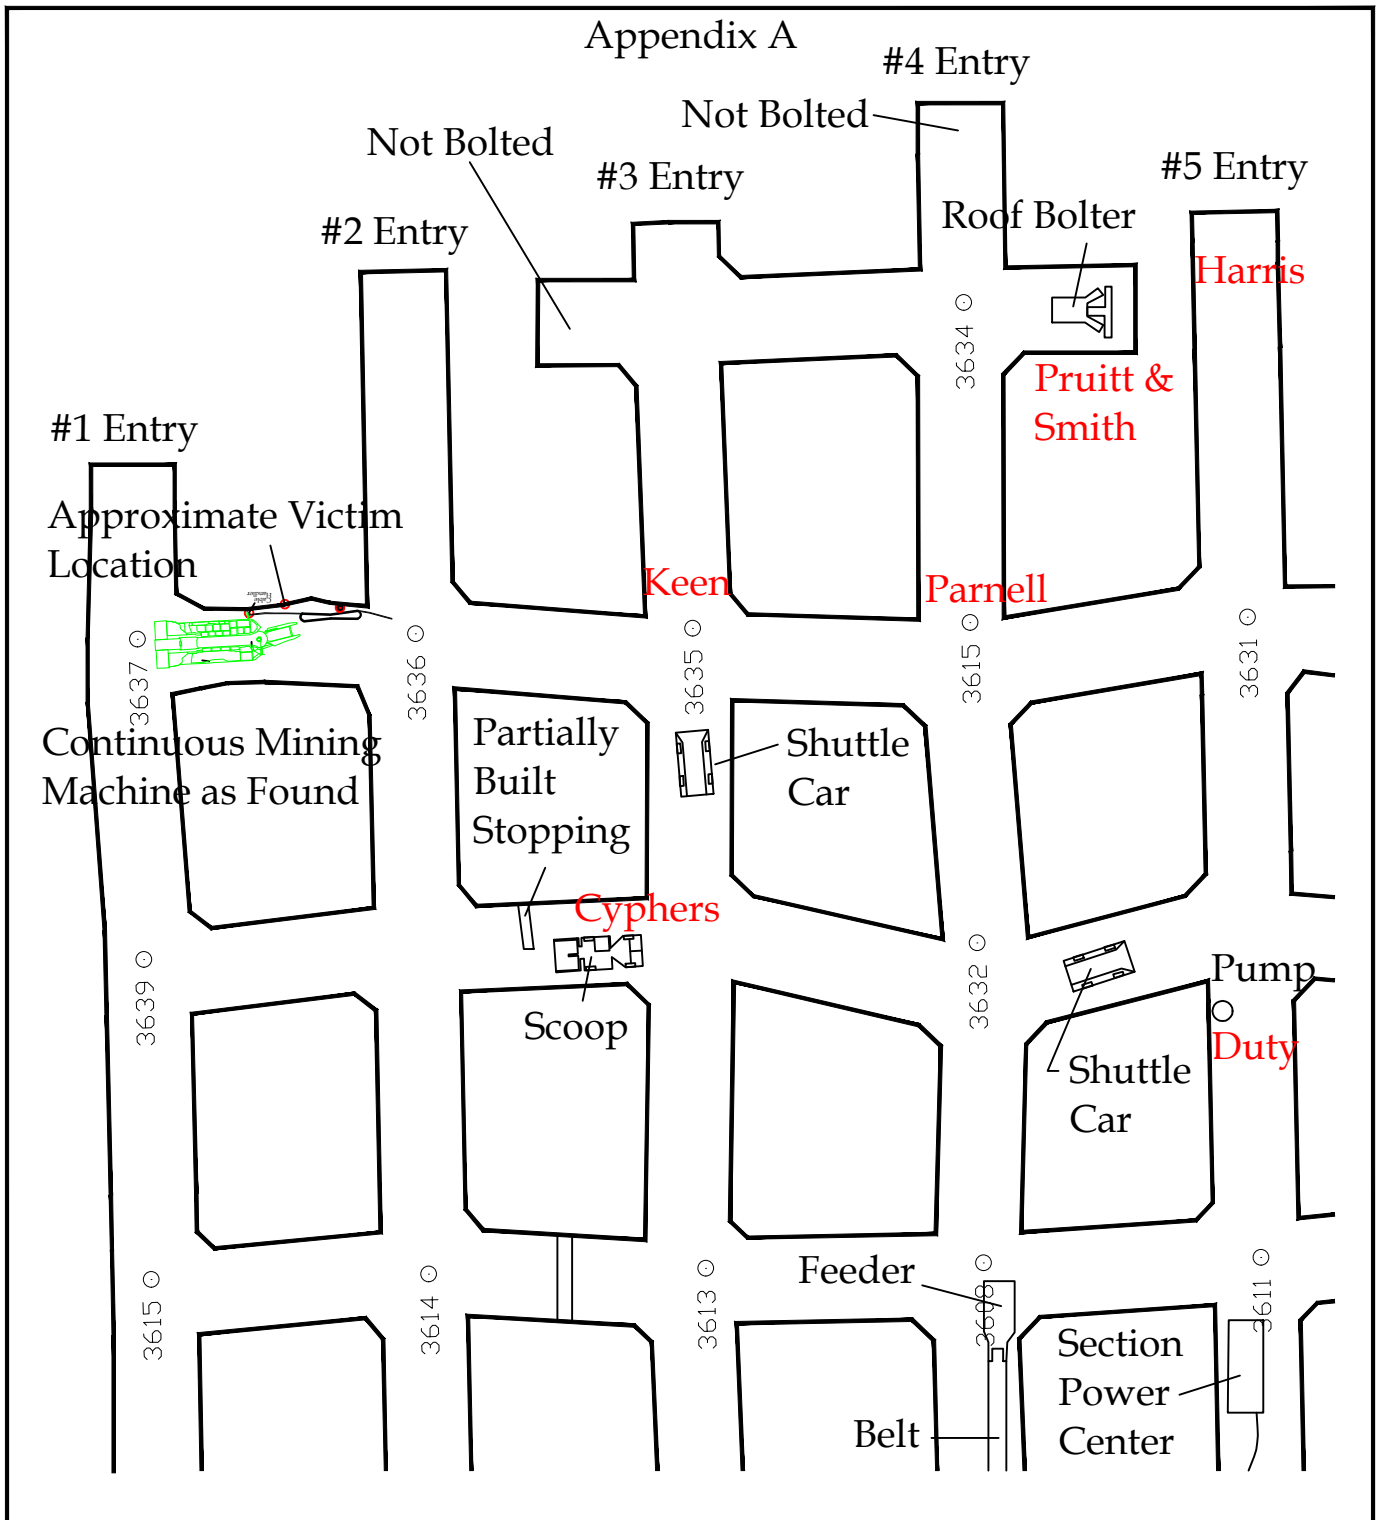
Appendix A

James Parnell, Shuttle Car Operator, assisted Gelentser by hanging curtain in the #1 entry while Gelentser was tramping to that location. Parnell went to the #3 entry where Jeffery Keen, Shuttle Car Operator, was waiting. Parnell stated that Gelentser dropped a loop of cable off the machine at the #4 and #3 entries. The last loop, cut slack, was still attached to the hook on the boom of the machine. He also stated Gelentser trammed the continuous mining machine past the #3 entry while duck walking behind the machine. Gelentser told Parnell to go to the #4 entry to keep the cable against the inby rib. He trammed the machine 2.5 crosscuts from the #4 entry to a location between entries #1 and #2 (see Appendix A).

The accident occurred in the crosscut between the #1 and #2 entries near spad number 3636 on the advancing H section of Sub Main B-003-0 MMU. The section consisted of 7 entries. Entries #5 and #6 provided intake air to ventilate the section. The section used split air ventilation with return air in entries #1, #2 and #7.

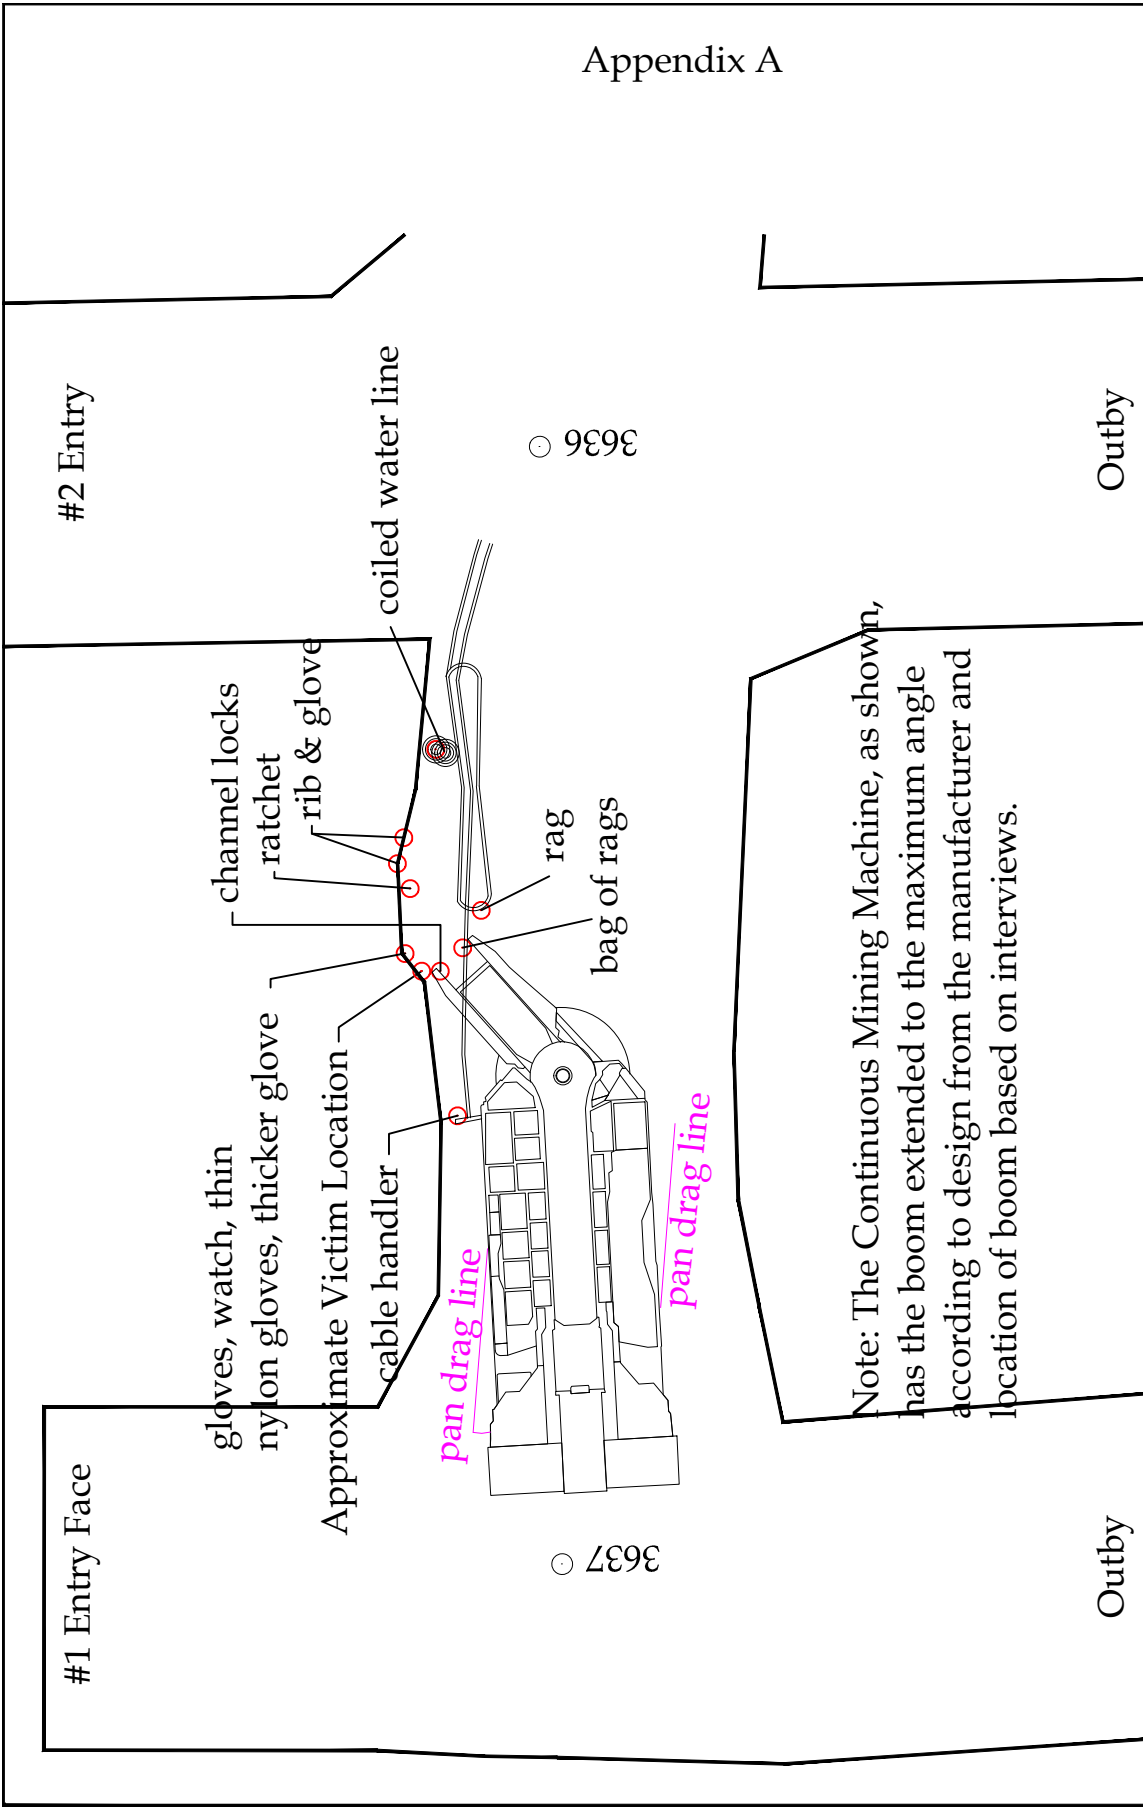
Appendix A

The last time the Tram On was cleared it was due to lost data communication between the continuous mining machine and the remote control unit. This also caused the pump motor to turn off. The tracks made by the continuous mining machine revealed that it was turning or pivoting toward the left. This action caused the back of the machine to move toward the right and pin Gelentser.
