UNITED STATES
DEPARTMENT OF LABOR
MINE SAFETY AND HEALTH ADMINISTRATION

REPORT OF INVESTIGATION

Machinery
May 14, 2014

MC #1 Mine
M-Class Mining, LLC
Macedonia, Franklin County, Illinois
I.D. No. 11-03189

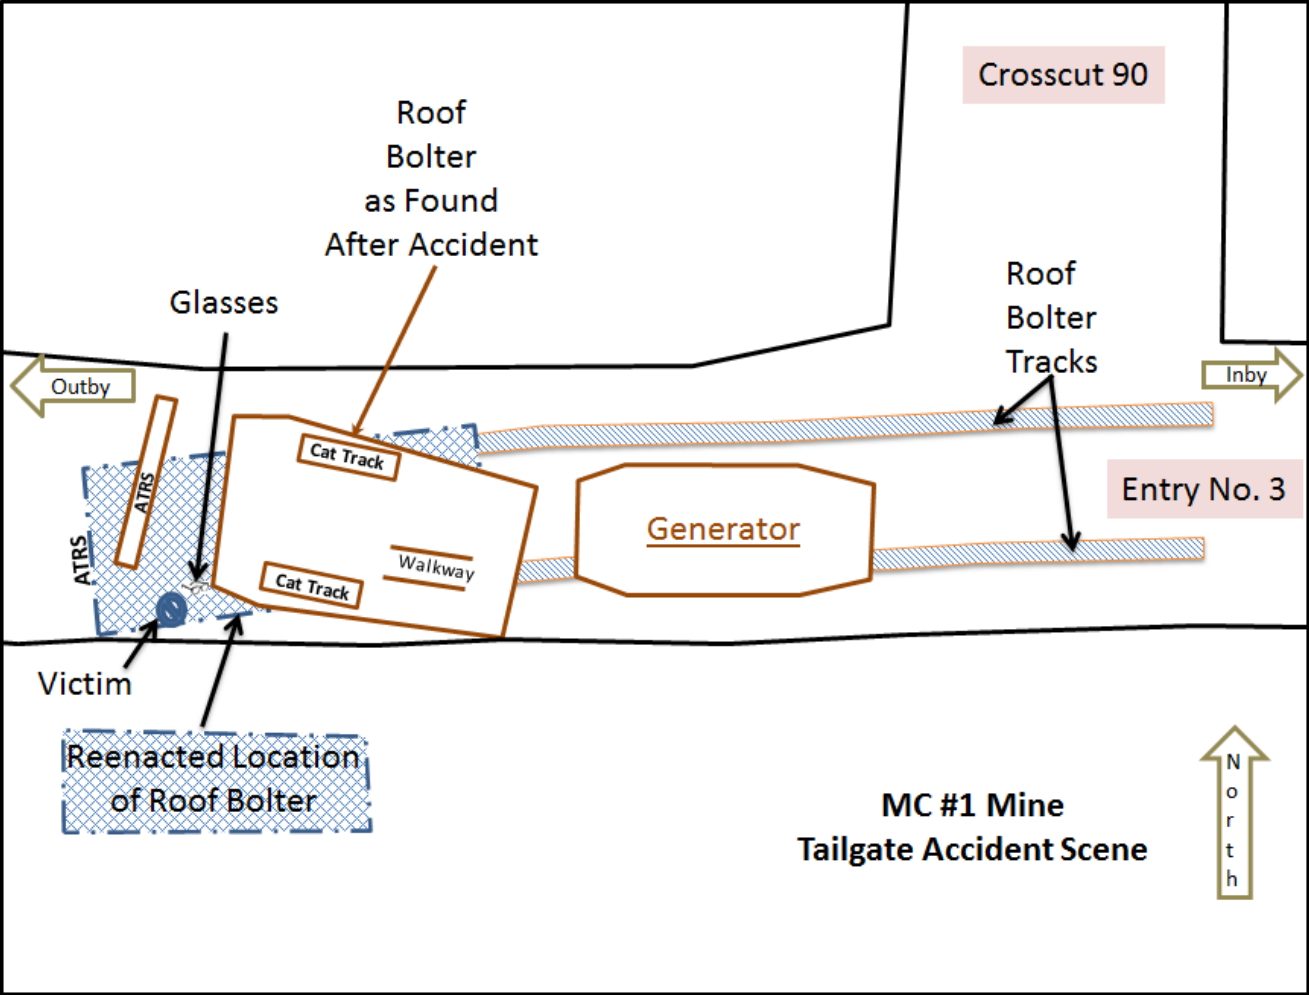
Drawing of Accident Scene

Sometime after 2:00 p.m., Payne positioned himself in front (outby) of the roof bolting machine. At 2:15 p.m. near No. 89 crosscut, Fuller saw Payne walking in front of the roof bolting machine and then lost sight of him. Fuller immediately stopped the roof bolting machine and backed up. After backing up the roof bolting machine a short distance, Fuller again saw a light in front of the roof bolting machine. He immediately dismounted off the rear of the machine. Fuller walked around the right side and front of the roof bolting machine, then to the left side, where he found Payne lying on the mine floor between the rib and the automated temporary roof support (ATRS) structure. Payne was found with his head pointing inby and his legs pointing outby. See Appendix A for a drawing of the accident scene.

Initially, the No. 87 crosscut was reported as the accident location, which was determined to be inaccurate. The accident occurred in the No. 3 entry of the Viking TG 1 air courses between No. 89 and No. 90 crosscuts. When investigators arrived at the accident scene, Payne had been removed from the mine and transported to the Franklin County Hospital. The roof bolting machine and the "white" diesel generator involved in the accident were positioned on the south side of the entry. The front end of the roof bolting machine was pointing outby with the generator hooked to the rear bumper of the roof bolting machine, utilizing a tow bar and chain arrangement. The trailing cable for the roof bolting machine was plugged into the generator. The excess trailing cable, which could not be stored on the cable reel, was coiled in the center walkway of the roof bolting machine.

On May 15, 2014, the roof bolting machine was moved to reposition it to the original cat track impression at the accident location. This was done to check for alignment between the marks on the south rib and the structure of the roof bolting machine. The ATRS structure on the roof bolting machine aligned with the marks on the rib.
