COAL MINE SAFETY AND HEALTH  
REPORT OF INVESTIGATION

Surface Coal Mine  
Fatal Machinery Accident  
June 04, 2014

Rogers Construction Inc. (S843)  
Whitewood, South Dakota

North Antelope Rochelle Mine  
Peabody Powder River Mining LLC  
Wright, Campbell County, Wyoming  
ID No. 48-01353

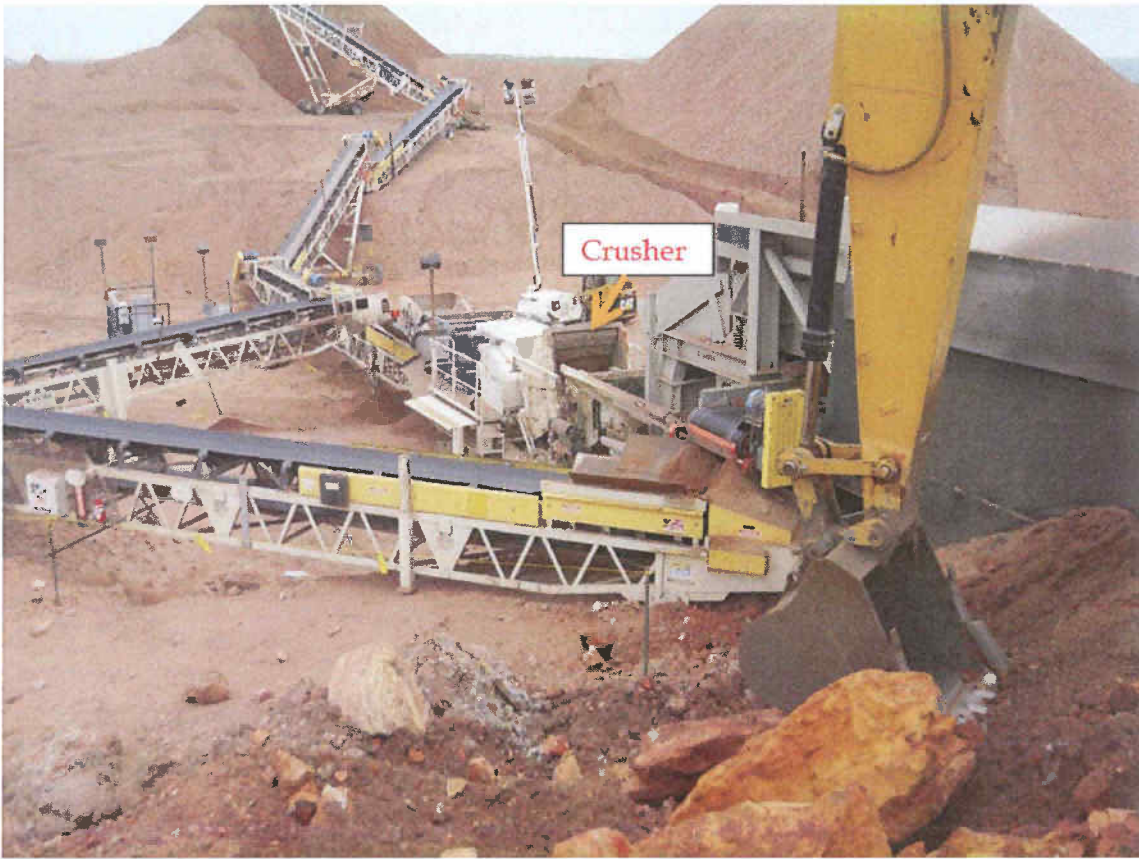
Photograph 1: Scoria Pit Overview

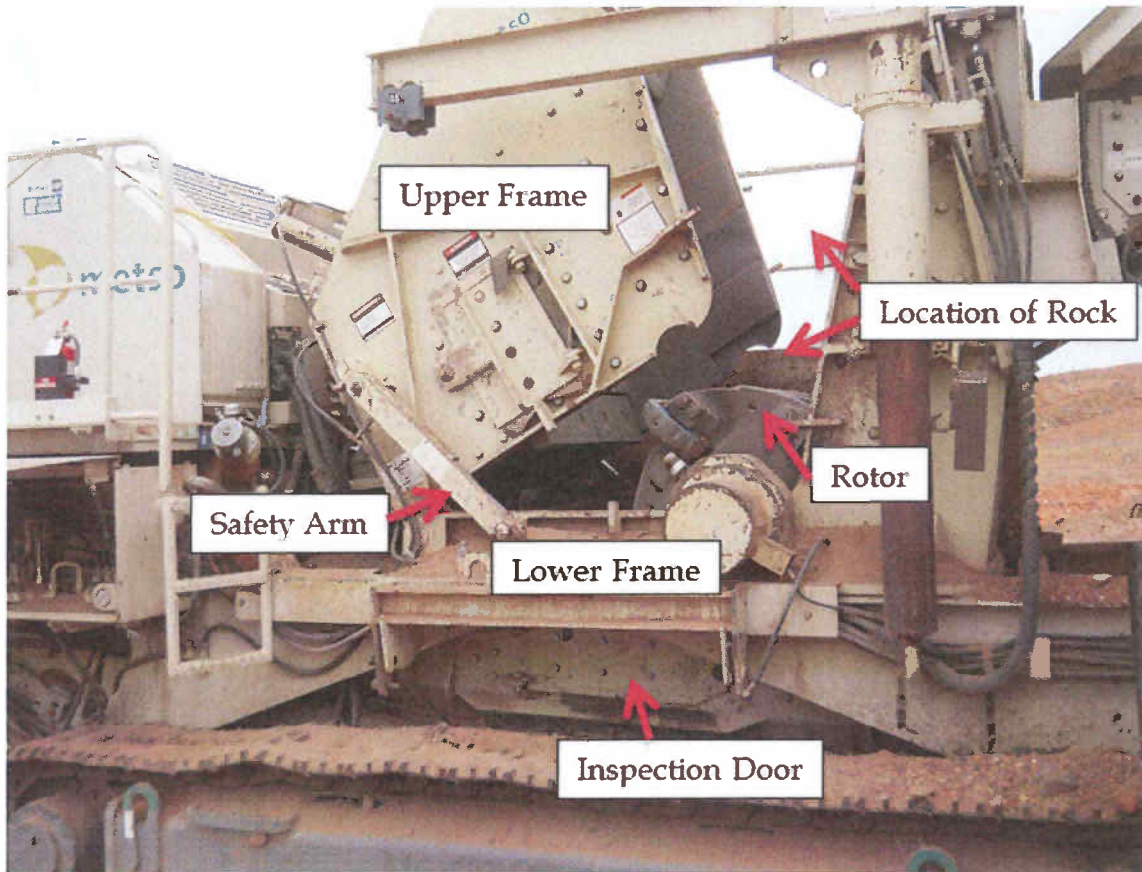
At approximately 5:35 a.m. on June 4, 2014, Joshua L. Wishard was fatally injured when he was crushed between the upper and lower frame of an impact crusher. Wishard and Chris Wells, Supervisor, were feeding raw scoria (volcanic rock with tiny holes) into the crusher unit (see Appendix A, Photo 2) when a large rock became lodged in the crusher feeder. Wells and Wishard used an excavator to remove the rock from the crusher. Wells then moved the Caterpillar 330 excavator to the fuel island to be refueled. Wishard started the motor of the crushing unit and raised the upper frame off the safety arm (removing the blocking mechanism) then positioned his body under the raised upper frame. The unblocked upper frame lowered and fatally crushed Wishard. There were no witnesses to the accident.

Photograph 2: Crushing Unit, Upper Frame In Raised Position

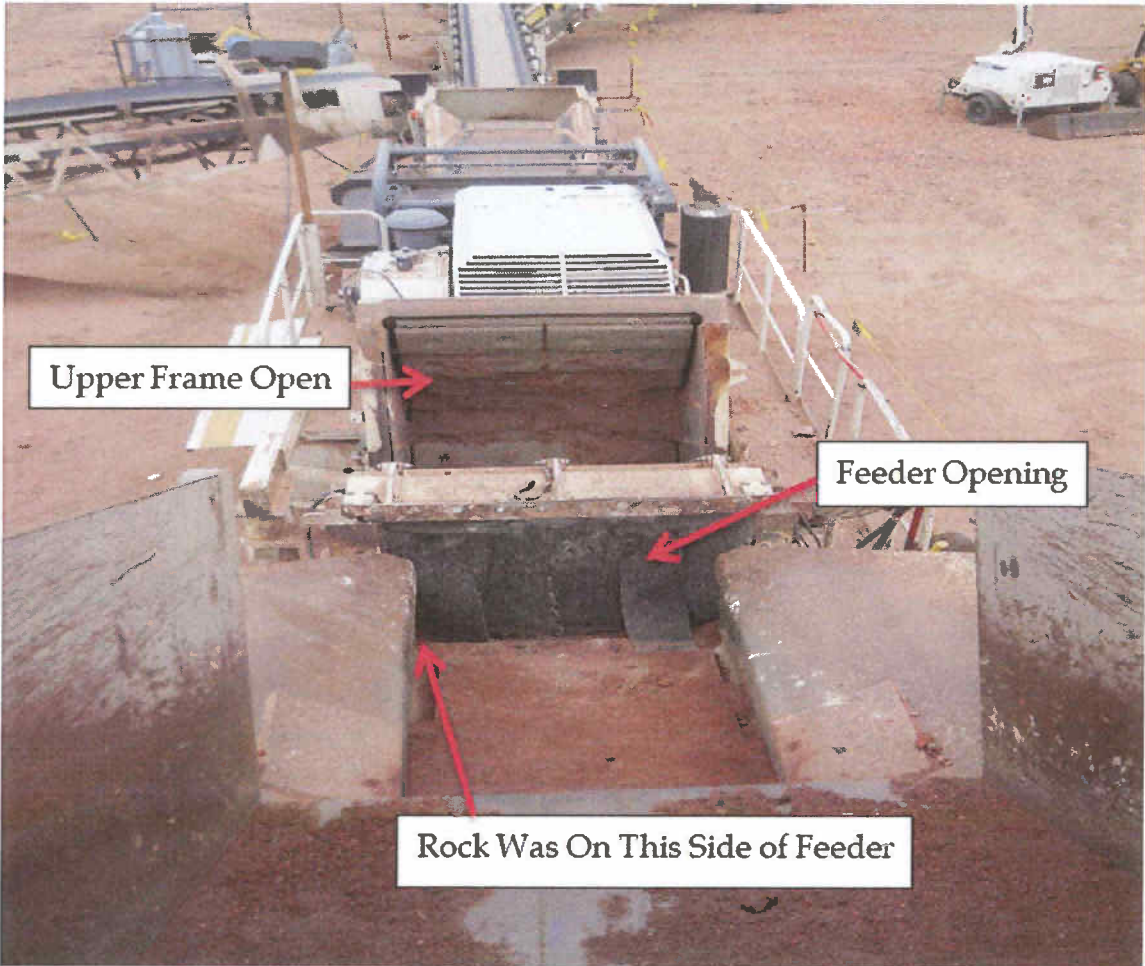
At approximately 4:30 a.m., on June 4, 2014, Wells noticed a large scoria rock, 38" x 36" x 25" lodged in the feeder (see Appendix A, Photo 3). Wells processed the raw material through the system to clear the crusher and belt conveyors in preparation to remove the large rock. Wells shut the system down in sequence and locked out and tagged the electrical power to the machine. Wells then positioned the Caterpillar 330 excavator on the right side of the crusher and put the bucket of the excavator in the feeder so Wishard could attach the metal chokers and nylon straps/slings in the first attempt to remove the rock from the feeder (see Appendix A, Photo 4). During the first attempt, the rock slipped out of the rigging through the feeder opening into the crusher hopper.

Photograph 3: Feeder

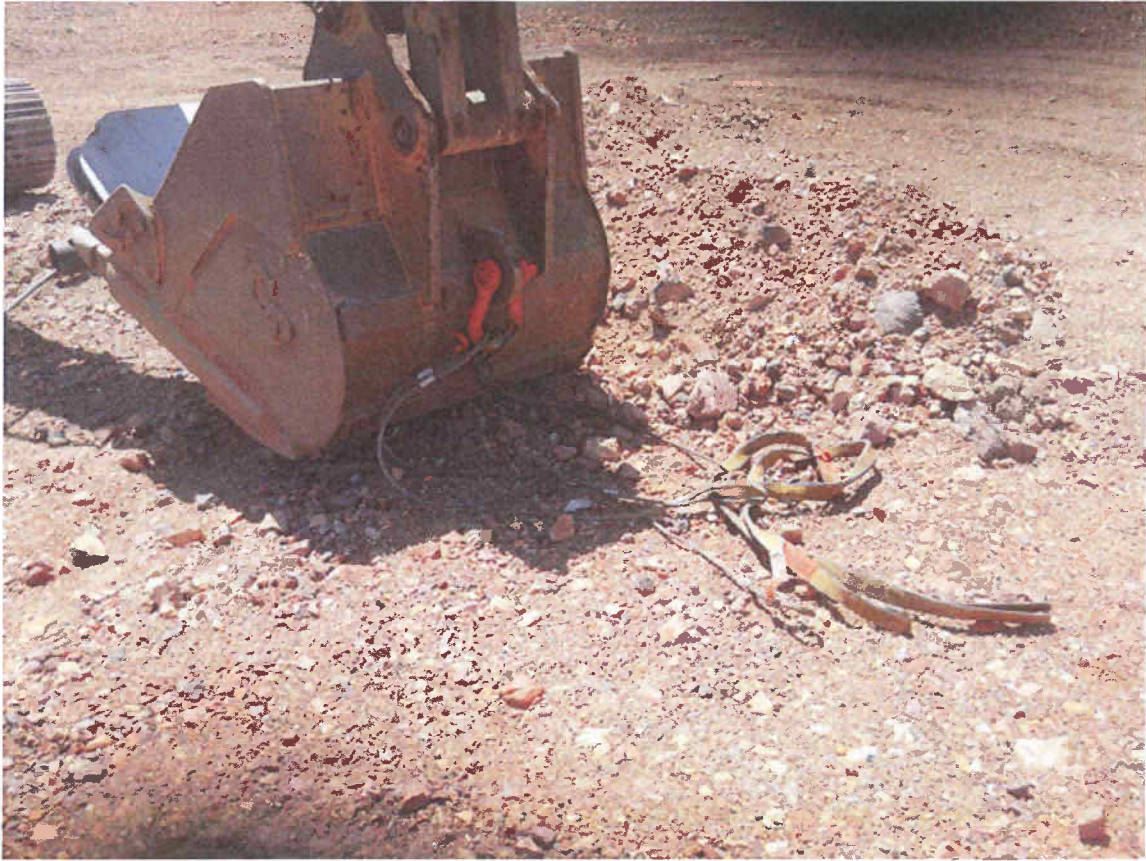
Photograph 4: Straps and Excavator Used To Make a Basket to Remove Rock

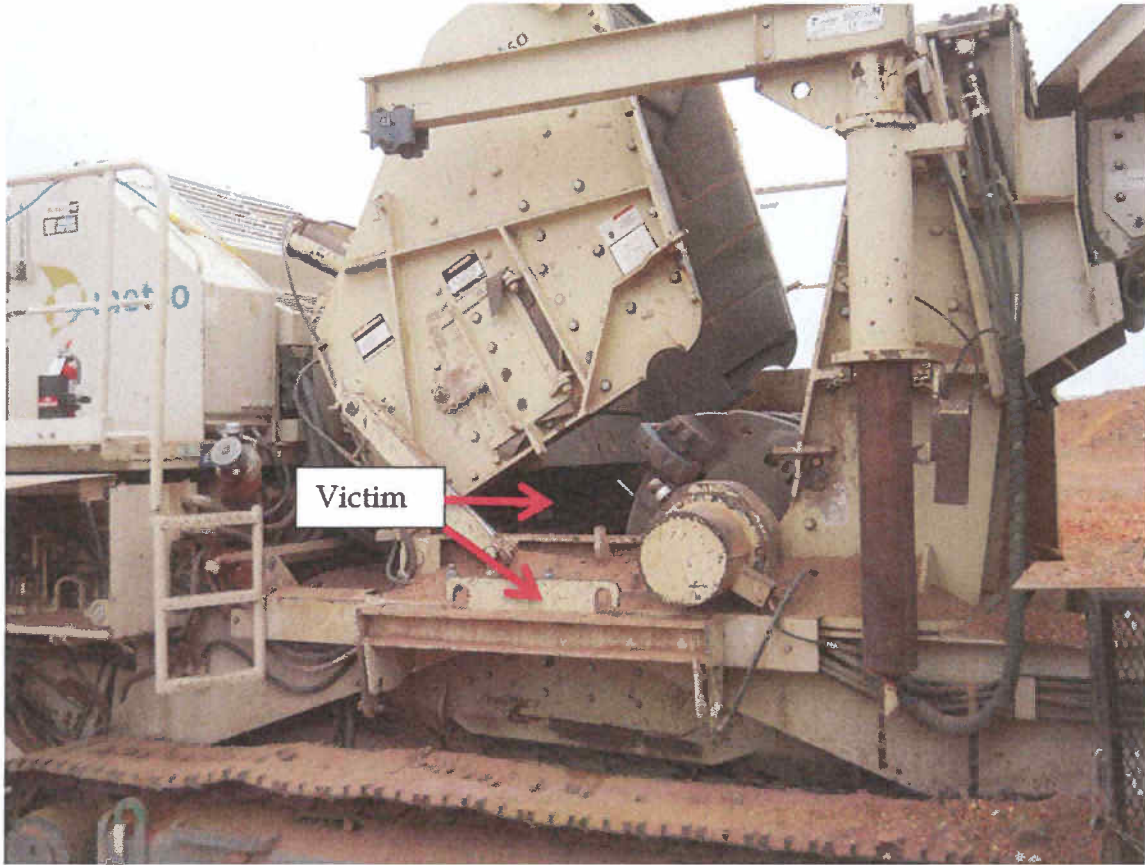
While Wells was moving the excavator, Wishard removed his lock and tag and started the diesel engine. Wishard then raised the upper frame of the crusher off the left safety arm and removed the safety arm from its support position to allow the upper frame to return to its normal position. For an unknown reason, Wishard positioned his body between the lower frame of the crusher and the raised upper frame (see Appendix A, Photo 5). While Wishard was leaning over the lower frame, the upper frame slowly moved down, fatally crushing Wishard.

Photograph 5: Victim Location

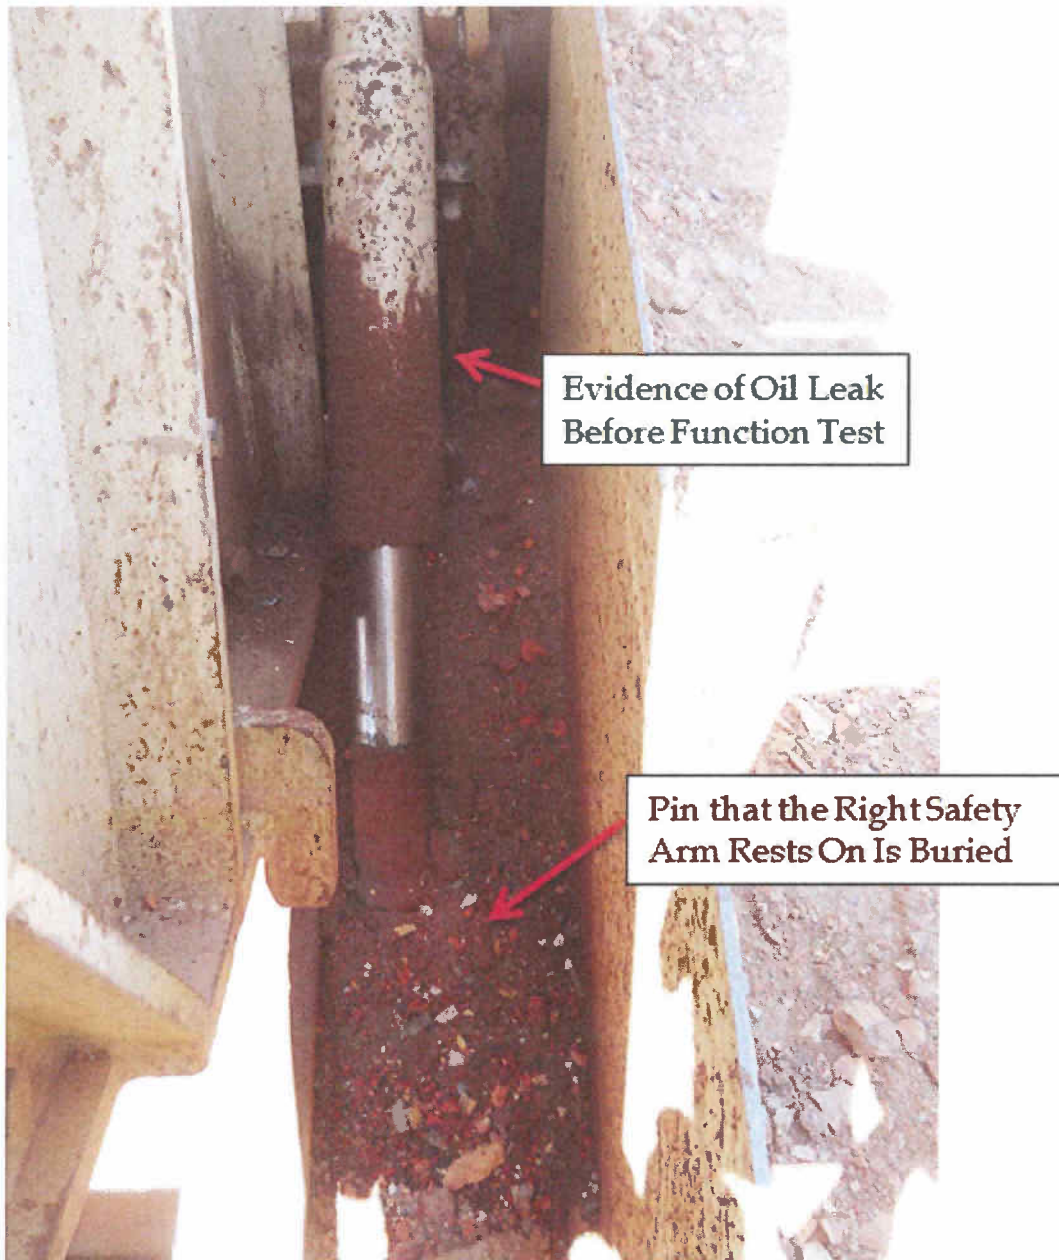
The right hydraulic cylinder had a substantial visible hydraulic leak (see Appendix A, Photo 6). This leak was present at the time of the accident and caused the upper frame to slowly fall onto the victim. Investigators could not determine, however, if the oil leak existed before the accident.

The oil leak was discovered by MSHA before the crusher frame was raised for the function test during the investigation. The oil accumulation below the cylinder was 9" wide x 69" long. This was the first time anyone saw evidence of an oil leak. The right cylinder had a film of hydraulic oil covered in scoria dust on it. The crushed scoria under the right cylinder had stains of hydraulic oil present. The scoria was a darker color due to the oil and was moist, indicating a fresh leak.

When one cylinder is leaking oil and losing pressure, it will cause the other cylinder to lose pressure as well. Since the right side cylinder was not maintained in safe operating condition and no safety arm or other blocking material was in place, the hydraulics bled off and the upper frame lowered and crushed Wishard. The manufacturer indicated

2. *Root Cause:* RCI failed to maintain the crusher in a safe operating condition. The right cylinder for lifting the upper frame had an oil leak that allowed the hydraulic pressure bleed off allowing the frame to lower unintentionally. Also, there was an accumulation of scoria present on and around the pin for the right safety arm so that it could not be used.

Photograph 6: Right Cylinder

*Corrective Action:* RCI established an additional written Standard Operating Procedure (SOP) to emphasize key aspects of their current task training program. The SOP addresses identifying safety issues to maintain equipment and repair/eliminate oil leaks. Also, the crushing unit was removed from the mine site for repairs. The crusher was inspected by an MSHA inspector to assure safe operating condition prior to it being used again at a mine.
